2008 Adopt-A-Lake Report

Volunteer Lake Monitoring Results

Report Completed: June 2009 Online Reports: http://www.orangecountyfl.net http://www.orangewateratlas.org

For Comments or questions please contact: **Orange County Environmental Protection Division Ecological Assessment Team** 800 Mercy Drive, Suite 4 Orlando, FL 32808 (407) 836-1400

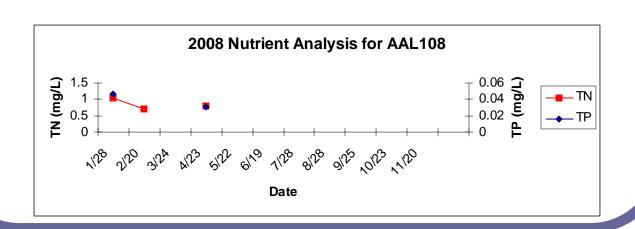
The average lake temperature for the year was 17° C. Dissolved oxygen was 5.4 mg/L, and pH was 7.2. Bacteria levels experienced a large spike in March, with a sample concentration of 2000 CFU/100 mL. There was not enough data to show a relationship between nitrogen and phosphorus levels.

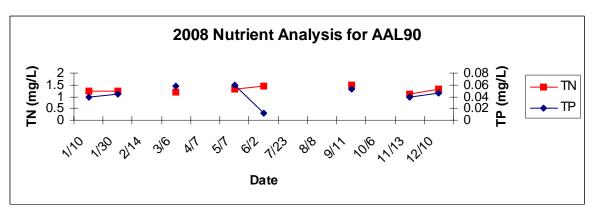
The average lake temperature for the year was 21° Celsius. The average for Dissolved Oxygen was 4.3 mg/L, pH was 6.4, and secchi depth was 0.9 meters. Bacteria levels had a peak in September of 3900 CFU/100 mL. There was not enough data to show a direct relationship in nutrients, however, the graph does suggest that Total phosphorus and total nitrogen were in proportion; except for June.

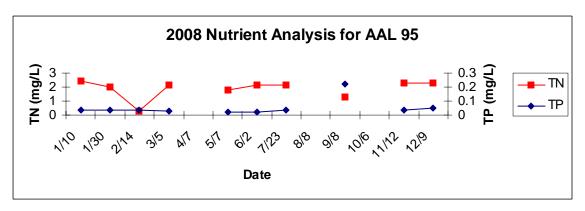
The average lake temperature for the year was 22° Celsius. The average for dissolved oxygen was 5.8 mg/L, pH was 7.4, and secchi depth was 1 meter. Bacteria levels were above 200 CFU/100 mL for all months except February, June, and July. Total phosphorus and total nitrogen remained in proportion with one another for all months collected, except February.

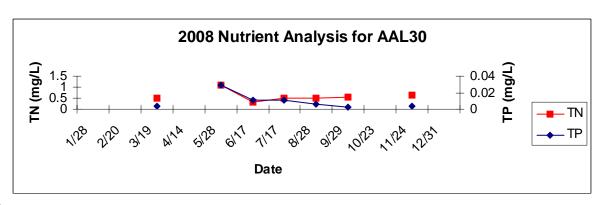
The average lake temperature for the year was 25° C. Dissolved oxygen was 8.8 mg/L, pH was 7.4 and secchi depth was 1.5 meters. Bacteria levels were above the average of 71 CFU/100 mL in May and October. Total nitrogen and phosphorus remained in fairly constant proportion to each other during the 2008 sampling season. There was a slight increase in for both observed in May.

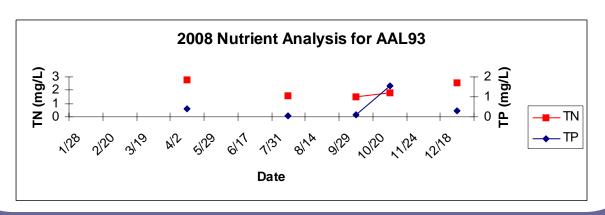
The average lake temperature for the year was 25° C. Dissolved oxygen was 7.4 mg/L, pH was 8.0 and secchi depth was 1.0 meter. Bacteria levels were relatively constant, with concentrations above 200 CFU/100 mL for 3 out of the 6 months sampled for 2008. Total nitrogen and phosphorus remained in fairly constant proportion to each other for the dates sampled.

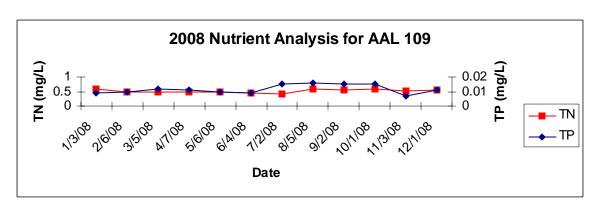
The average lake temperature for the year was 27° C. Dissolved oxygen was 5.4 mg/L, pH was 6.7 and secchi depth was 1.4 meters. Bacteria levels were relatively constant, under 80 CFU/100 mL, except for the October sample which had a concentration of 420 CFU/100 mL. Total nitrogen and phosphorus remained in fairly constant proportion to each other during the 2008 sampling season.

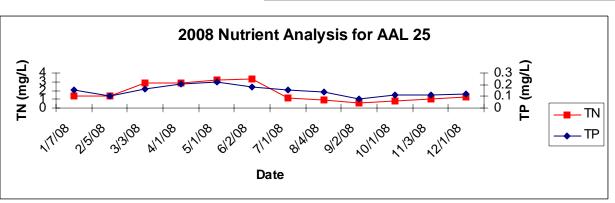
The average lake temperature for the year was 23° Celsius. The average for dissolved oxygen was 6.9 mg/L, pH was 6.2, and secchi depth was 0.9 meters. Bacteria levels were very high throughout the year, with peaks in July, and October. Nutrient levels fluctuated between the wet and dry season. Total phosphorus and total nitrogen were in proportion for the 2008 year.

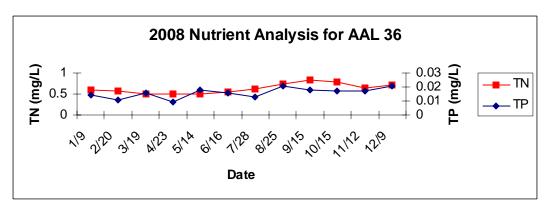
The average lake temperature for the year was 24° Celsius. The average for dissolved oxygen was 7.7 mg/L, pH was 7.8, and secchi depth was 1.8 meters. Bacteria levels peaked in January and then decreased for the remainder of the year. Total phosphorus and total nitrogen both showed an increase over the year, except for November, where there was a slight decrease in total nitrogen.

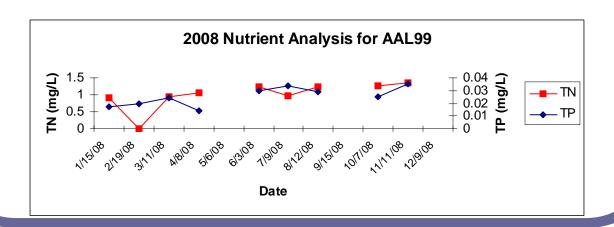
The average lake temperature for the year was 23° Celsius. The average for Dissolved Oxygen was 6.7 mg/L, pH was 7.2, and secchi depth was 1 meter. Bacteria levels increased during the summer months of June-August. Nutrient levels did not show any significant pattern.

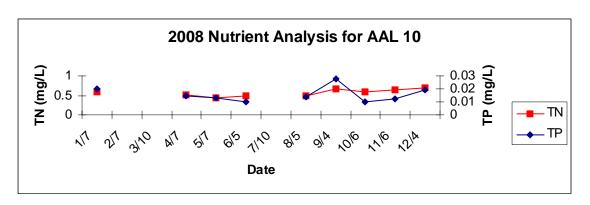
The average lake temperature for the year was 27° Celsius. The average for dissolved oxygen was 8.1 mg/L, pH was 7.6, and secchi depth was 1.9 meters. Bacteria levels were fairly constant except for a peak in July. Total phosphorus and total nitrogen were in relative proportion to one another throughout the season. Slight fluctuations in total phosphorus were observed; while total nitrogen increased.

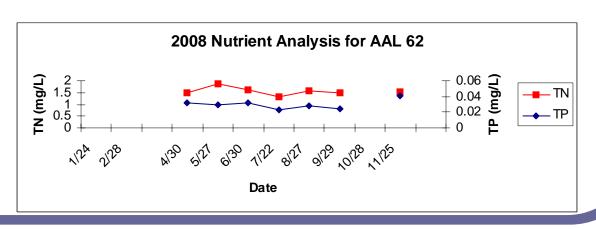
The average lake temperature for the year was 25° Celsius. The average for dissolved oxygen was 6.9 mg/L, and pH was 7.4. Bacteria levels were above 200 CFU/100 mL for most of the season with a spike of 6200 CFU/100 mL. Total phosphorus and total nitrogen were in proportion with both increases and declines throughout the year

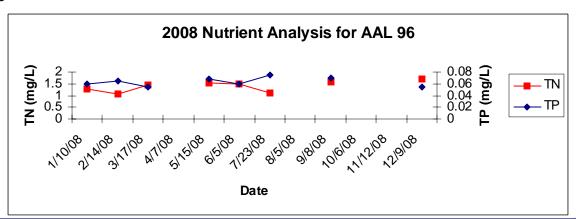
The average lake temperature for the year was 22° C. Dissolved oxygen was 4.3 mg/L, pH was 7.2 and secchi depth was 0.9 meters. Bacteria levels experienced a large spike of 4000 CFU/100 mL in May. On average, the fecal coliform counts were above 200 CFU100mL throughout 2008. Total nitrogen and total phosphorus remained in fairly constant proportion to each other during the 2008 sampling season.

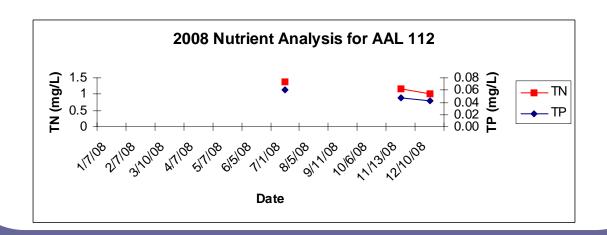
The average lake temperature at this site was 26°C. Dissolved oxygen was 6.1 mg/L, pH was 6.4 and secchi depth was 0.6 meters. Bacteria levels were relatively high for all of the collection dates. Total nitrogen and total phosphorus were in proportion to each other for the dates sampled in 2008.

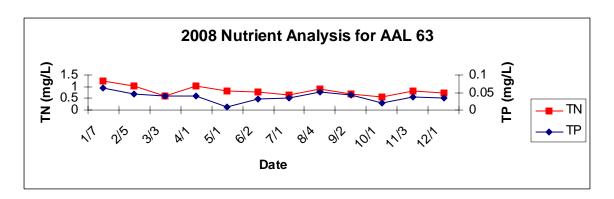
The average lake temperature for the year was 24° Celsius. The average for dissolved oxygen was 5.6 mg/L, pH was 6.9, and secchi depth was 2.9 meters. Bacteria levels were high, remaining above 200 CFU/100 mL for most of the season. Total phosphorus and total nitrogen concentrations showed both increases and declines throughout the year.

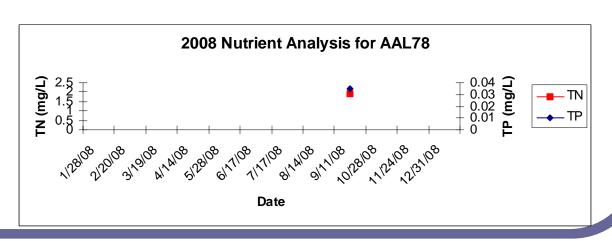
The average lake temperature for the year was 26° C. Dissolved oxygen was 5.6 mg/L, pH was 7.2 and secchi depth was 1.0 meter. Bacteria levels had one sample over 200 CFU/100 mL in September; which was 580 CFU/100 mL. There was not enough data to determine a relationship between total nitrogen and total phosphorus.

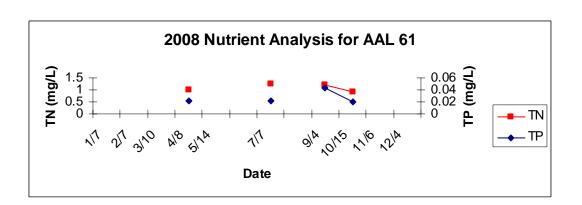
The average lake temperature for the year was 28° Celsius. The average for dissolved oxygen was 5.5 mg/L, pH was 7.4 and secchi depth was 0.8 meters. Bacteria levels were low for the 2008 year. Total phosphorus and total nitrogen concentrations were in proportion with each other for the dates sampled.

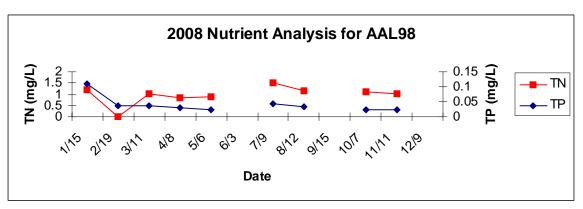
The average lake temperature for the year was 24° Celsius. The average for dissolved oxygen was 8.0 mg/L, pH was 7.1, and secchi depth was 0.7 meters. Bacteria levels fluctuated throughout the season. In August, the bacteria spiked at 250 CFU/100 mL. Total phosphorus and total nitrogen were in proportion with each other. A slight increased was observed during July, followed by a decrease.

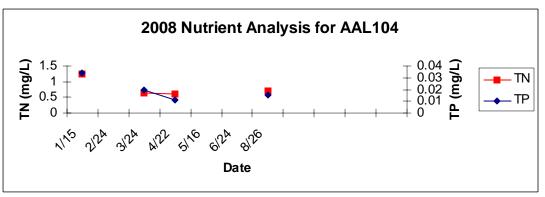
The average lake temperature for the year was 22° Celsius. The average for Dissolved Oxygen was 6.2 mg/L, pH was 6.3 and secchi depth was 1.8 meters. Bacteria levels increased slightly in February, but all were a below 50 CFU/100 mL. There was not enough data to show a relationship between total nitrogen and total phosphorus.
