Lake Killarney Hydrologic / Nutrient Budget Evaluation

Final Report

January 2013

Environmental Research & Design, Inc.

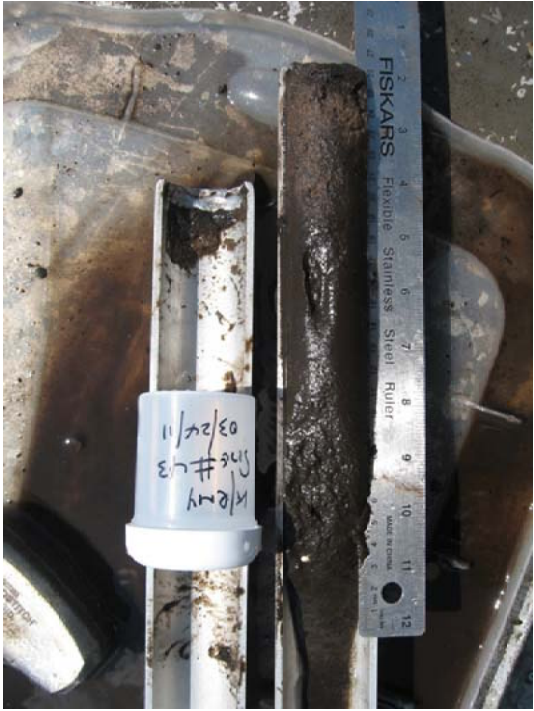
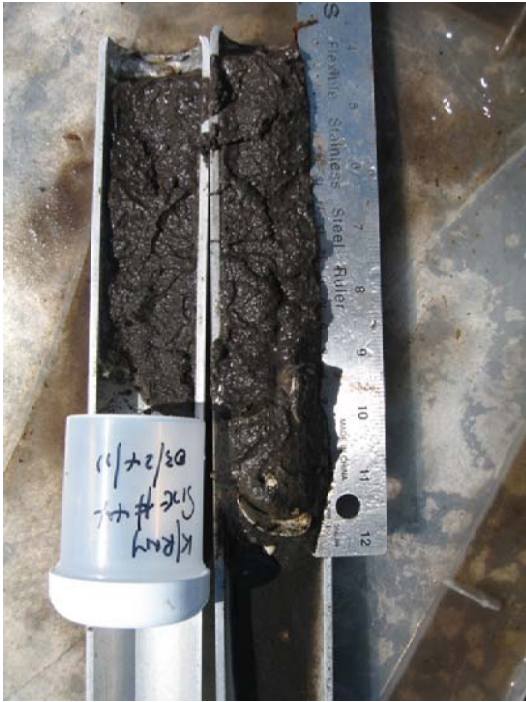
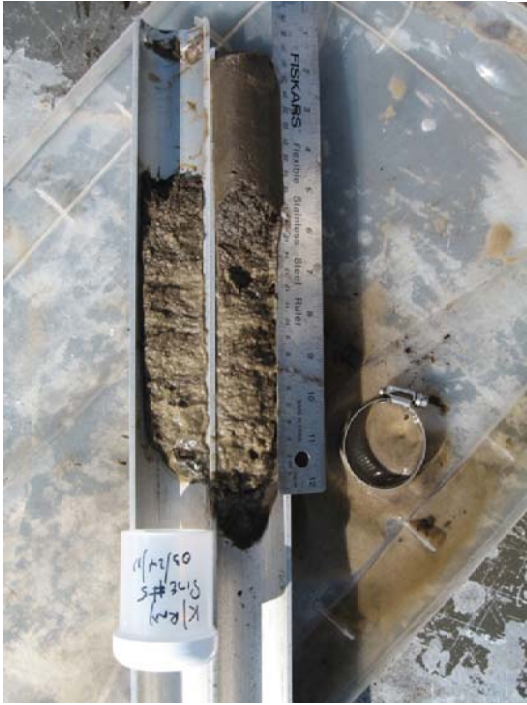
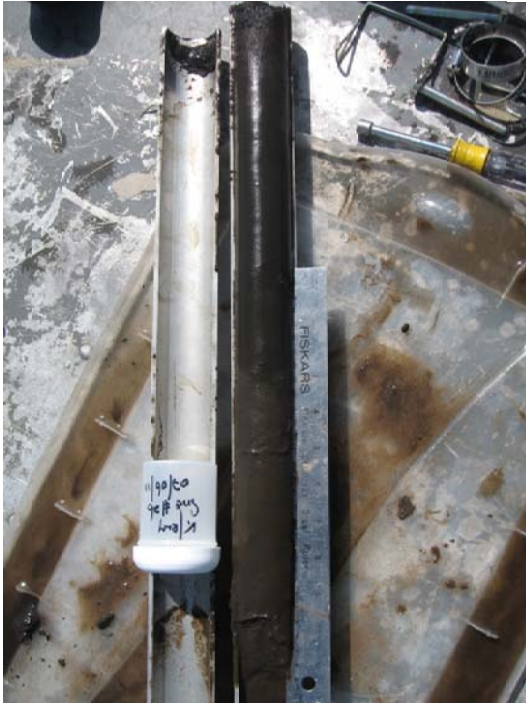
Figure 2-6. Photographs of Typical Sediment Characteristics in Lake Killarney.

b. Organic muck overlying sand

d. Organic muck with shell fragments

a. Sandy sediments

c. Deep organic muck sediments

Visual characteristics of sediment core samples were recorded for each of the 45 sediment samples collected in Lake Killarney during March 2011. A summary of visual characteristics of sediment core samples is given in Table 2-5. In general, a surficial layer of unconsolidated organic muck was observed in Lake Killarney at 13 of the 45 monitoring sites, with measured depths ranging from 0-8 cm. This unconsolidated surficial layer is comprised primarily of fresh organic material (such as dead algal cells) and detritus which has recently accumulated onto the bottom of the lake. This organic material is easily disturbed by wind action or boating activities. In deeper portions of the lake, characterized by thick muck deposits, the organic muck becomes more consolidated beneath the surficial layer, with a consistency similar to pudding. These layers reflect older organic deposits which are resistant to further degradation. These layers typically do not resuspend into the water column except during relatively vigorous wind activity on the lake. Shallow and shoreline areas of the lake are characterized by a mixture of brown fine sand and muck. Photographs of typical sediment characteristics in Lake Killarney are given on Figure 2-6.

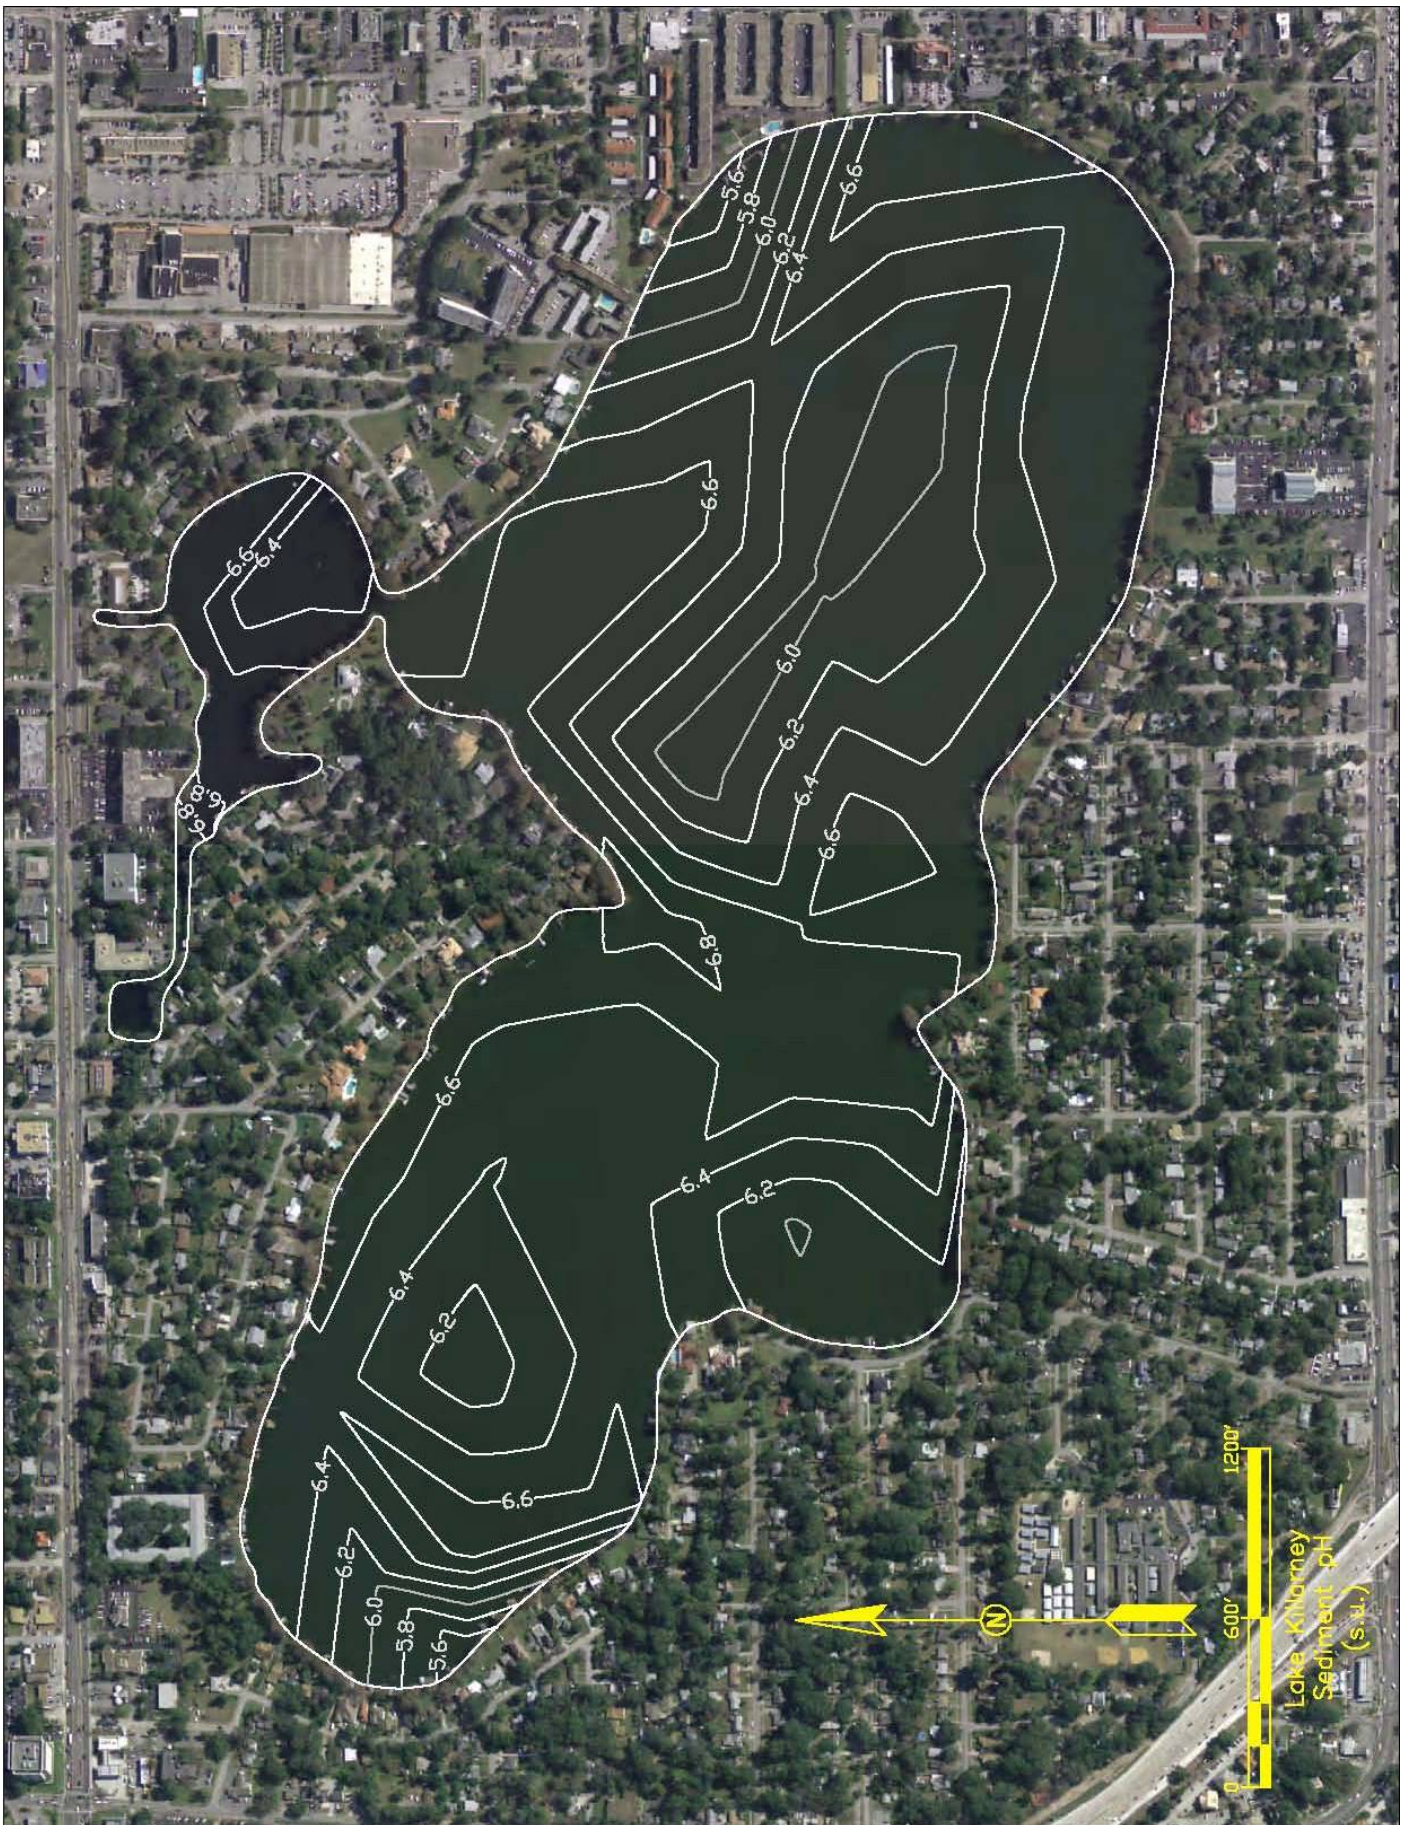
Figure 2-7. Isopleths of pH in the Top 10 cm of Sediments in Lake Killarney.

Isopleths of pH in the top 10 cm of sediments in Lake Killarney are illustrated on Figure 2-7, based upon the information provided in Table 2-6. The majority of areas within Lake Killarney are characterized by pH values ranging from approximately 6.0-6.6. In general, pH values of approximately 6.2 or less were observed in areas of deep organic muck within the lake, although pH values equal to this or less were also observed in shoreline areas along the southwestern and northeastern portions of the lake.

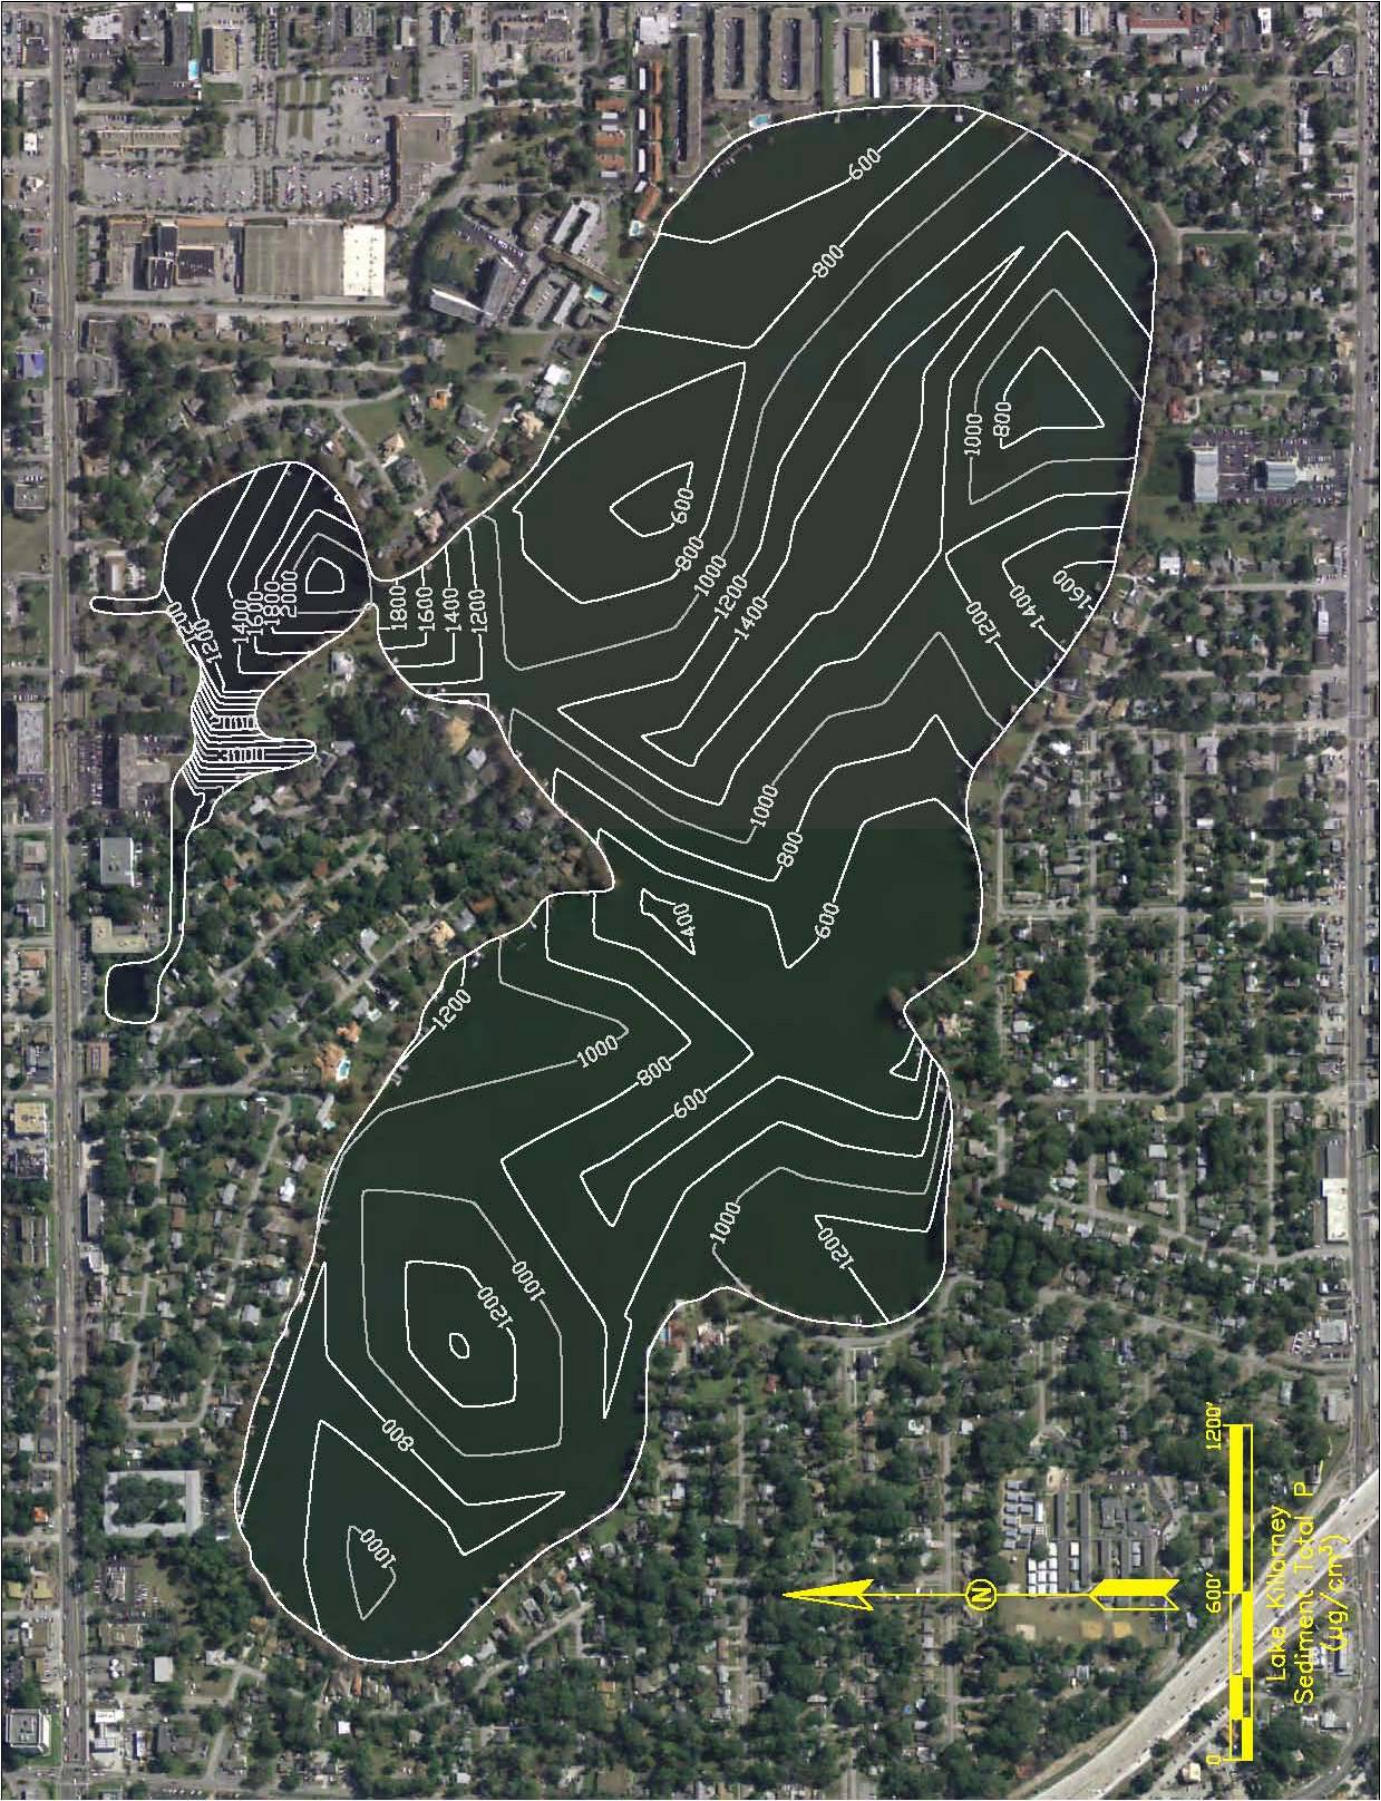
Figure 2-11. Isopleths of Total Phosphorus ($\mu\text{g}/\text{cm}^3$) in the Top 10 cm of Sediments in Lake Killarney.

Isopleths of sediment phosphorus concentrations in Lake Killarney are presented on Figure 2-11, based on information contained in Table 2-6. Areas of elevated sediment phosphorus concentrations are present in the central and southeastern portions of the lake, similar to the areas of elevated moisture and organic content illustrated on Figures 2-8 and 2-9, respectively. In general, overall total phosphorus concentrations observed in Lake Killarney appear to be somewhat elevated compared with phosphorus sediment concentrations typically observed in urban lakes.

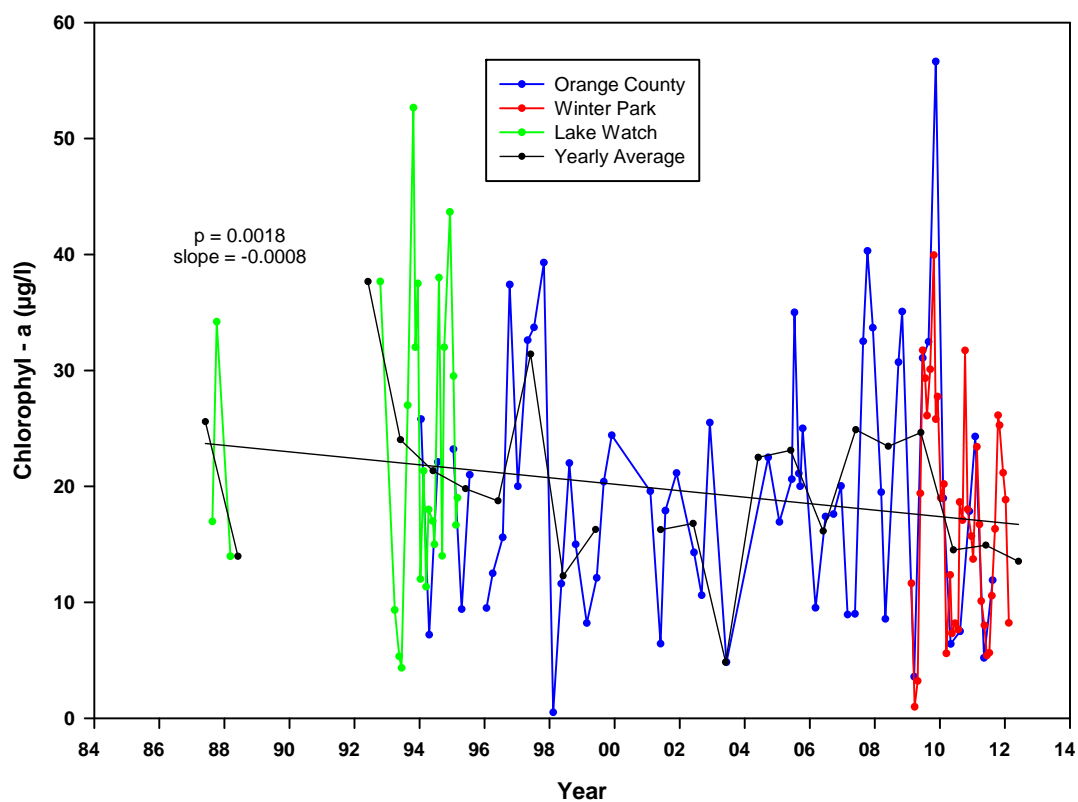
Figure 2-17. Summary of Trends in Chlorophyll-a and Secchi Disk Depth in Lake Killarney from 1985-2011.

Variations in measured concentrations of chlorophyll-a (corrected) and Secchi disk depth in Lake Killarney from 1985-2011 are illustrated on Figure 2-17. Measured chlorophyll-a concentrations in the lake have ranged from 1-55 mg/m^3 over the monitoring period, although the majority of values range from approximately 5-40 mg/m^3 . Measured chlorophyll-a concentrations by Orange County, LAKEWATCH, and the City of Winter Park appear to be relatively similar. Mean annual concentrations of chlorophyll-a in Lake Killarney exhibit a trend similar to that observed for total phosphorus, with a slow decline over time. More recent chlorophyll-a concentrations in the lake have been highly variable. The calculated p value of 0.0018 indicates a highly significant downward trend.

Variability in measured Secchi disk depths in Lake Killarney are also illustrated on Figure 2-17. Measurements have ranged from near zero to 5.5 m, although both of these extreme values appear unlikely. The majority of the measured values appear to fall in the range of 0.5-2 m. A trend of increasing Secchi disk depth is apparent over time, and the calculated p value of 0.0028 indicates that the trend is highly significant.

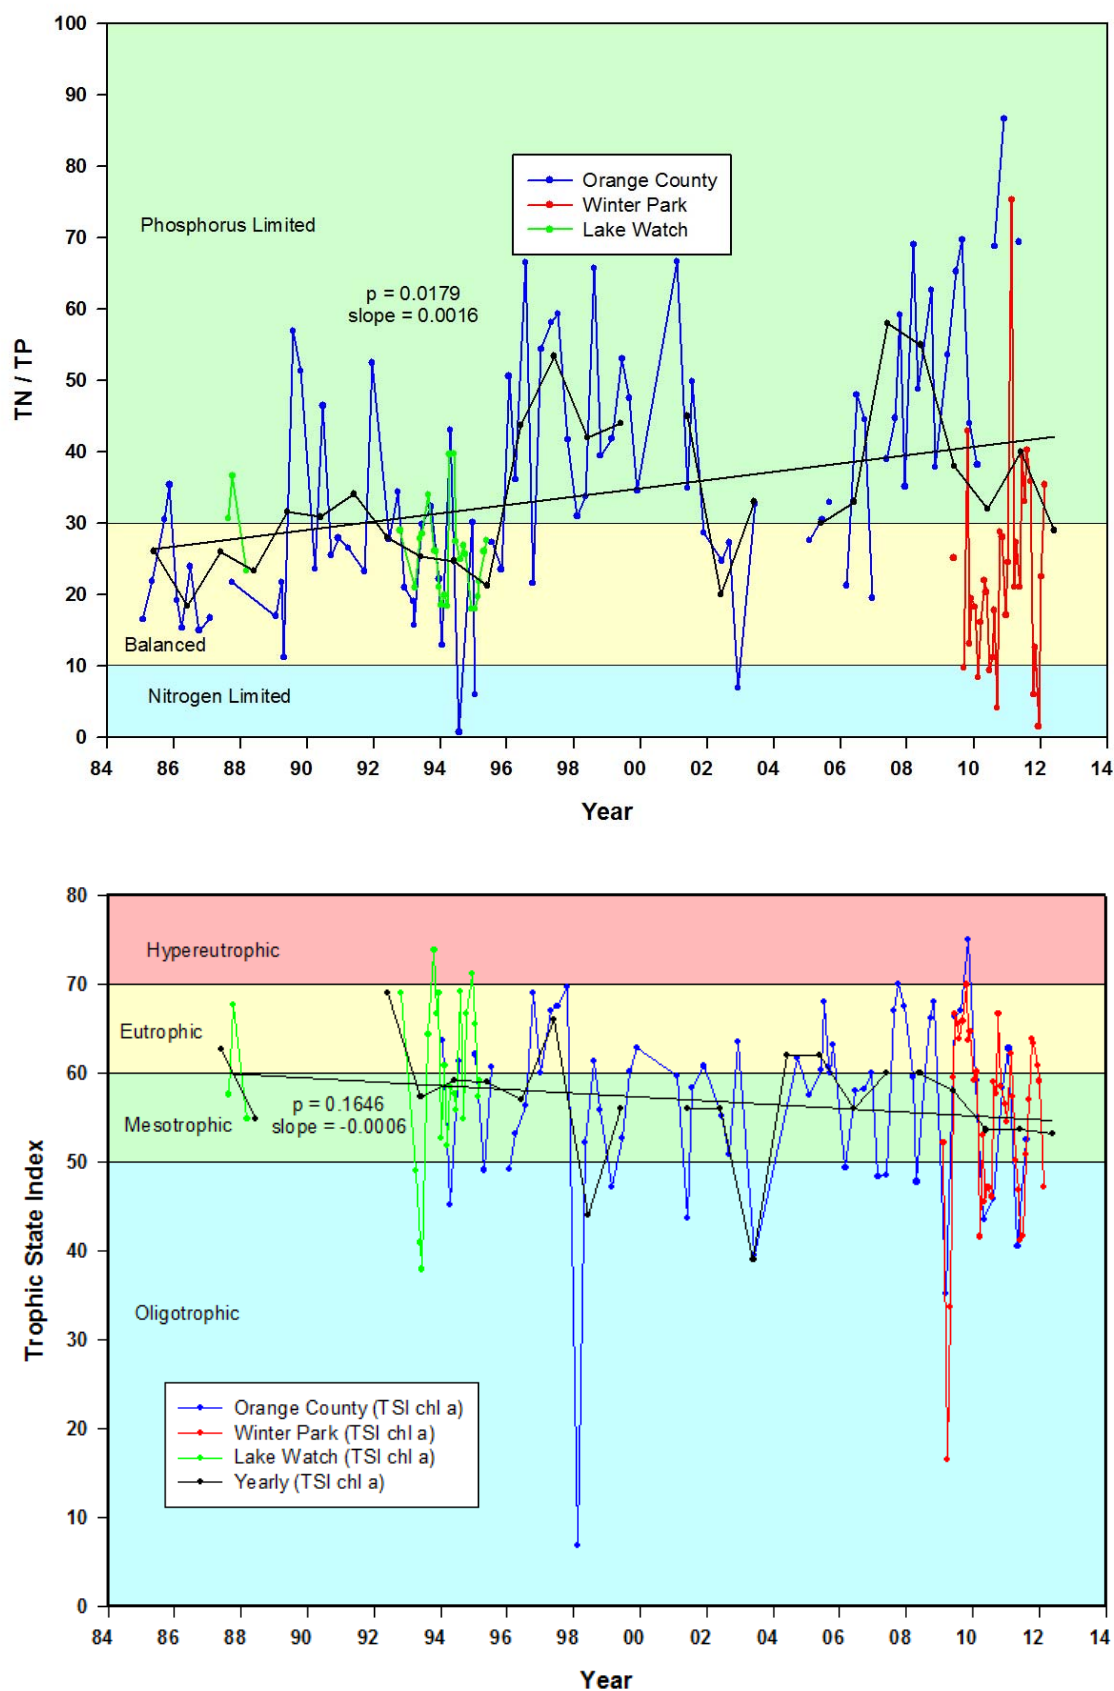
Figure 2-18. Summary of Trends in TN/TP Ratio and TSI Values in Lake Killarney from 1985-2011.

A summary of mean annual total nitrogen/total phosphorus (TN/TP) ratios in Lake Killarney from 1985-2011 is given in Figure 2-18. Based on the mean annual TN/TP ratios indicated on Figure 2-18, it appears Lake Killarney exists in either a nutrient-balanced or phosphorus-limited condition much of the time. The data appear to suggest that Lake Killarney is becoming more phosphorus-limited over time, although recent monitoring by Orange County indicates phosphorus-limited conditions presently while the Winter Park data suggest nitrogen-limited conditions. A trend line for changes in TN/TP ratios is also shown on Figure 2-18 which indicates a general trend toward increasing phosphorus limitation within the lake. The p value of 0.0179 suggests that the trend is highly significant.

Mean annual TSI values in Lake Killarney from 1985-2011 are also summarized on Figure 2-18. Mean annual TSI conditions in Lake Killarney have ranged from oligotrophic to borderline eutrophic-hypereutrophic conditions, with most values reflecting mesotrophic to eutrophic conditions, and the calculated p value of 0.1646 indicates that the trend is not statistically significant.

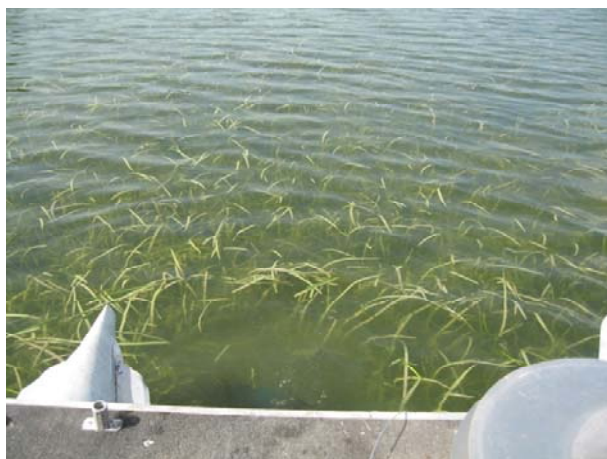
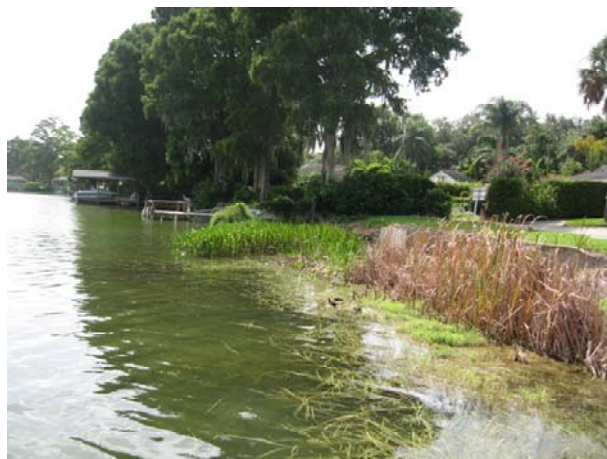
Figure 2-30. Photographs of Submerged Aquatic Vegetation Under Existing Conditions.

a. Eelgrass in shoreline areas

b. Floating eelgrass cut by boating activities

Photographs of submerged aquatic vegetation in Lake Killarney under existing conditions are given in Figure 2-30. Abundant growth of eelgrass occurs in virtually all shoreline areas of the lake, often extending to water depths of 8-10 ft. In some areas, the dense growth of eelgrass interferes with navigation and boating activities, and floating eelgrass cut by boating activities can be seen along lakefront shorelines on virtually any day.

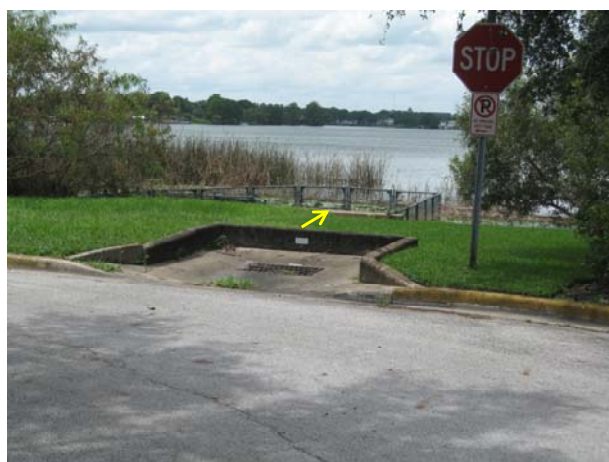
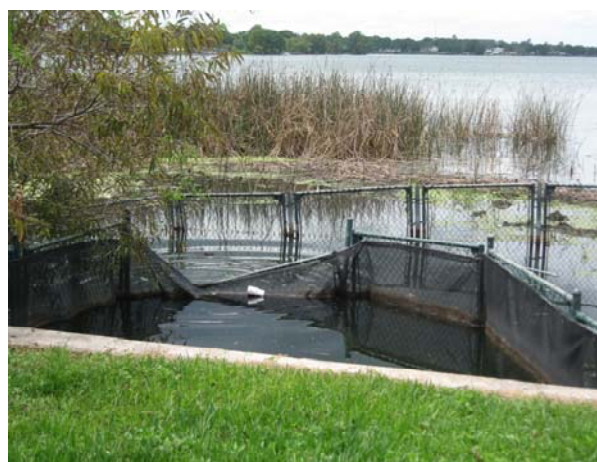
Figure 5-5. Photographs of the Beachview Avenue Monitoring Site.

a. Inlet at end of Beachview Drive

b. Leaf and debris trap at pipe outfall

Photographs of the Beachview Avenue monitoring site are given on Figure 5-5. Runoff is conveyed along a curb and gutter system and directed into a grate inlet and underground stormsewer system. The stormsewer discharges into a leaf and debris trap constructed from chain-link fencing and filter fabric outside of the pipe outfall. Field monitoring was conducted inside the grate inlet indicated on Figure 5-5a.

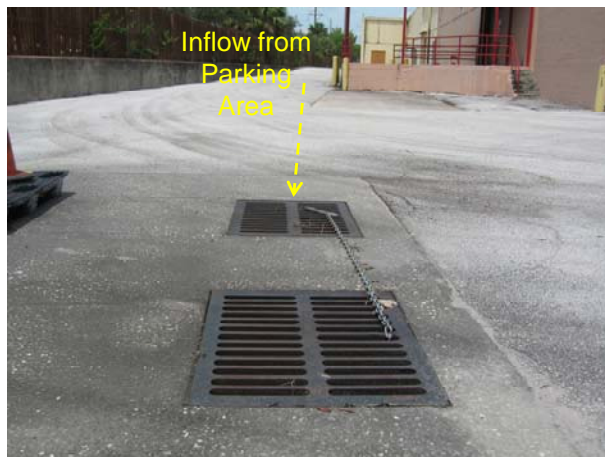
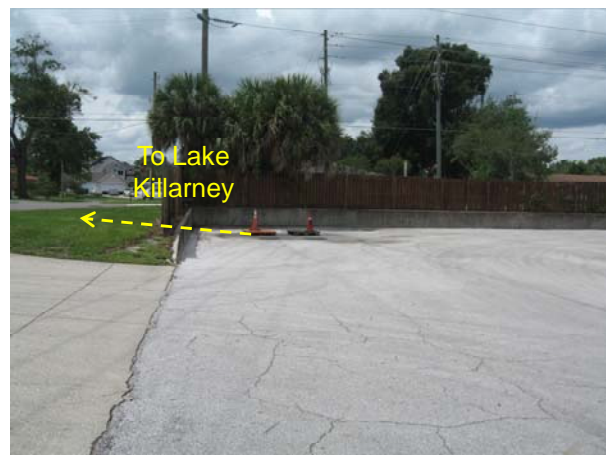
Figure 5-9. Photographs of the Executive Drive Monitoring Site.

a. Final grate structures of stormsewer system

b. Off-site discharges occur to Lake Killarney

Photographs of the Executive Drive monitoring site are given on Figure 5-9. The grate structures indicated on Figure 5-9a are connected to an extensive underground stormsewer system which conveys drainage from the shopping center area and reflects the final point of access for the stormsewer system prior to discharge off-site. After leaving the site, the runoff is conveyed into the east lobe of Lake Killarney.

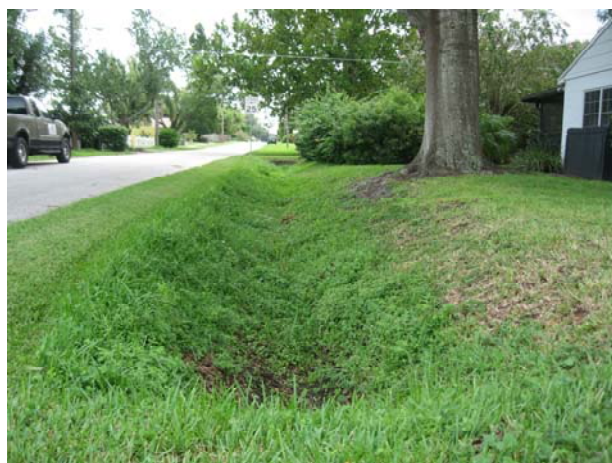
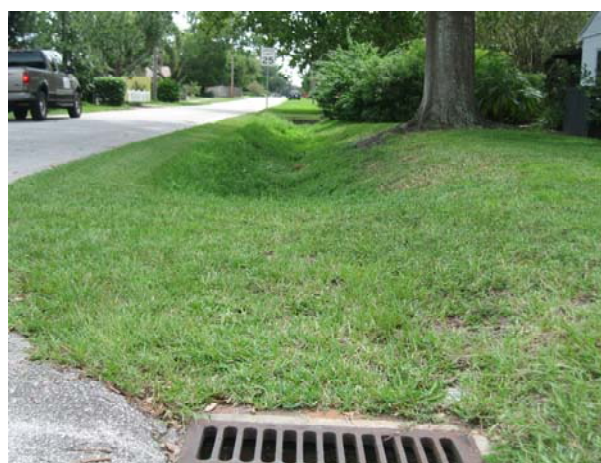
Figure 5-11. Photographs of the Formosa Avenue Monitoring Site.

a. Typical swale drainage system along Formosa Ave.

b. Inlet grate along Killarney Drive

Photographs of the Formosa Avenue monitoring site are given on Figure 5-11. The drainage system along Formosa Avenue consists primarily of vegetated roadside swales which enter an underground stormsewer system near the intersection of Formosa Avenue and Killarney Drive. Runoff generated along Killarney Drive is conveyed in a curb and gutter system and combines with the runoff from Formosa Drive. The combined inflows then are conveyed through an underground stormsewer into Lake Killarney. Monitoring was conducted in the final stormsewer inlet prior to discharge to Lake Killarney.

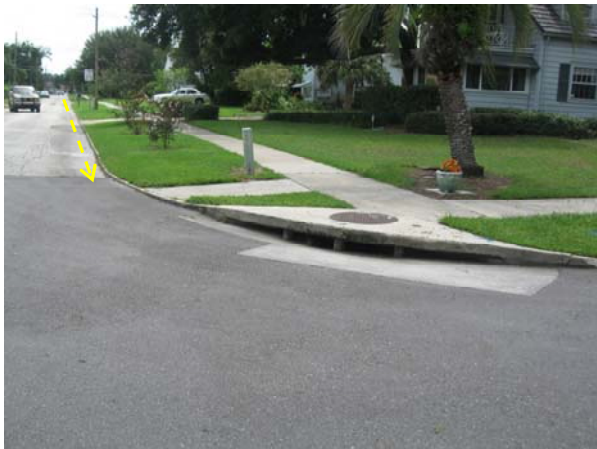
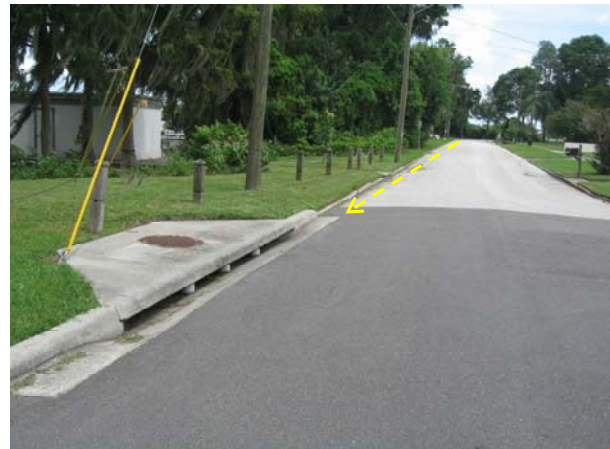
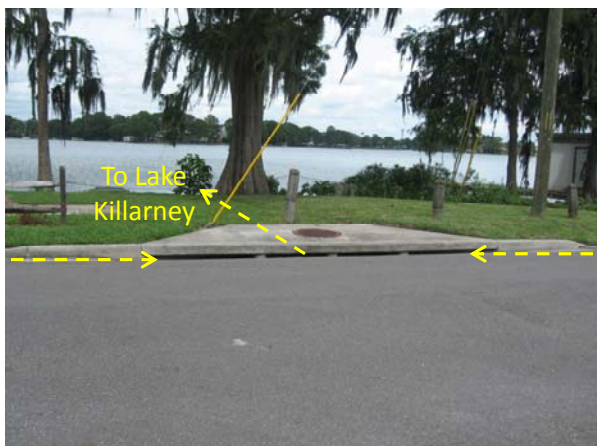
Photographs of the
Ohio Street Monitoring Site.

a. Curb inlet at end of Ohio Street

b. Curb inlet on Killarney Drive

c. Discharge to Lake Killarney

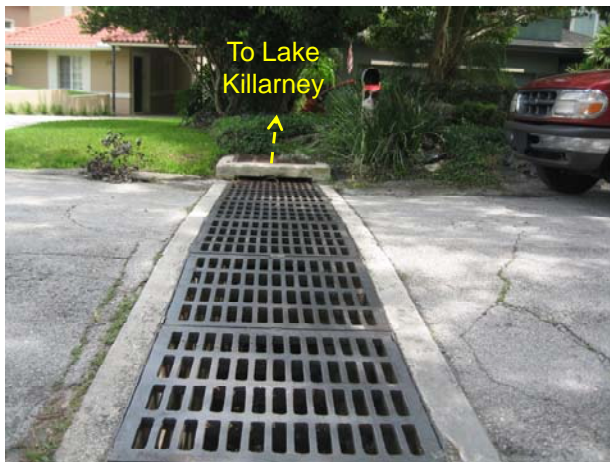
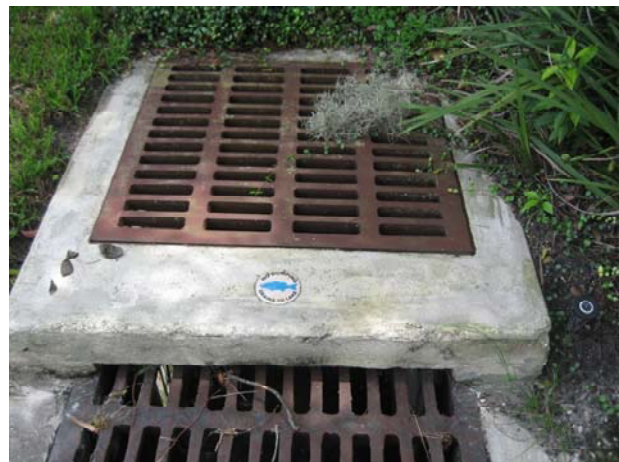
Figure 5-15. Photographs of the Ololu Drive Monitoring Site.

a. Inlet grate across Ololu Street

b. Overflow grate with "Drains to Lake" decal

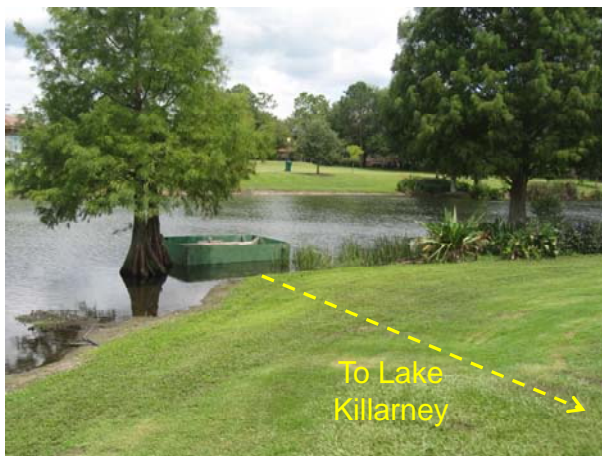
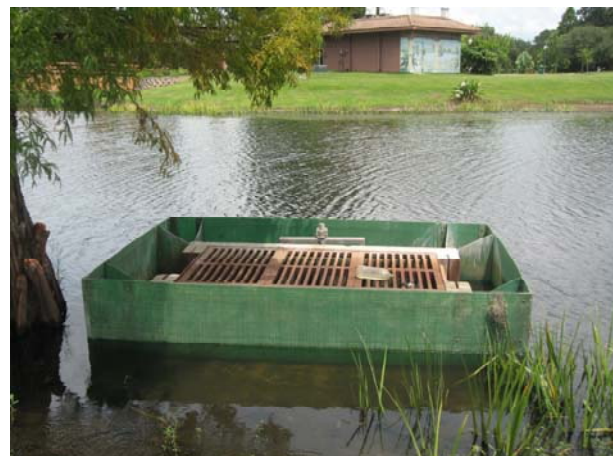
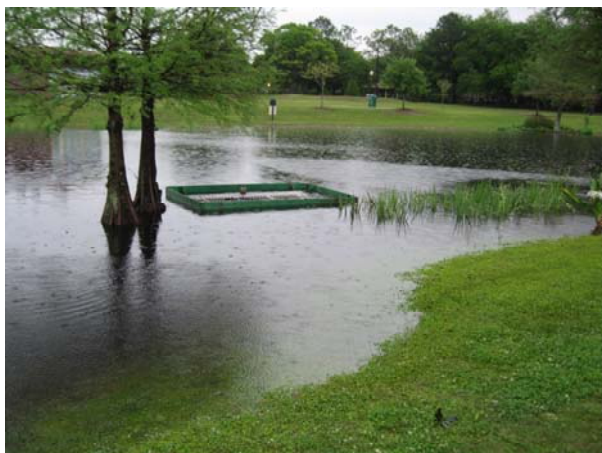
a. Lake Mendsen at outfall

b. Outfall structure to Lake Killarney

c. Lake Mendsen under flooded conditions

Photographs of the Lake Mendsen monitoring site are given on Figure 5-17. Monitoring at Lake Mendsen was conducted in the stormsewer pipe which discharges from the outfall structure. This pipe was accessed by removing one of the metal grates on top of the outfall structure during each monitoring event. A photograph of Lake Mendsen under flooded conditions is given on Figure 5-17c.
