Lake Pickett Hydrologic/Nutrient Budgets and Water Quality Management Plan

Lake Pickett Community Meeting
September 10, 2018

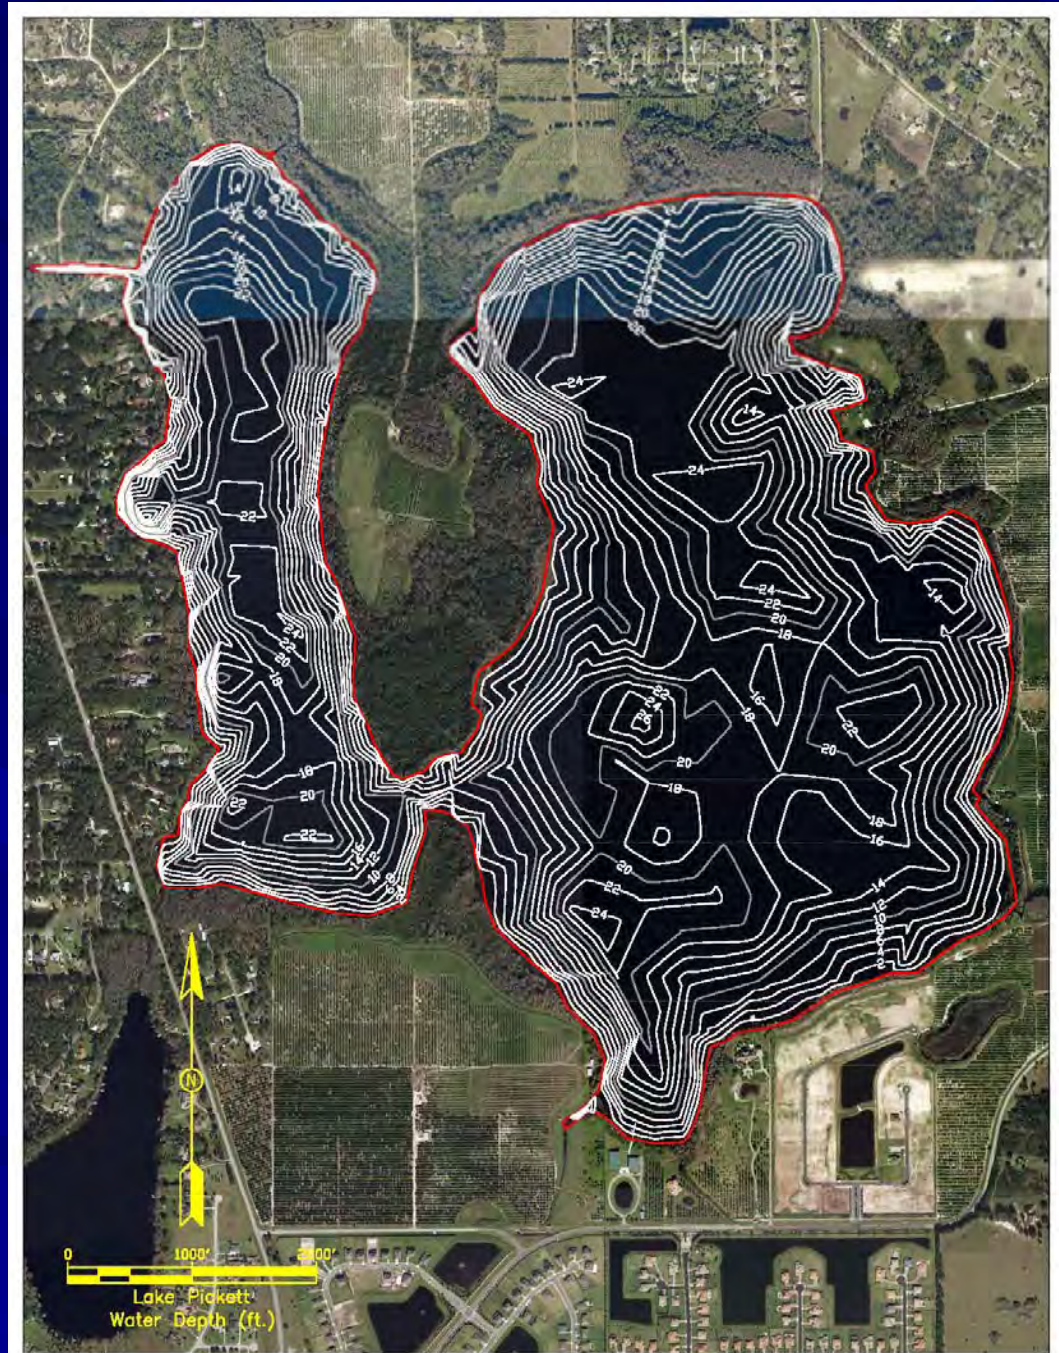
Water Depth Contours for Lake Pickett on November 11, 2015 (Water Elev. = 54.03 ft.)

Parameter	Value
Surface Area	745 acres
Total Volume	10,609 ac-ft
Mean Depth	14.2 ft
Maximum Depth	29 ft
Shoreline Length	41,272 ft (7.82 miles)

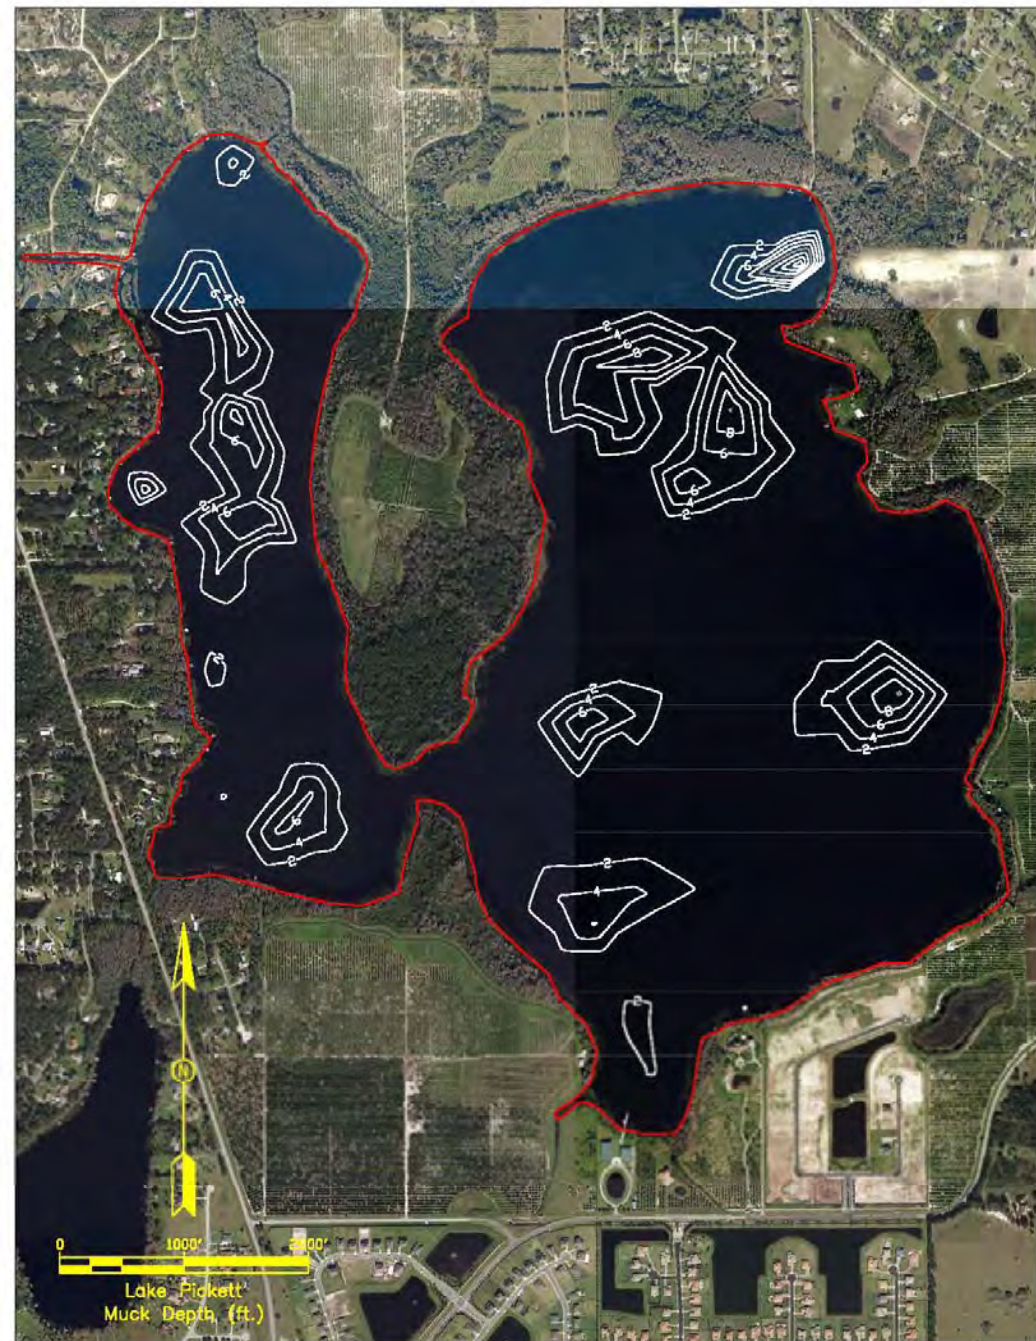
Muck Depth Contours for Lake Pickett on November 11, 2015

Muck Volume = 958 ac-ft

Mean Depth = 1.3 ft

8% of original lake
volume filled

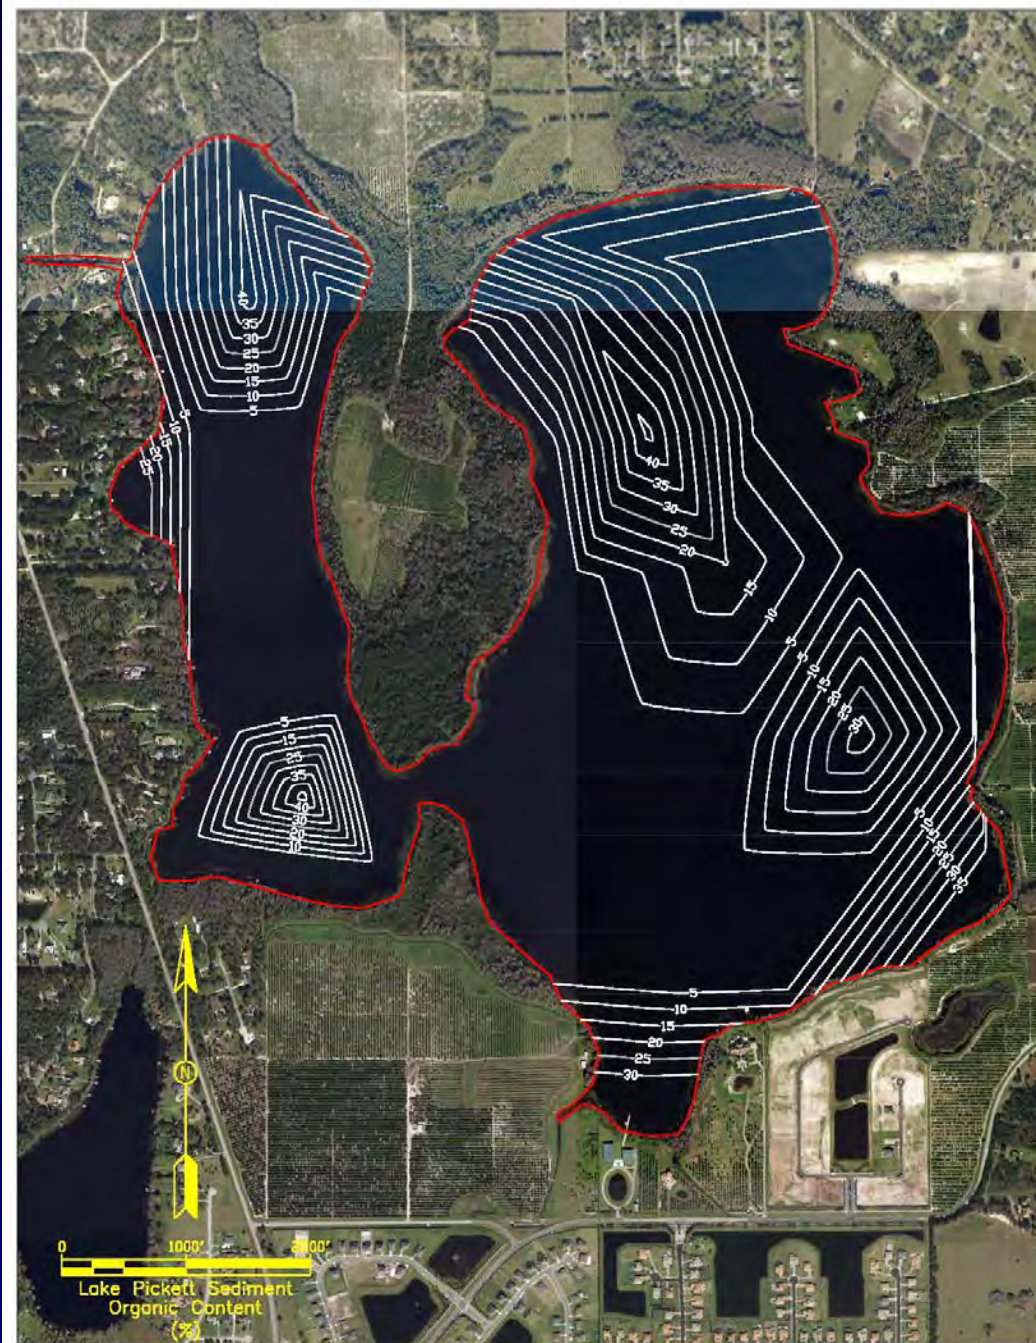
Isopleths of Organic Content (%) in the Top 10 cm of Sediments in Lake Pickett During November 2015

- Elevated organic content corresponds with areas of organic muck

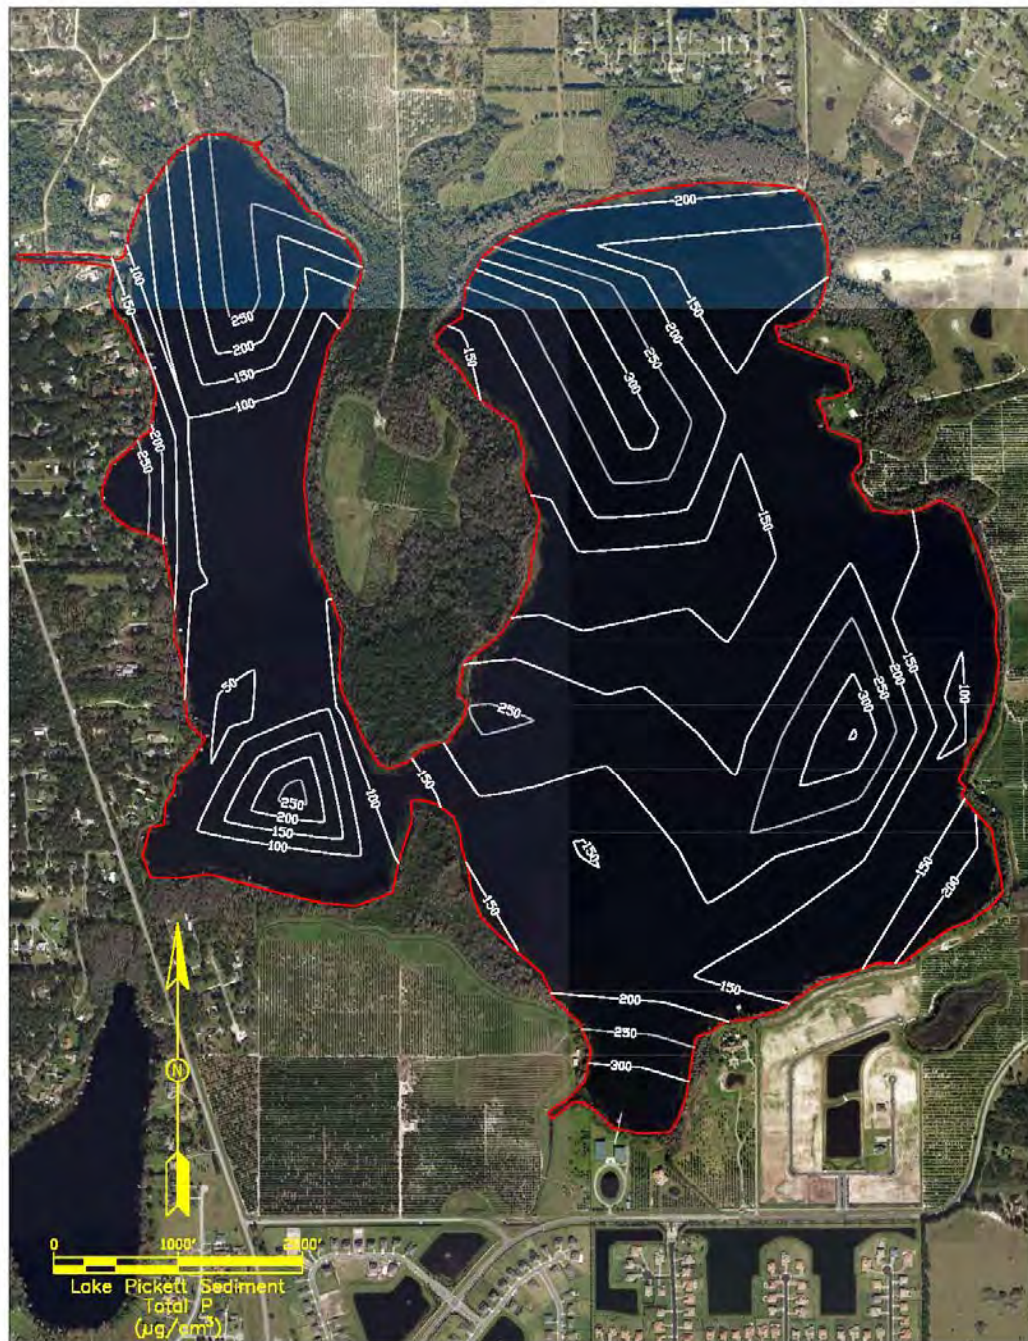
Isopleths of Total Phosphorus ($\mu\text{g}/\text{cm}^3$) in the Top 10 cm of Sediments in Lake Pickett During November 2015

- Sediment phosphorus concentrations are low to moderate in value

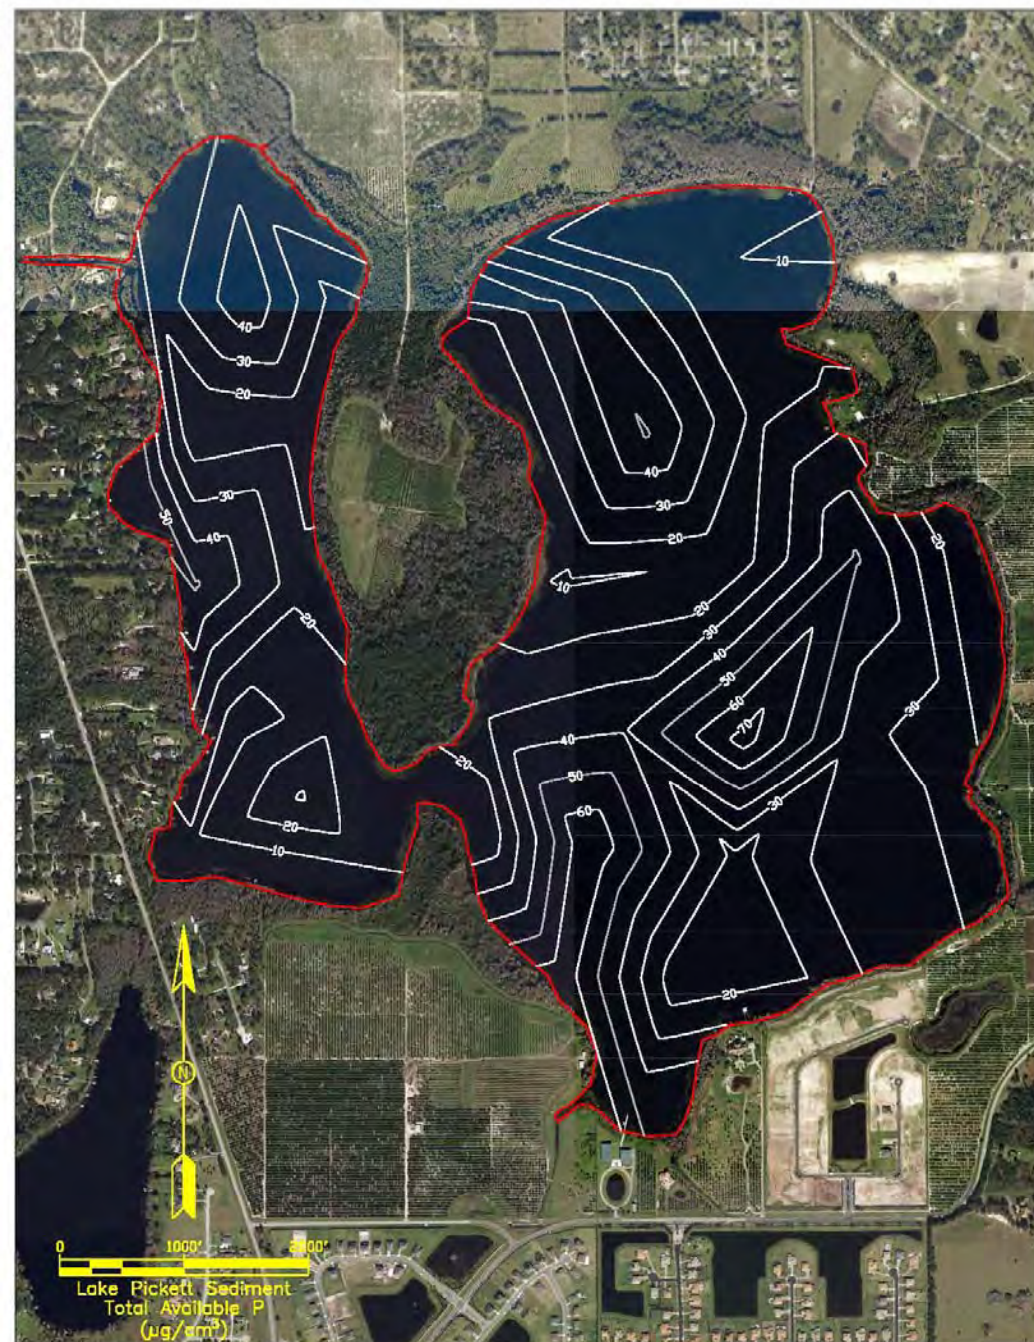
Isopleths of Total Available Phosphorus ($\mu\text{g}/\text{cm}^3$) in the Top 10 cm of Sediments in Lake Pickett During November 2015

- Measure of the amount of phosphorus that can be potentially released from the sediments through internal recycling

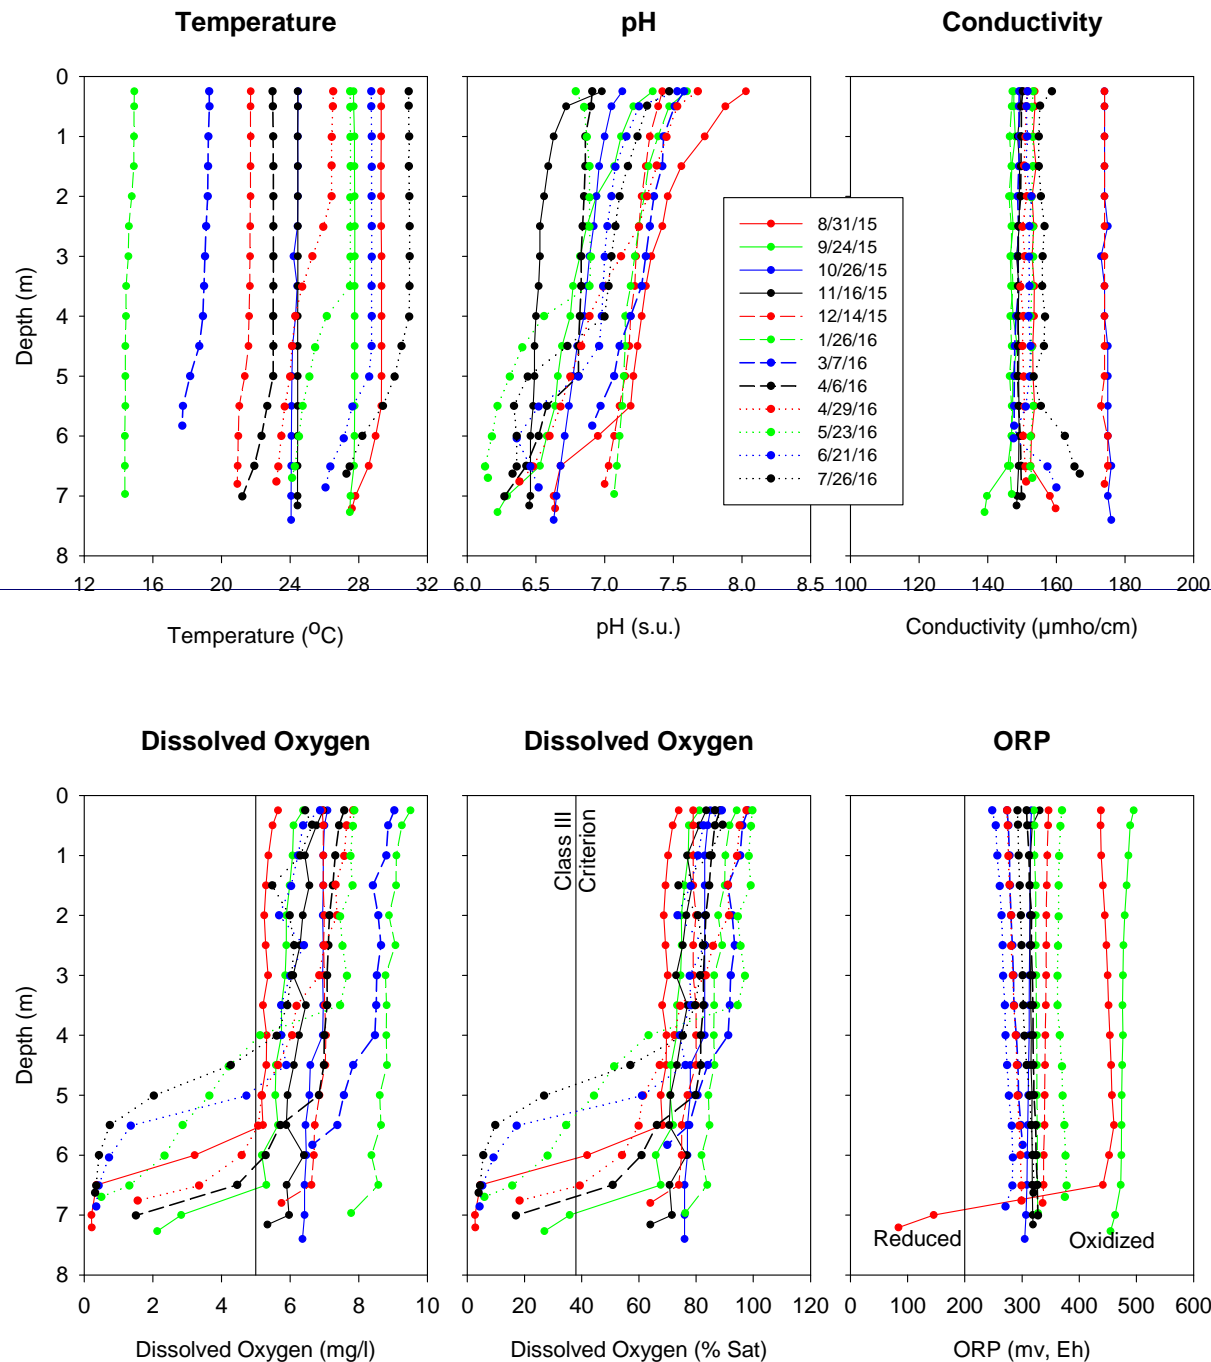
Vertical Field Profiles Collected in Lake Pickett at Site 1

- Similar profiles at the other monitoring sites

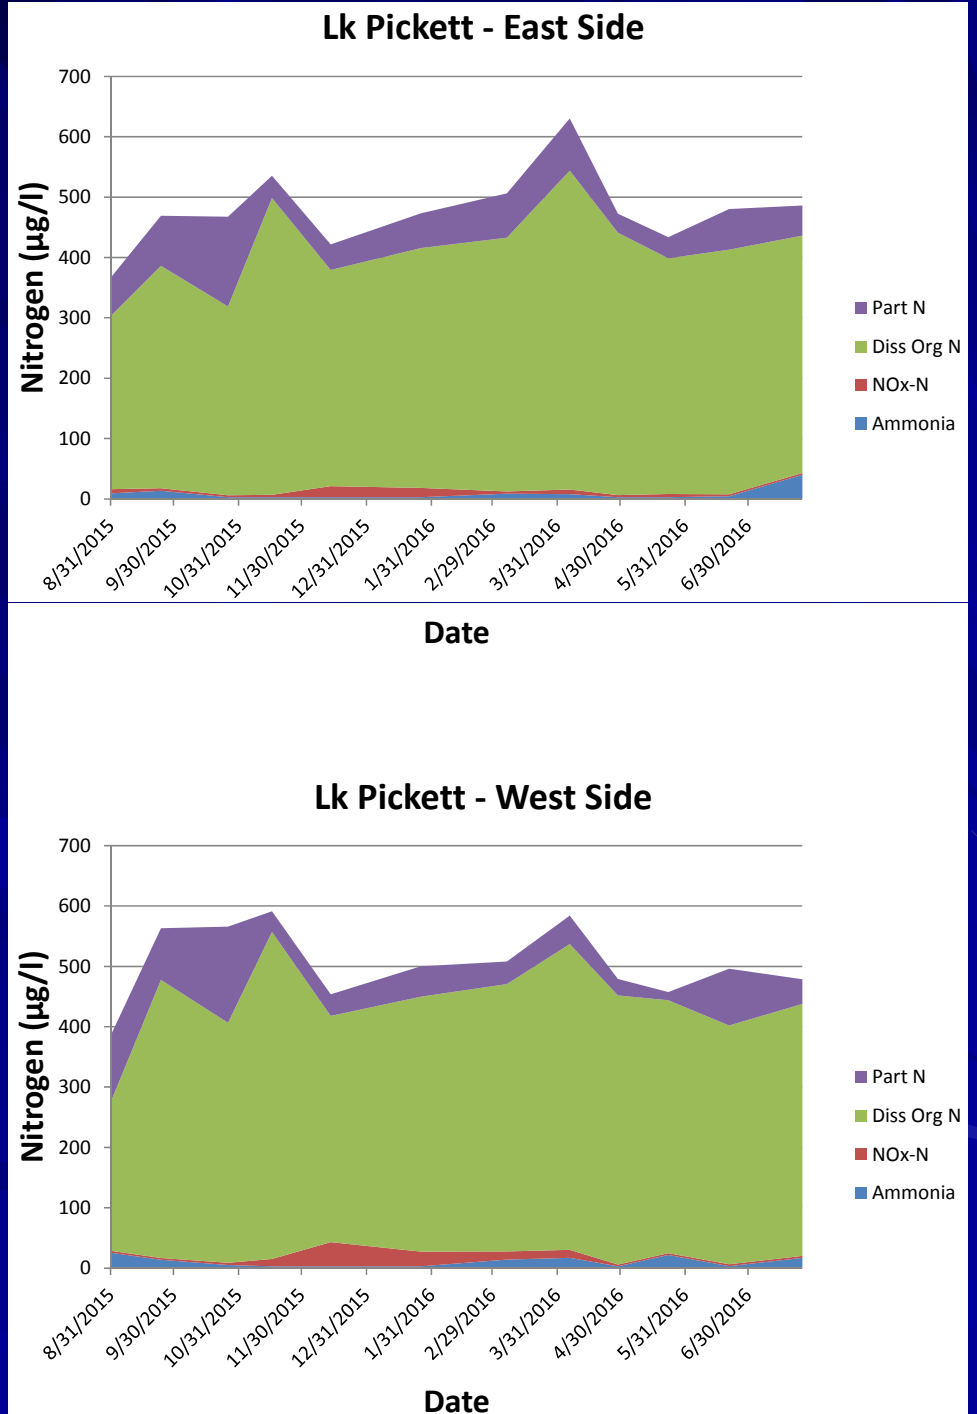
Variability in Measured Concentrations of Nitrogen Species in the East and West Lobes of Lake Pickett from August 2015-July 2016

- Virtually all nitrogen combined with organic matter
- Very little nitrogen is available for algal uptake

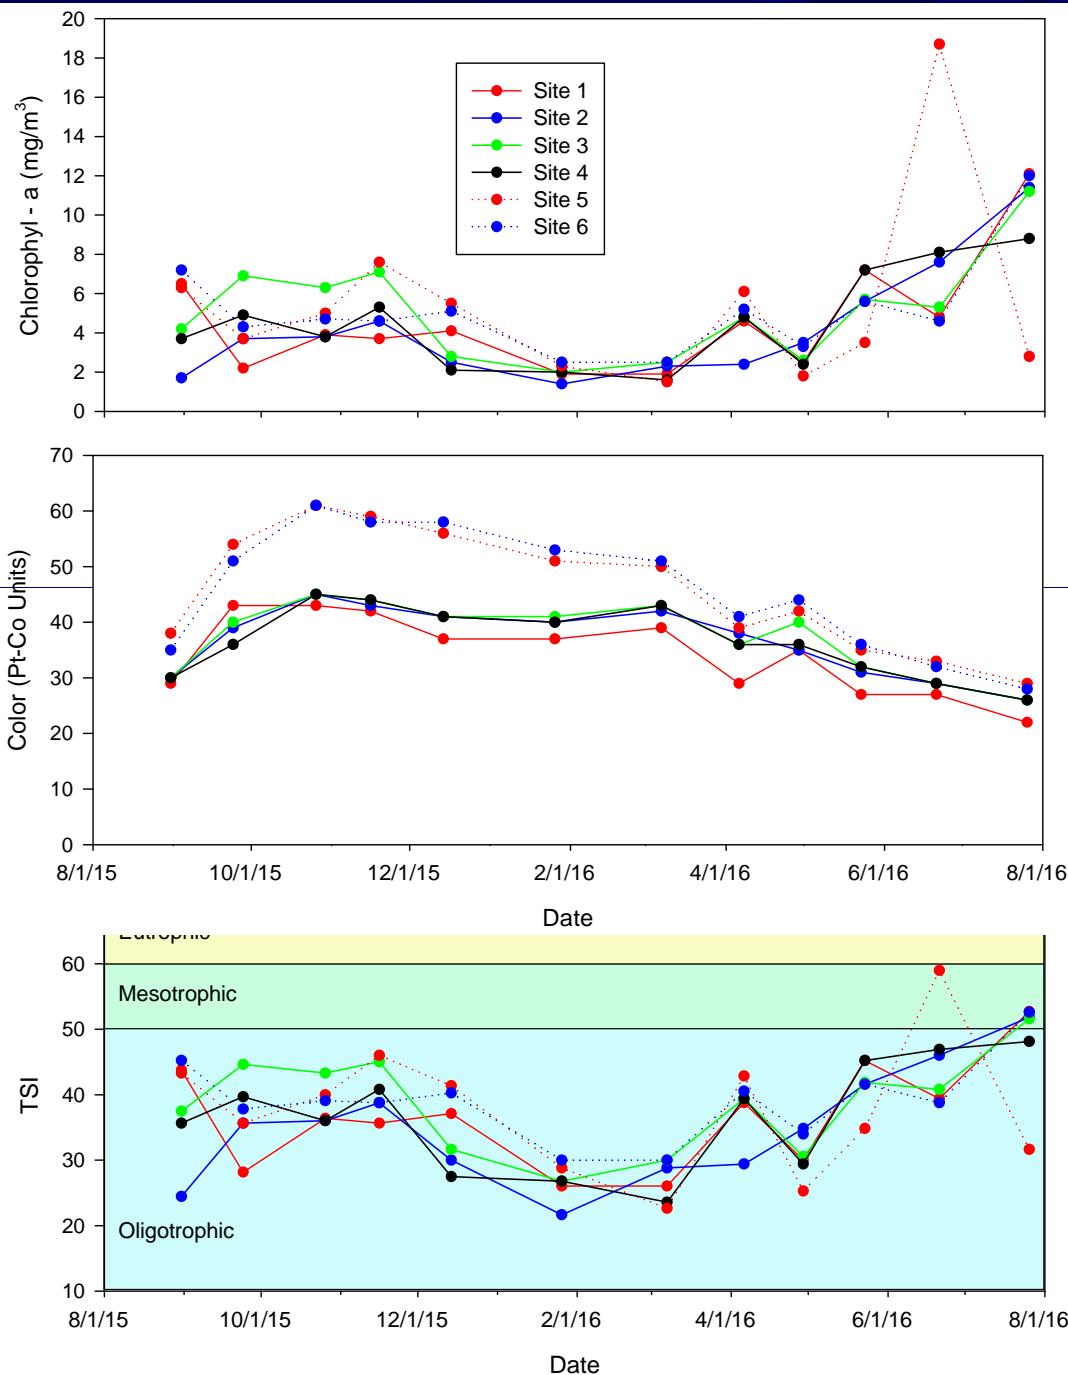
Variability in Measured Concentrations of Chlorophyll-a, Color, and TSI Values at the 6 Surface Water Monitoring Sites in Lake Pickett from August 2015-July 2016

- Chlorophyll peaks during summer conditions
- Color is higher in west lobe
- TSI indicates primarily oligotrophic conditions
- TSI greater during summer conditions

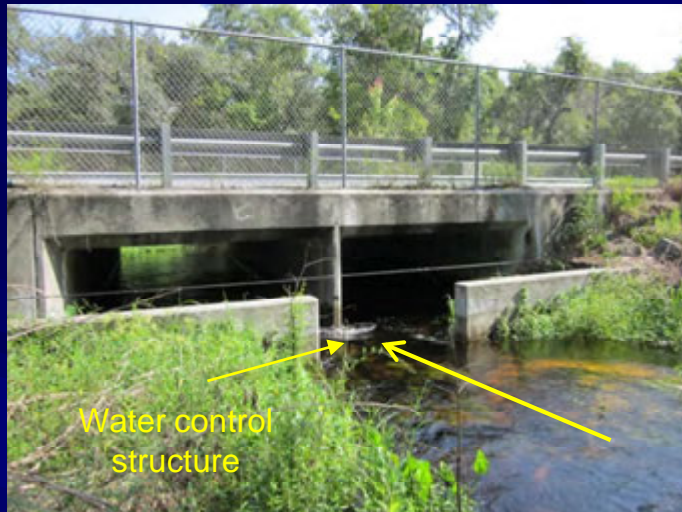
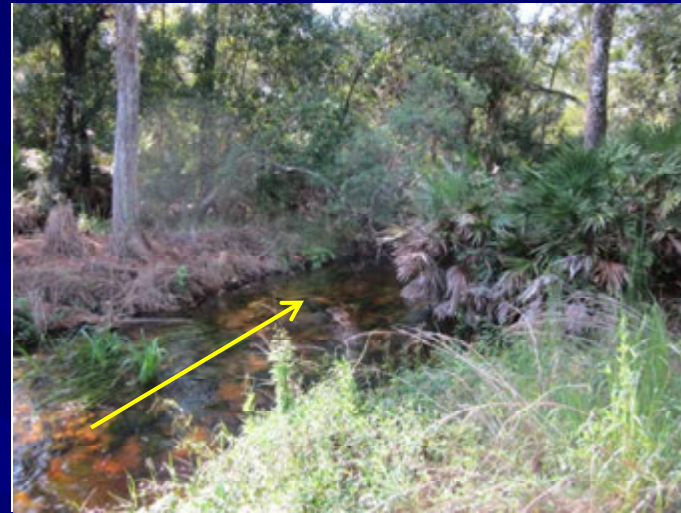
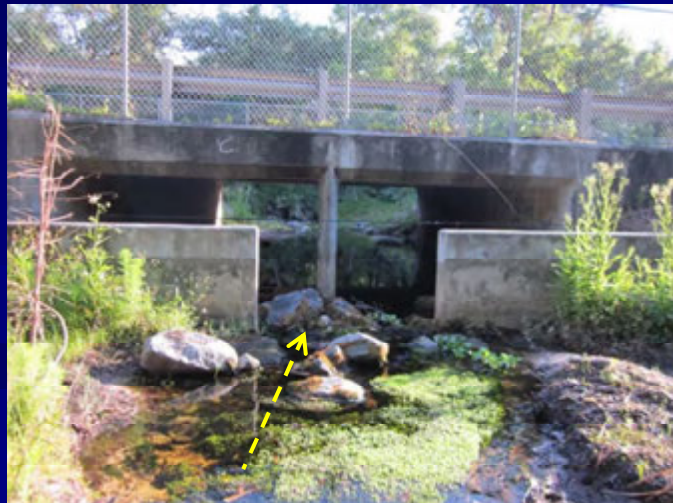
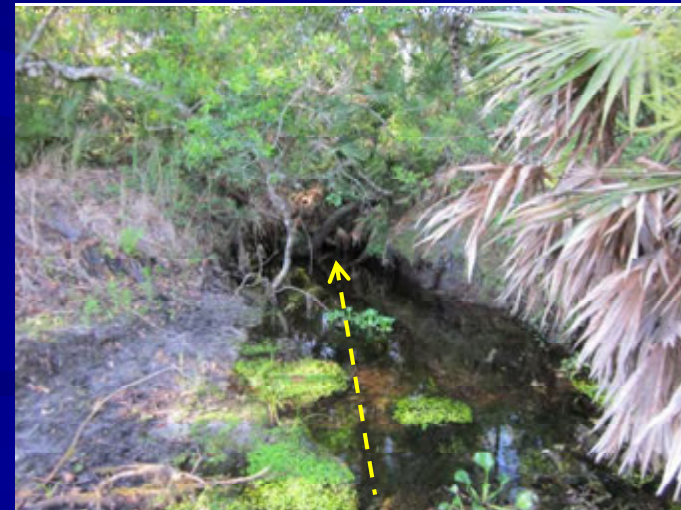
Lake Pickett Water Control Structure

a. Upstream and downstream areas under moderate flow conditions

b. Upstream and downstream areas under low/no flow conditions

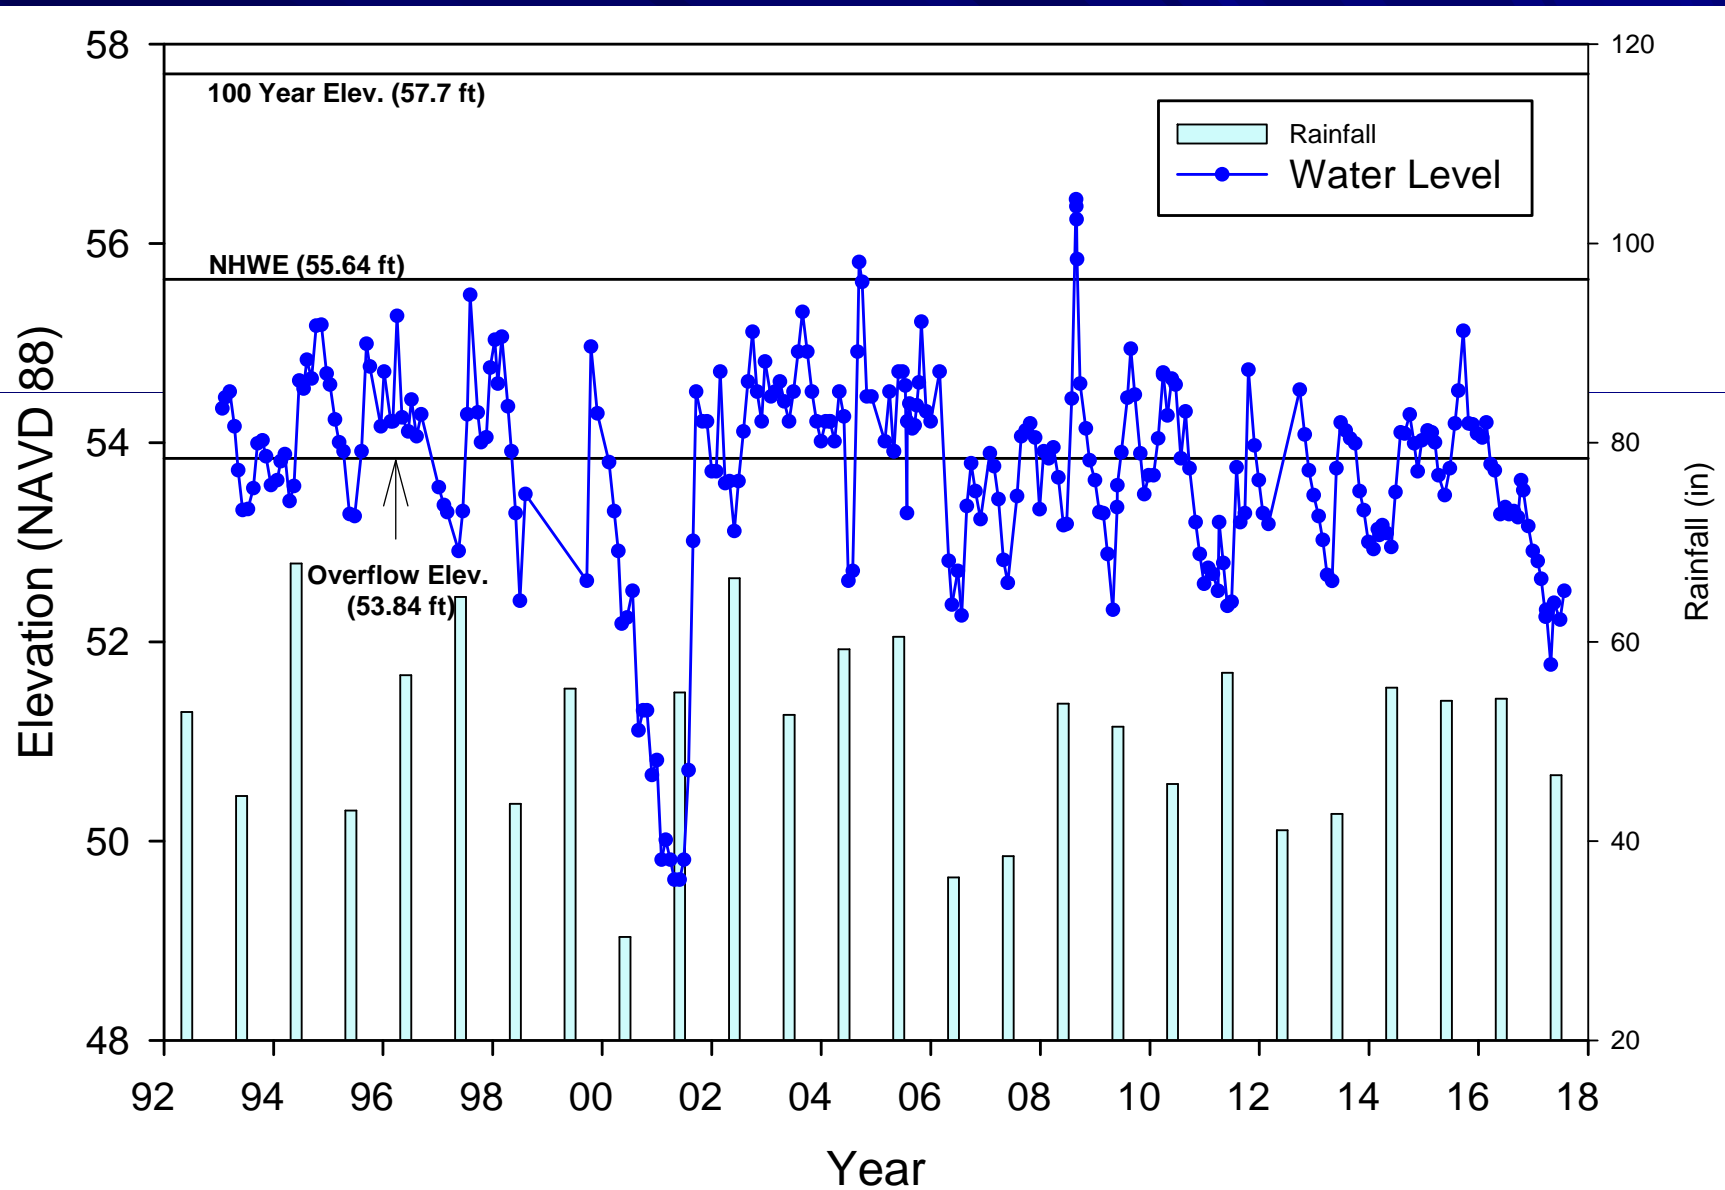
Monitored Water Level Elevations in Lake Pickett from 1992-2016

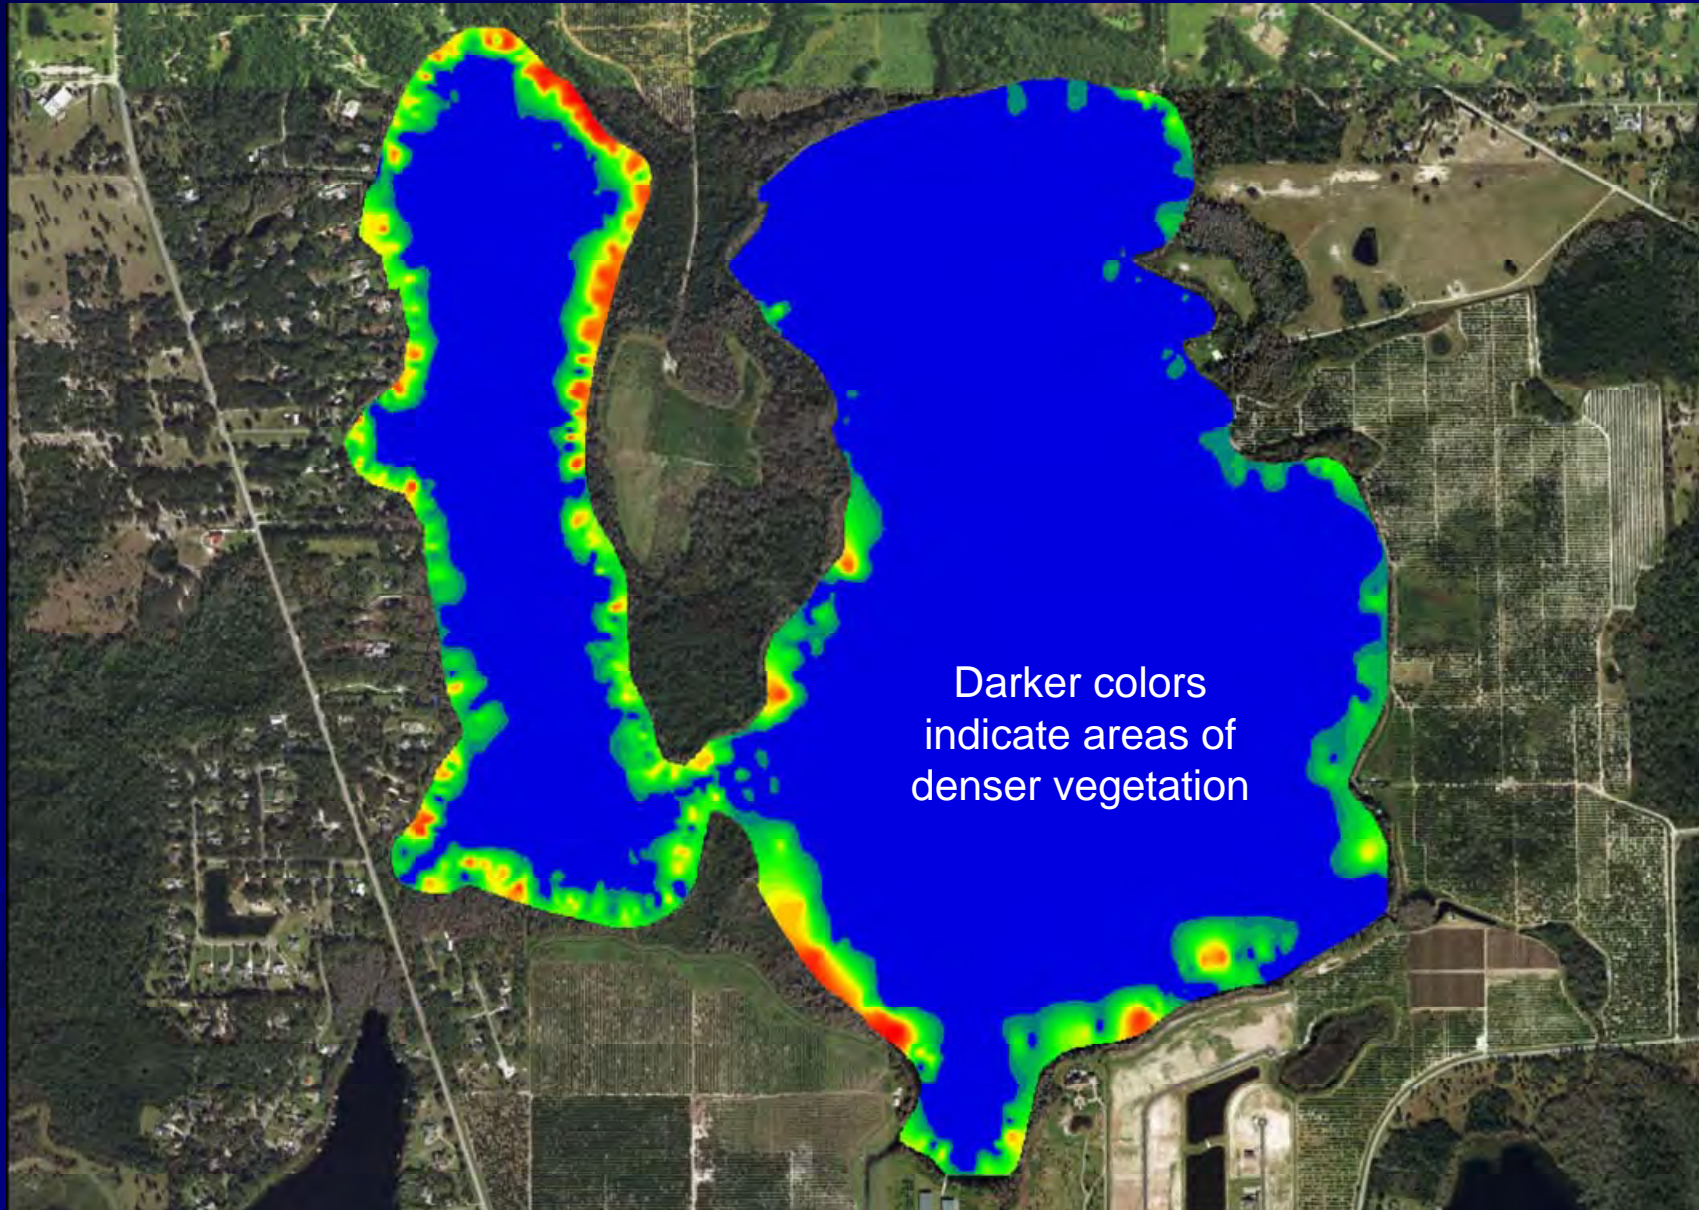
Vegetation Biovolume Heat Map for Lake Pickett

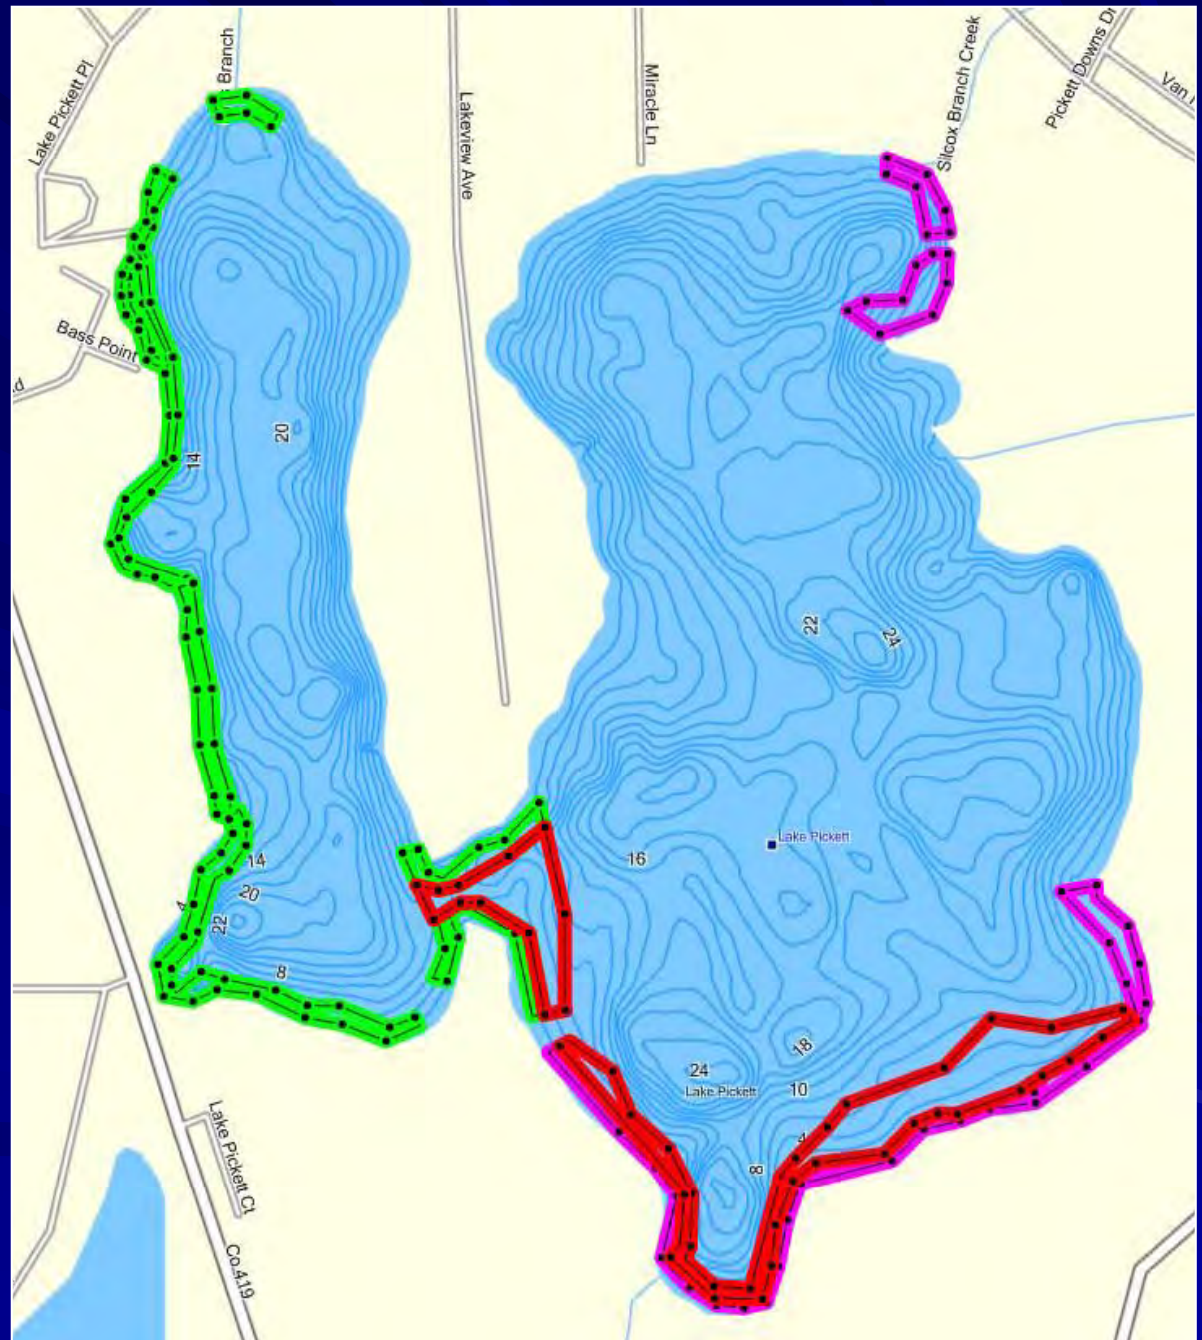
Vegetation Control Areas

(August 8, 2012)

- Total area = 73 ac.
- Coloring indicates vegetation type and method of treatment

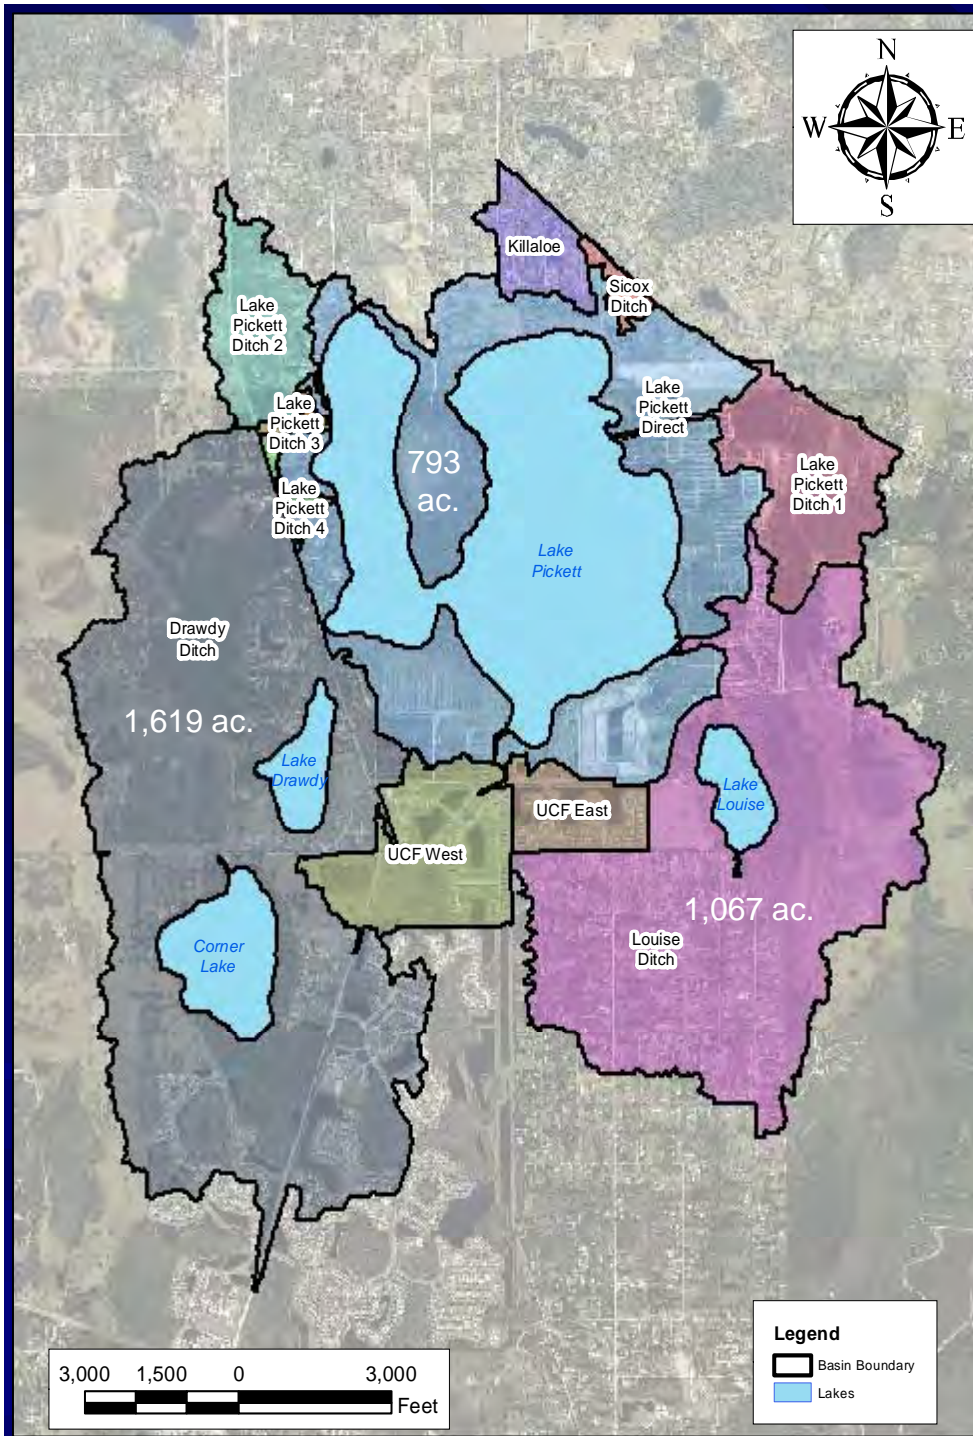
Overview of the Current Lake Pickett Drainage Basin

Each sub-basin represents an area that discharges to the lake through the same pipe, ditch, canal, or tributary

- 11 sub-basins

- Total area = 4,264 ac.

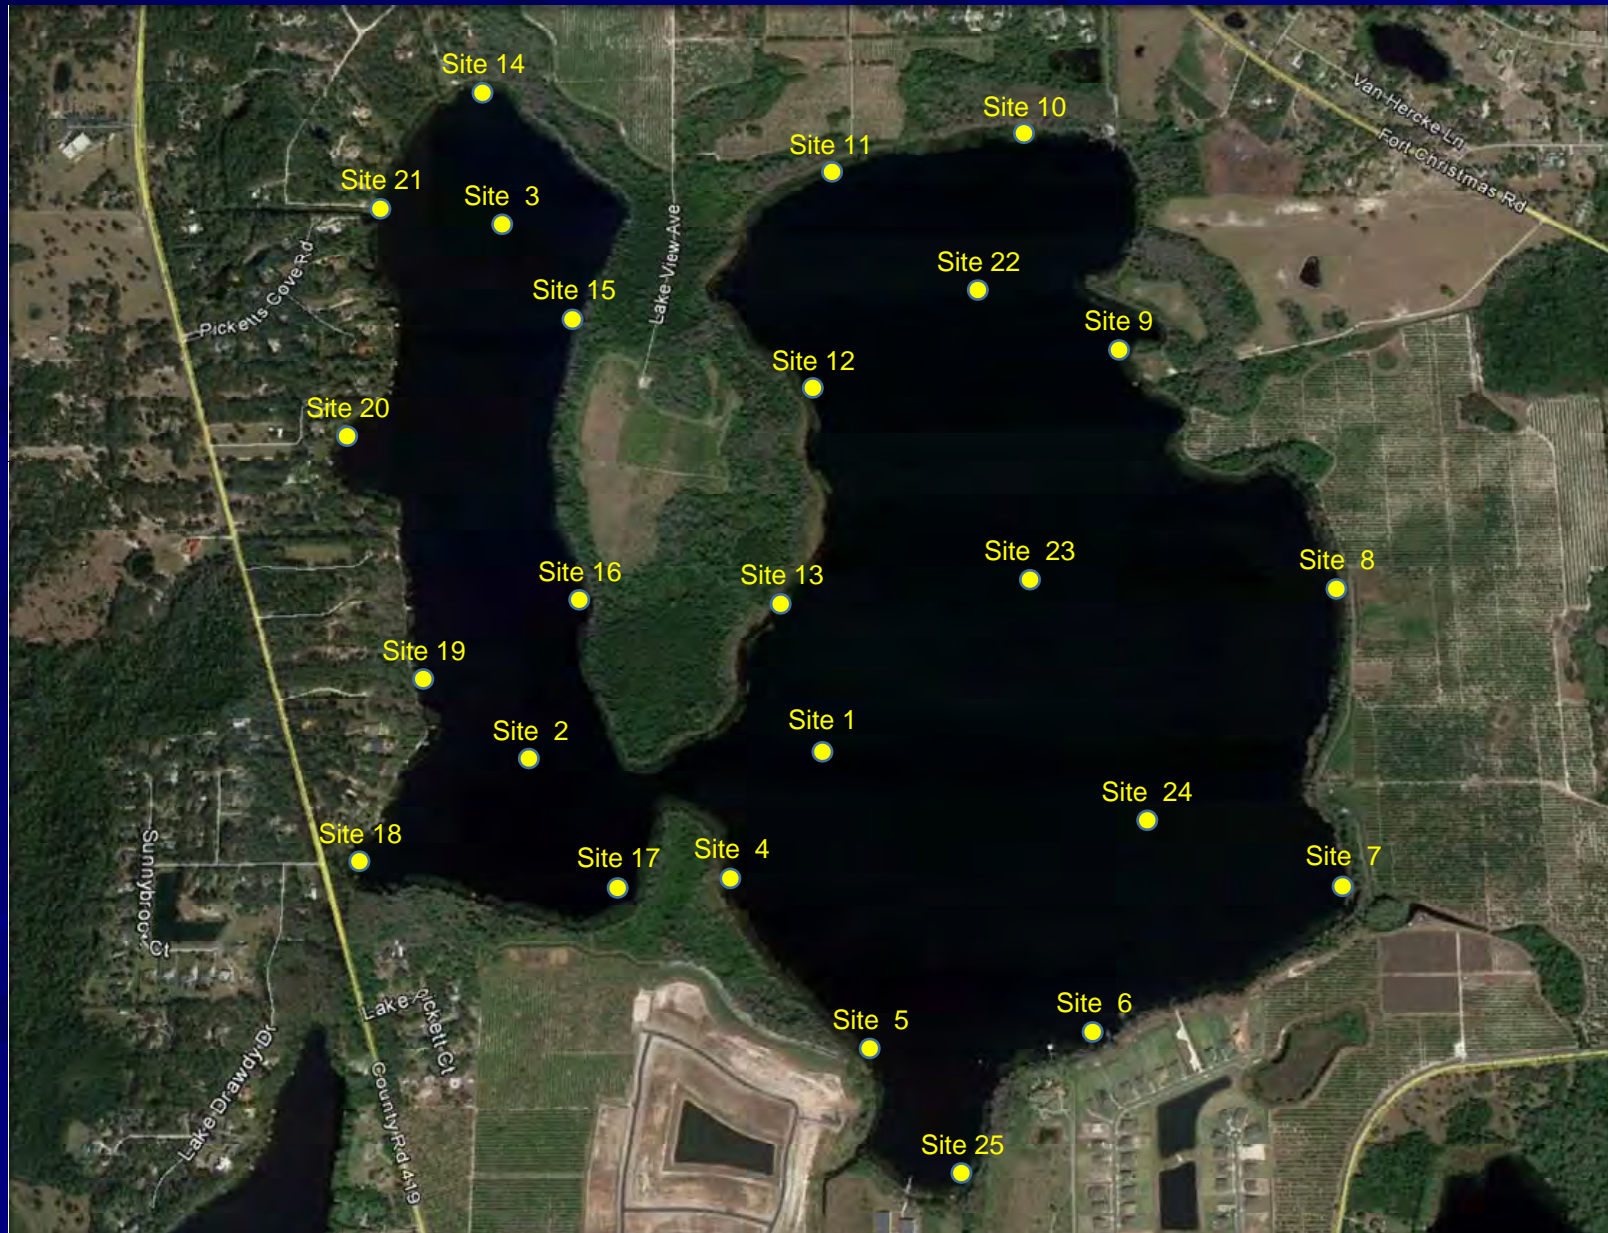
Mean Seepage Inflow Isopleths for Lake Pickett from August 2015-August 2016

Parameter	Units	Value
Lake Area	acres	745
Mean Seepage Inflow	liters/m ² -day	0.52
	ac-ft/year	465
	ft/yr	0.62
