Lake Pickett Hydrologic/Nutrient Budgets and Water Quality Management Plan

Lake Pickett Community Meeting
September 10, 2018

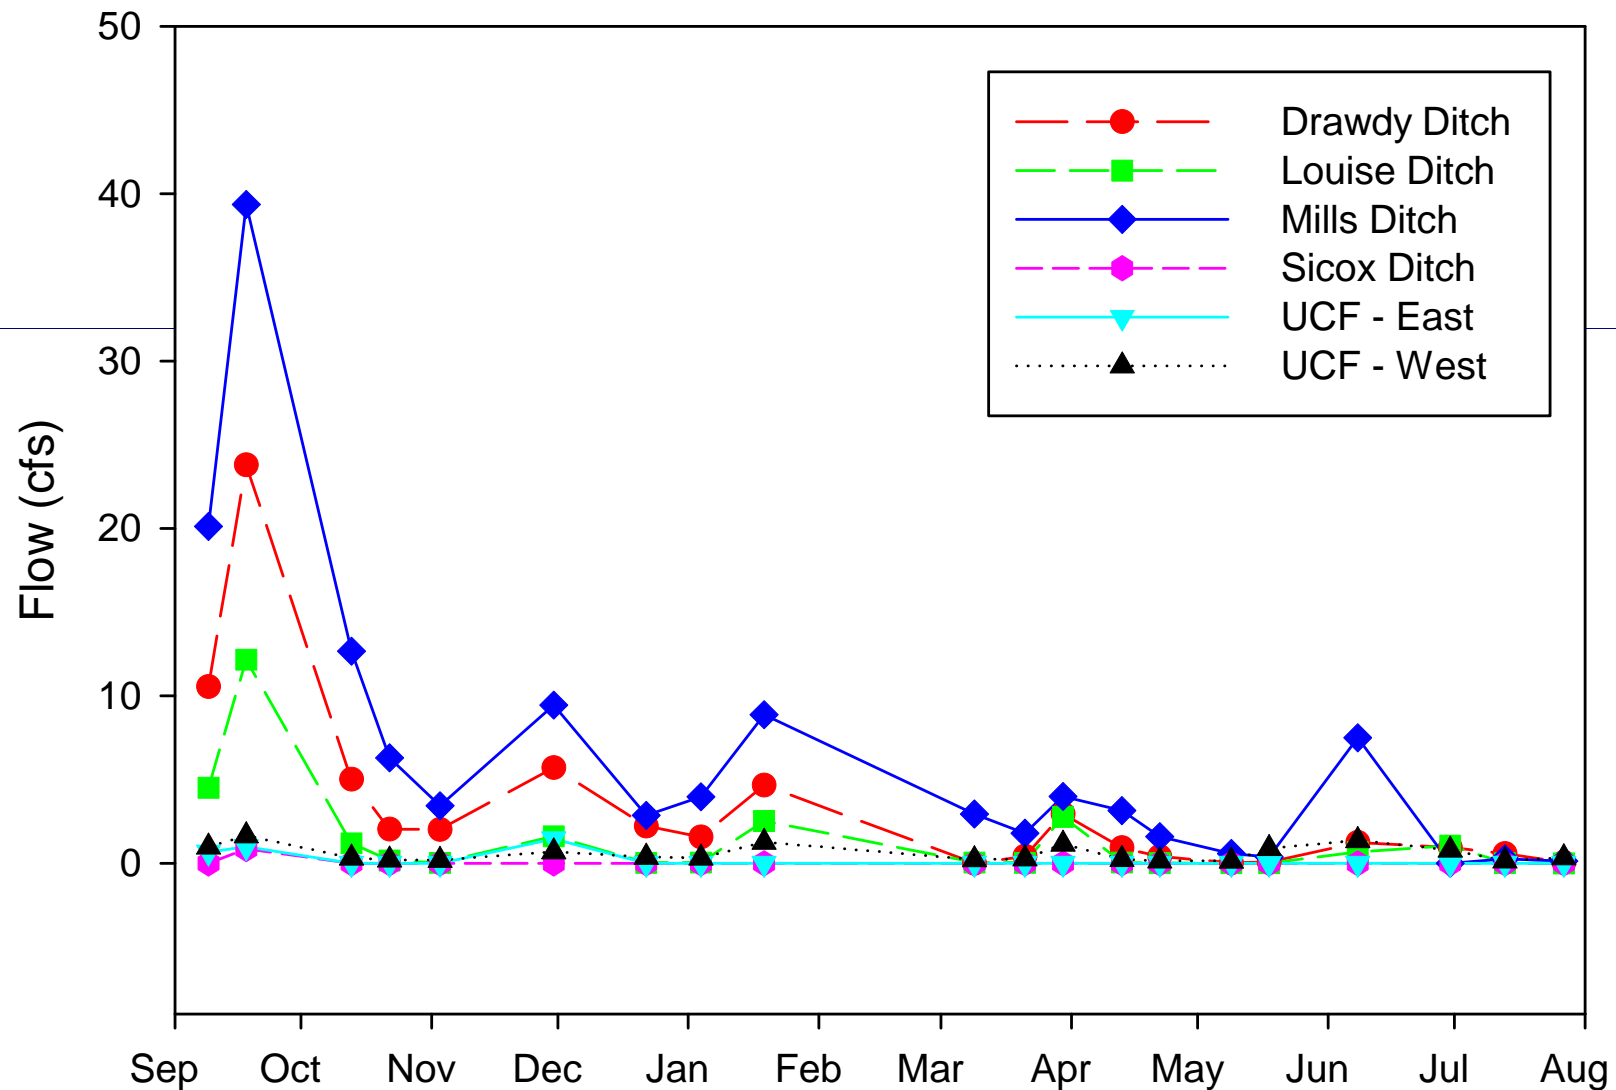
Comparison of Measured Discharge Rates at the Tributary Monitoring Sites

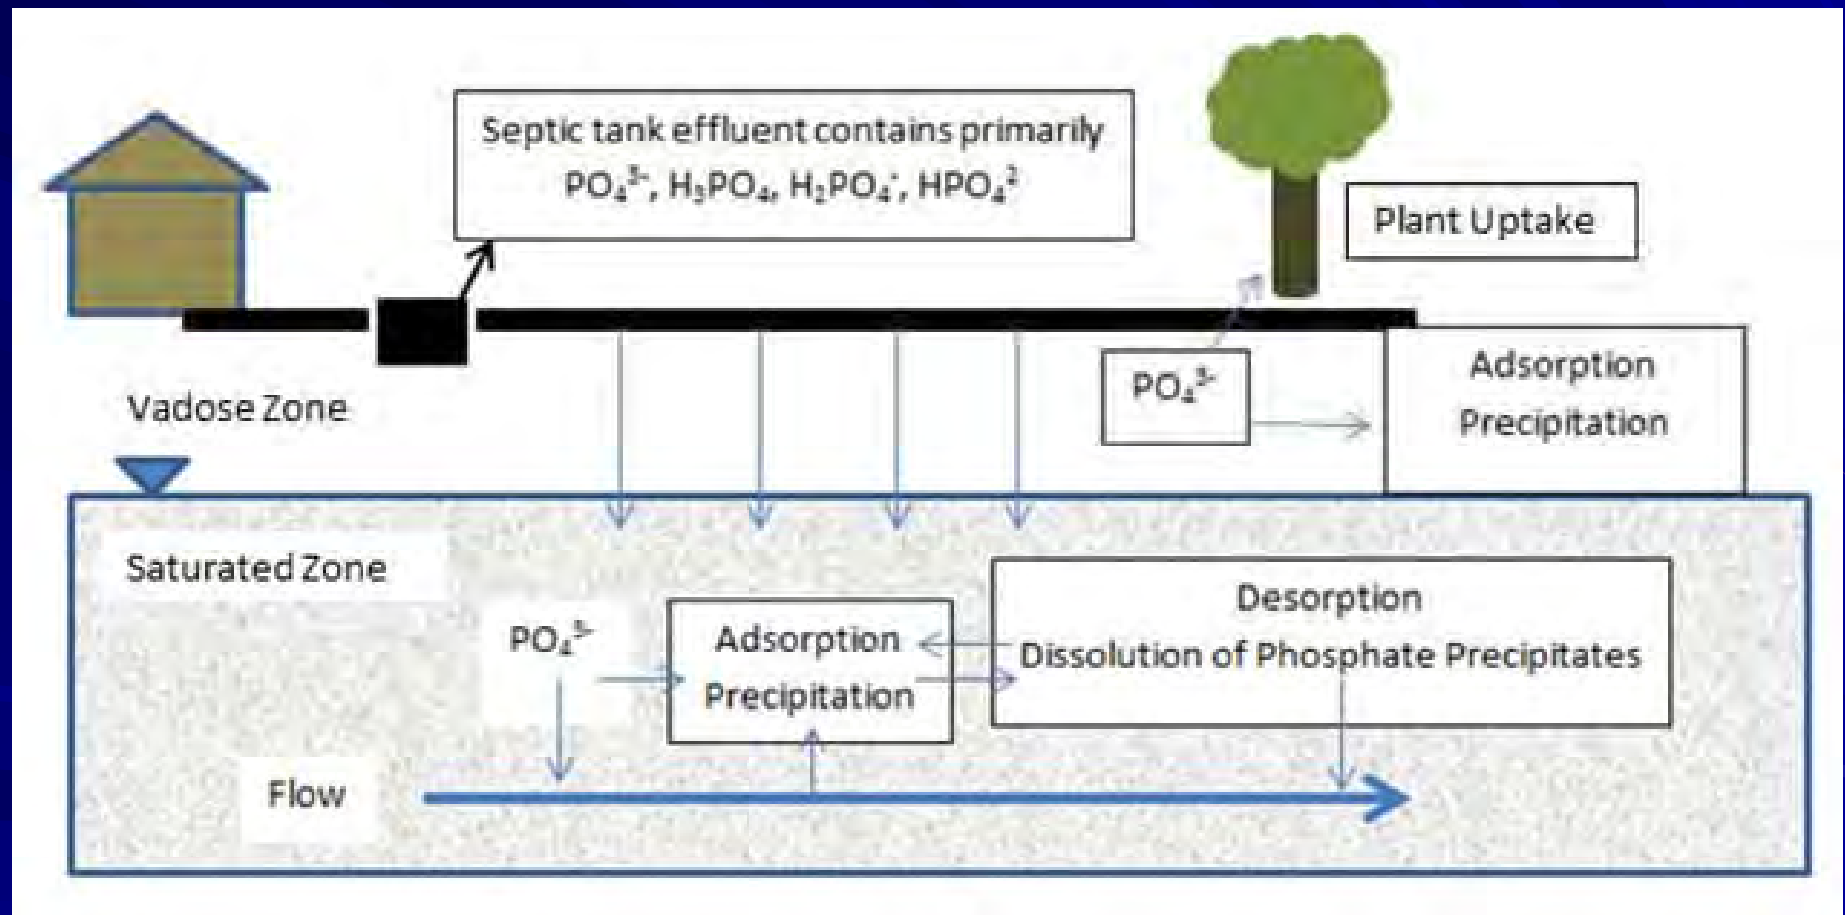
Overview of Phosphorus Movement and Uptake Mechanisms for Septic Tank Effluent

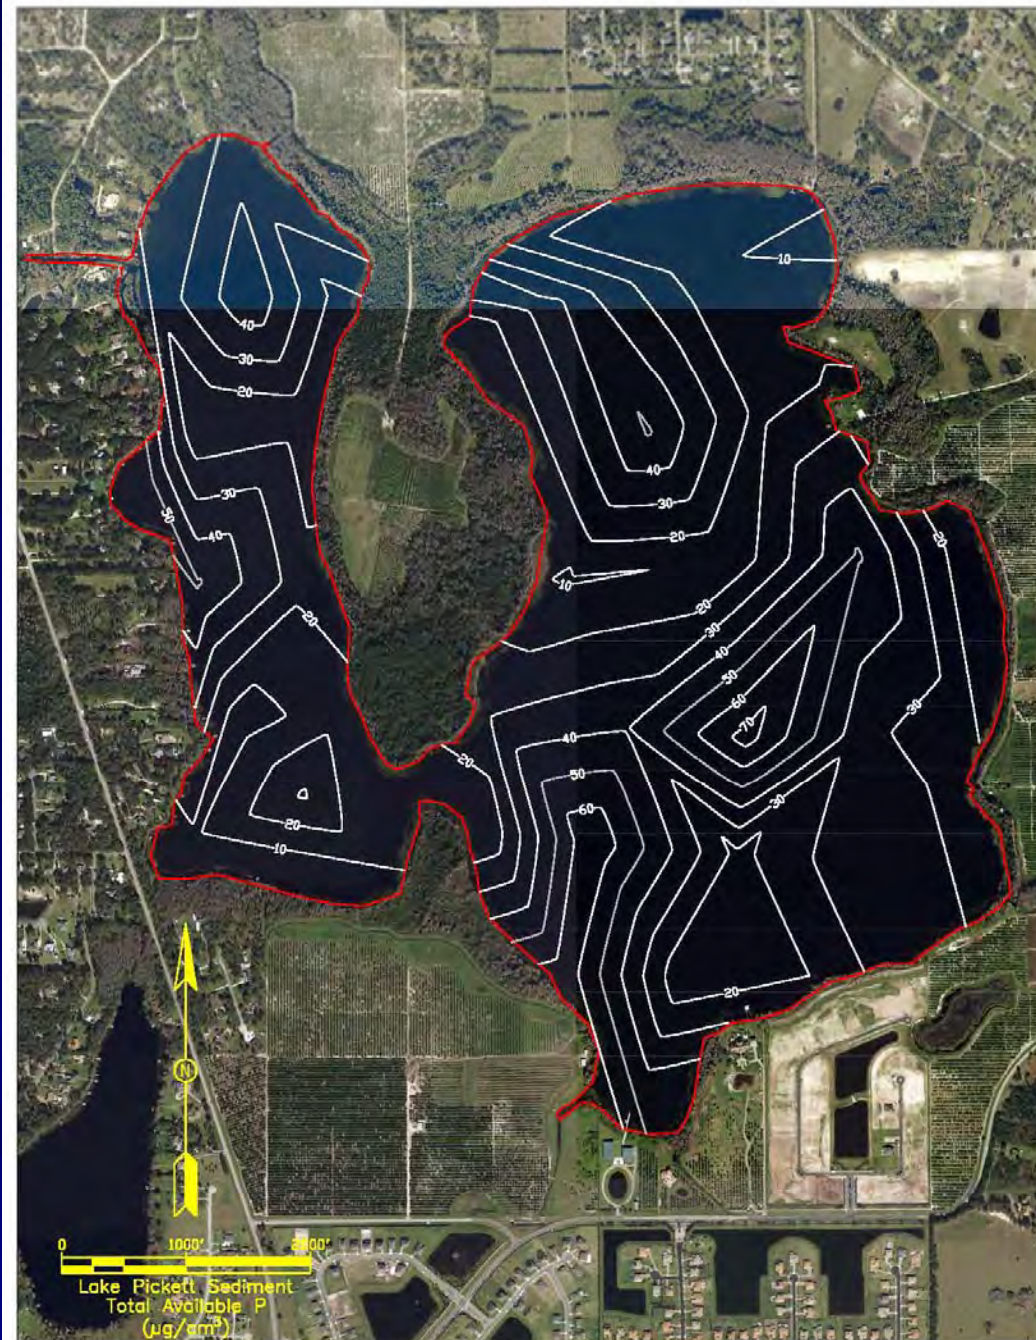
- Each area contains the same amount of available P and receives equal amounts of alum

Isopleths of Total Available Phosphorus ($\mu\text{g}/\text{cm}^3$) in the Top 10 cm of Sediments in Lake Pickett During November 2015

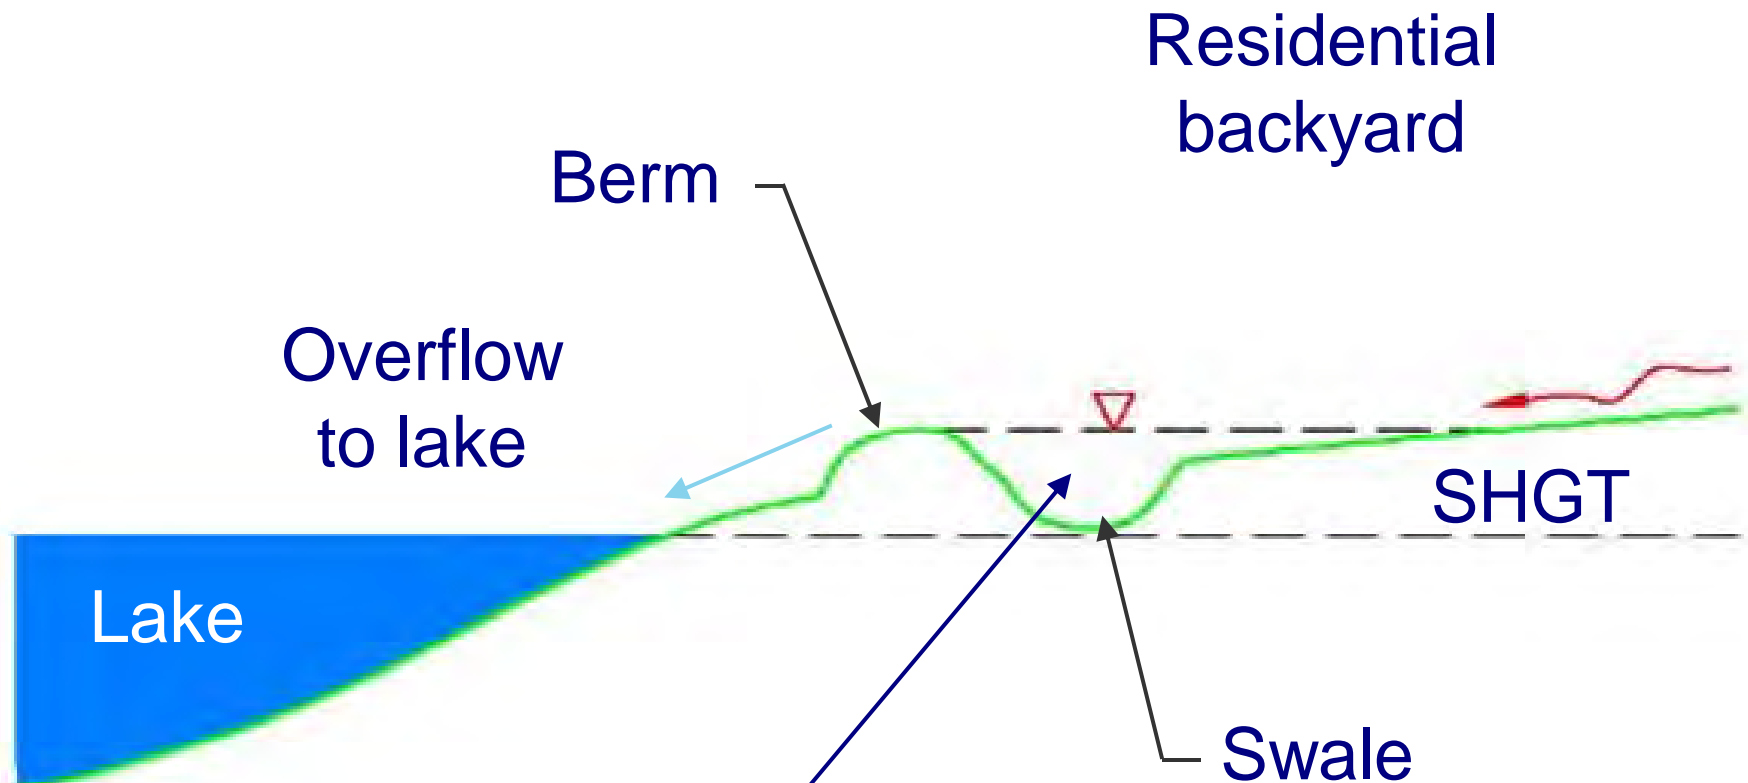
Schematic of Recommended Rear Yard Swale and Berm Design

Storage volume should meet WMD
design criteria

- Direct overland flow originates from the rear yards of homes directly on Lake Pickett
 - In addition to nutrients, direct overland flow contributes pesticides and pet wastes to the lake
 - The number of lakefront homes is currently limited but is likely to increase over time
- Direct overland flow contributes 4% of annual phosphorus loadings to the lake
 - Exceeds phosphorus loadings from groundwater
- Best option for these areas is a rear yard berm and swale system

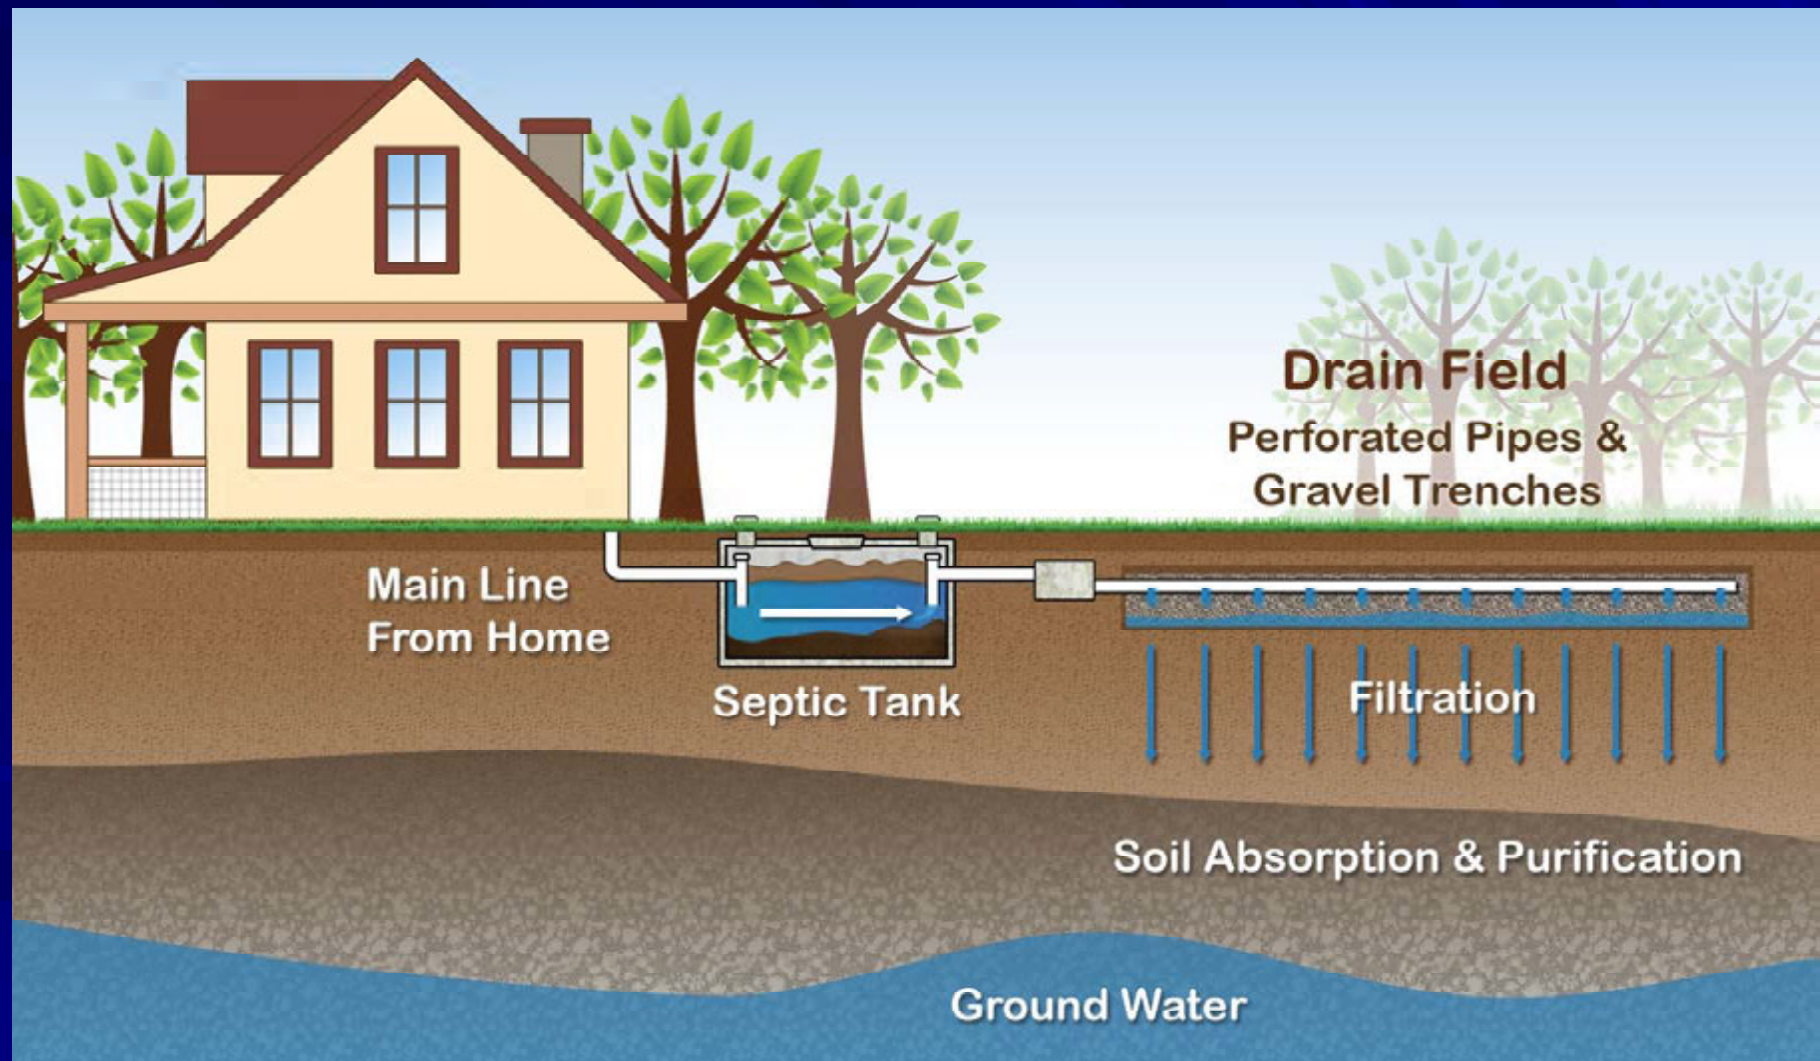
Overview of a Conventional Septic Tank System

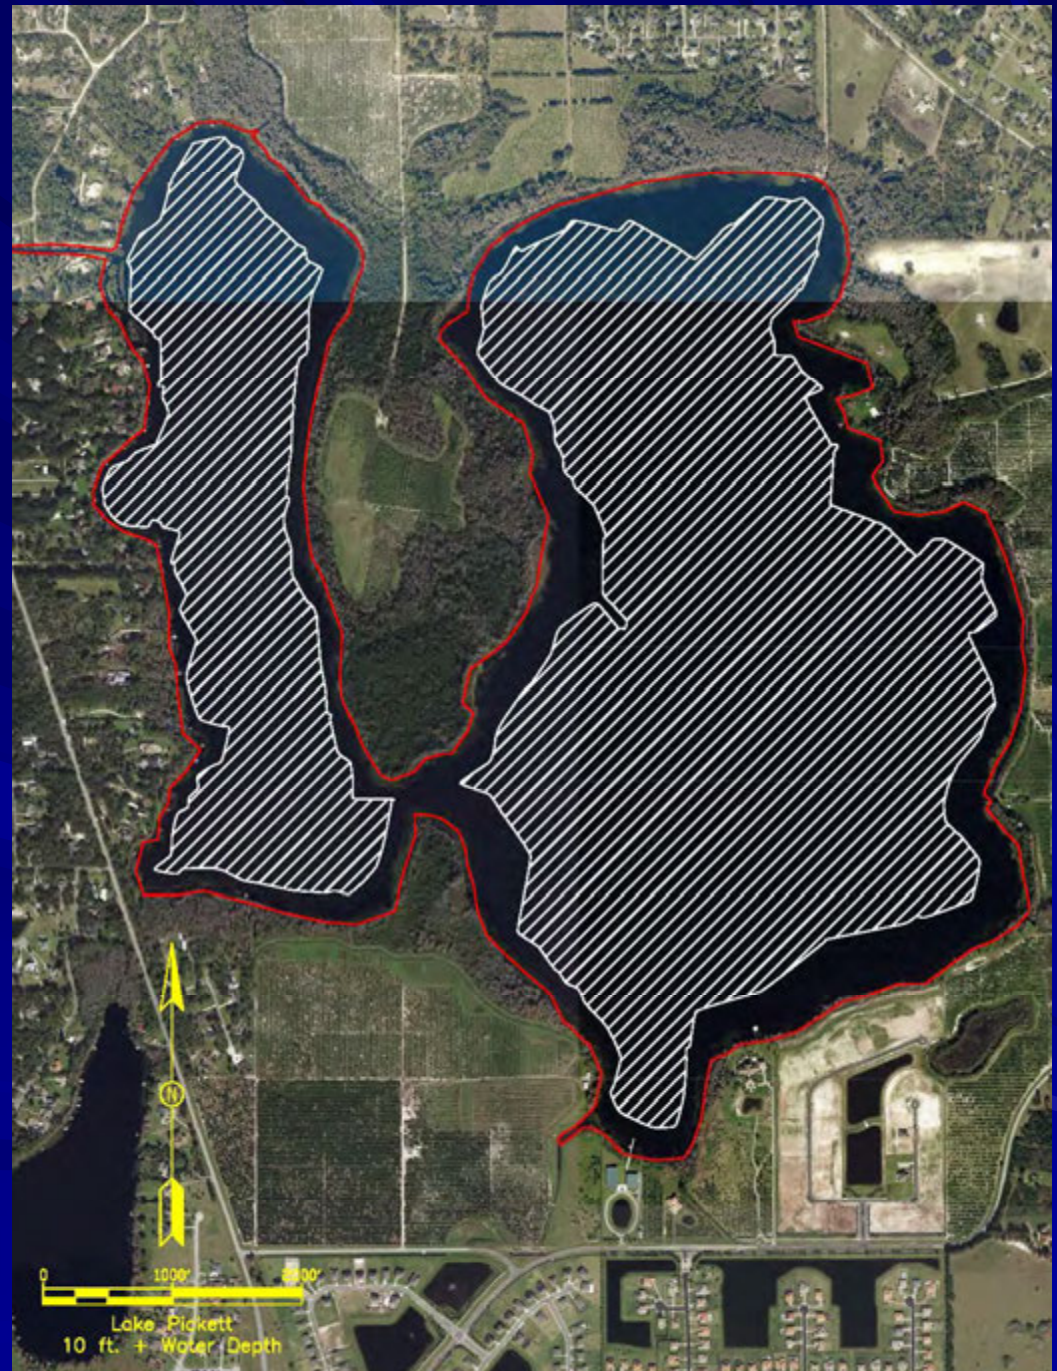
Areas of Lake
Pickett with Water
Depths > 10 ft

- Studies have indicated that boating activities can disturb bottom sediments to a water depth of 10-15 feet
- Normal boating activities should be restricted to water depths of 10 feet or more
 - Idle speed zones should be established in areas > 10 feet
 - deep
- Normal operation for boats designed for enhanced wake should be restricted to water depths of 15 feet or more

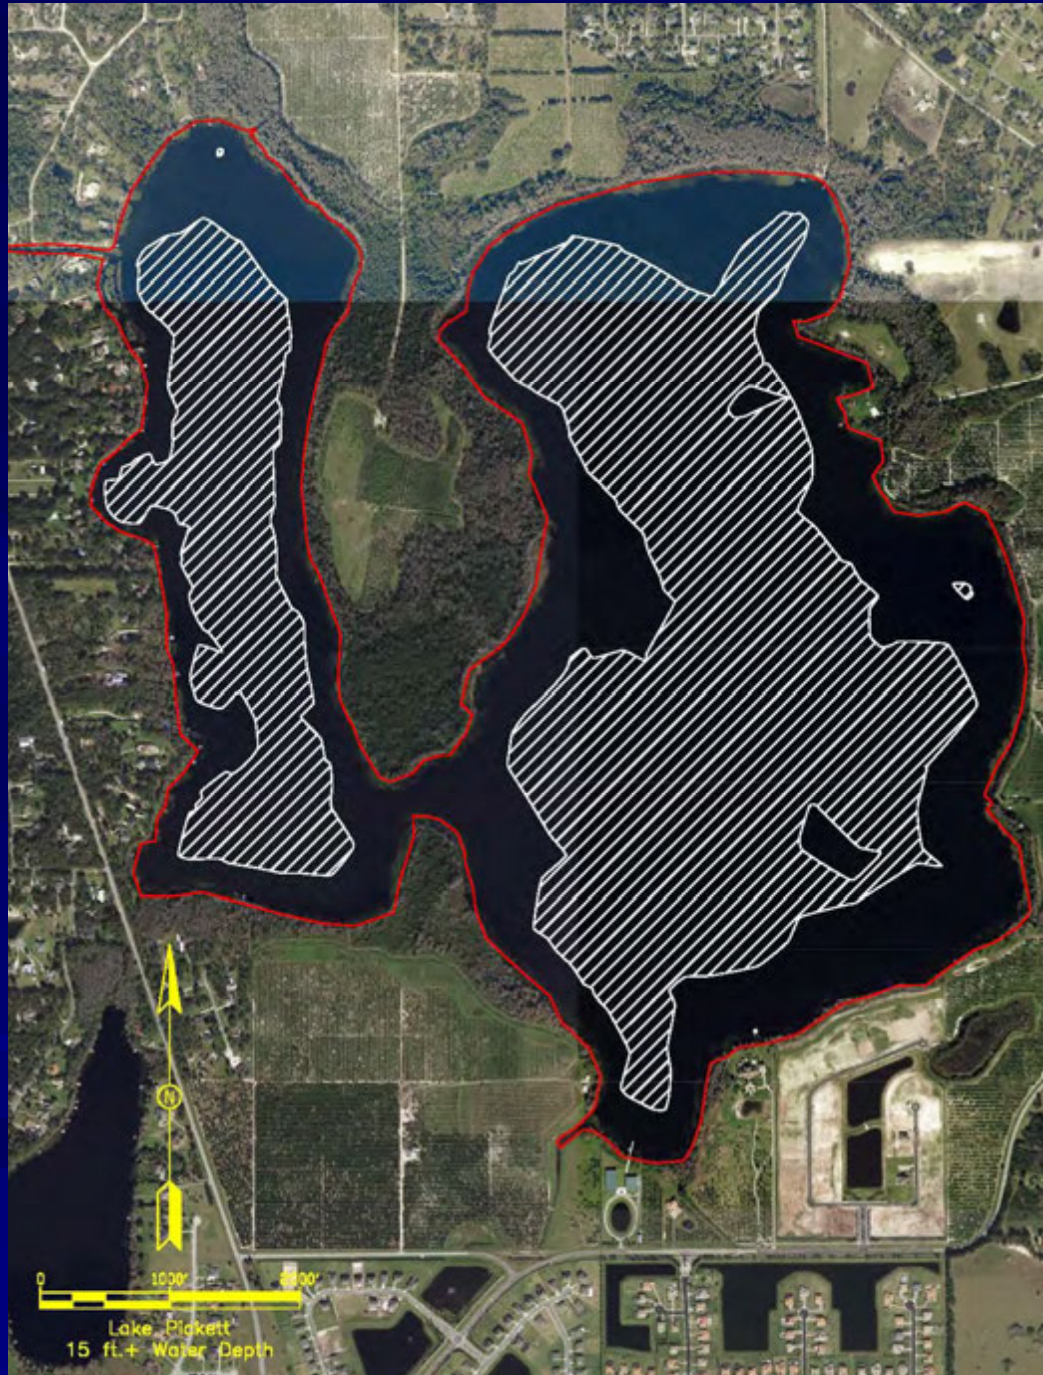
Areas of Lake
Pickett with Water
Depths > 15 ft

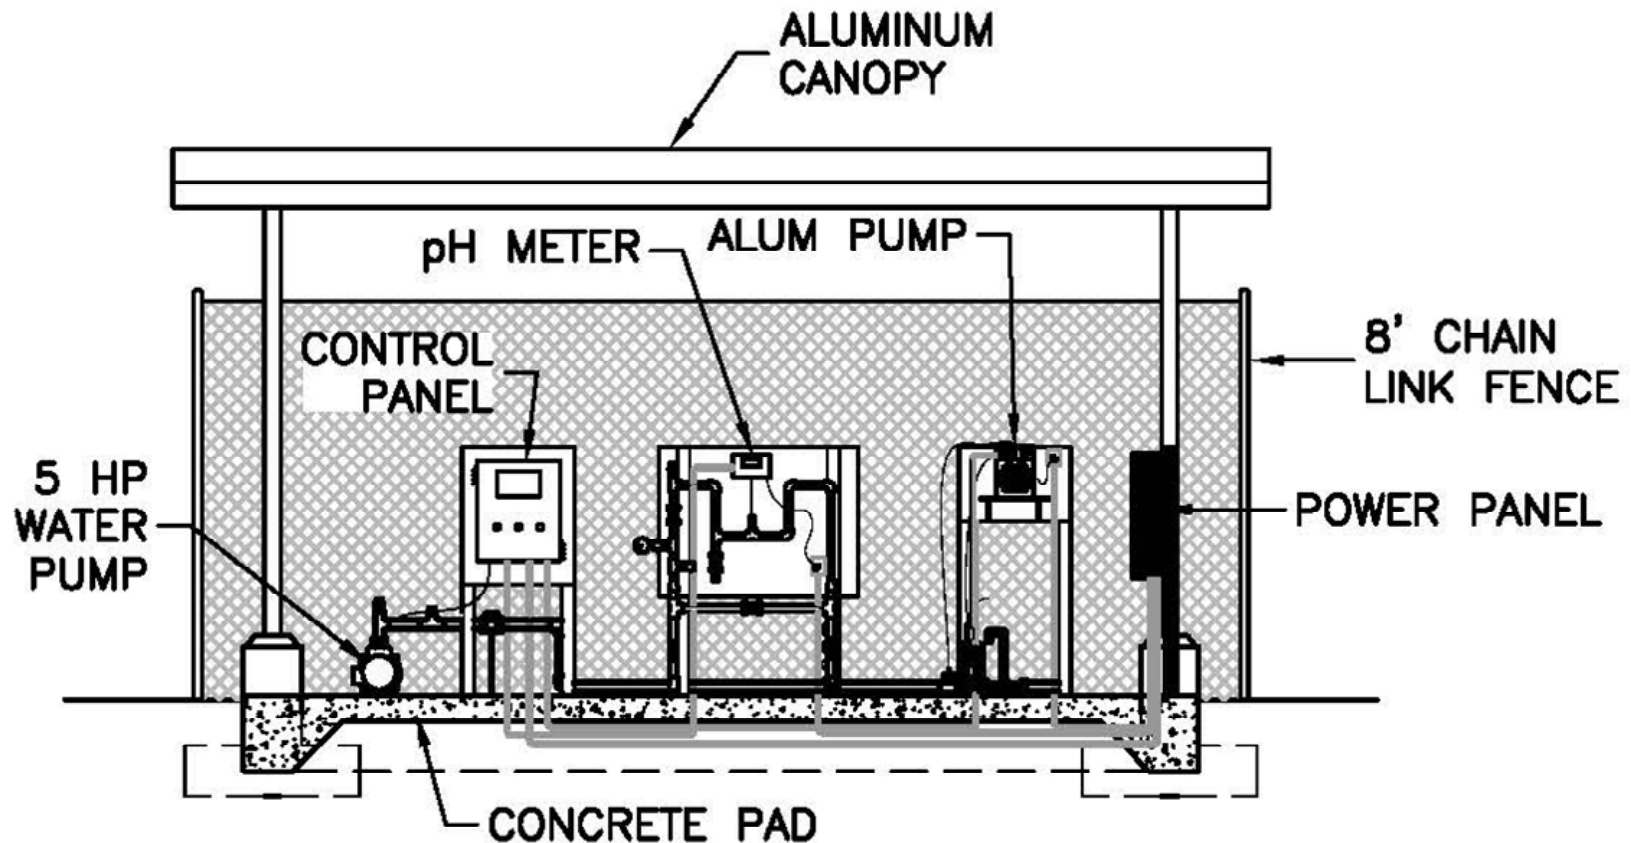
System Components and Controls for the In-Lake Alum Addition System

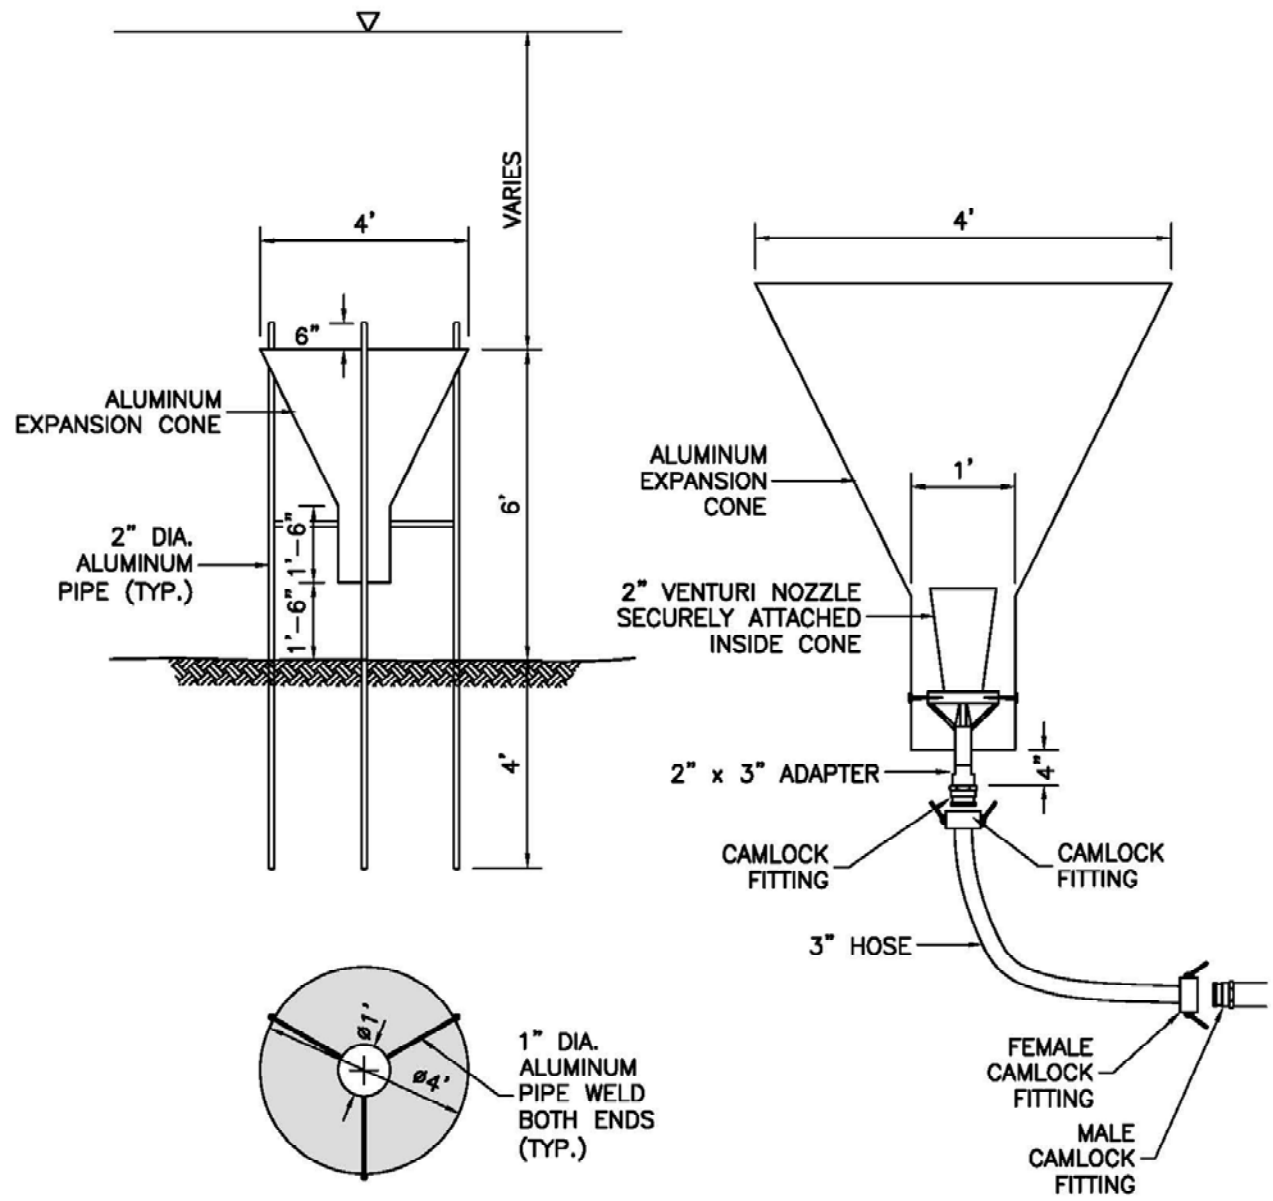
Schematic of the In-Lake Alum Injection Structure
