# Lake Holden Revised Hydrologic / Nutrient Budget and Management Plan

Final Report

July 2004

**Environmental Research & Design, Inc.**

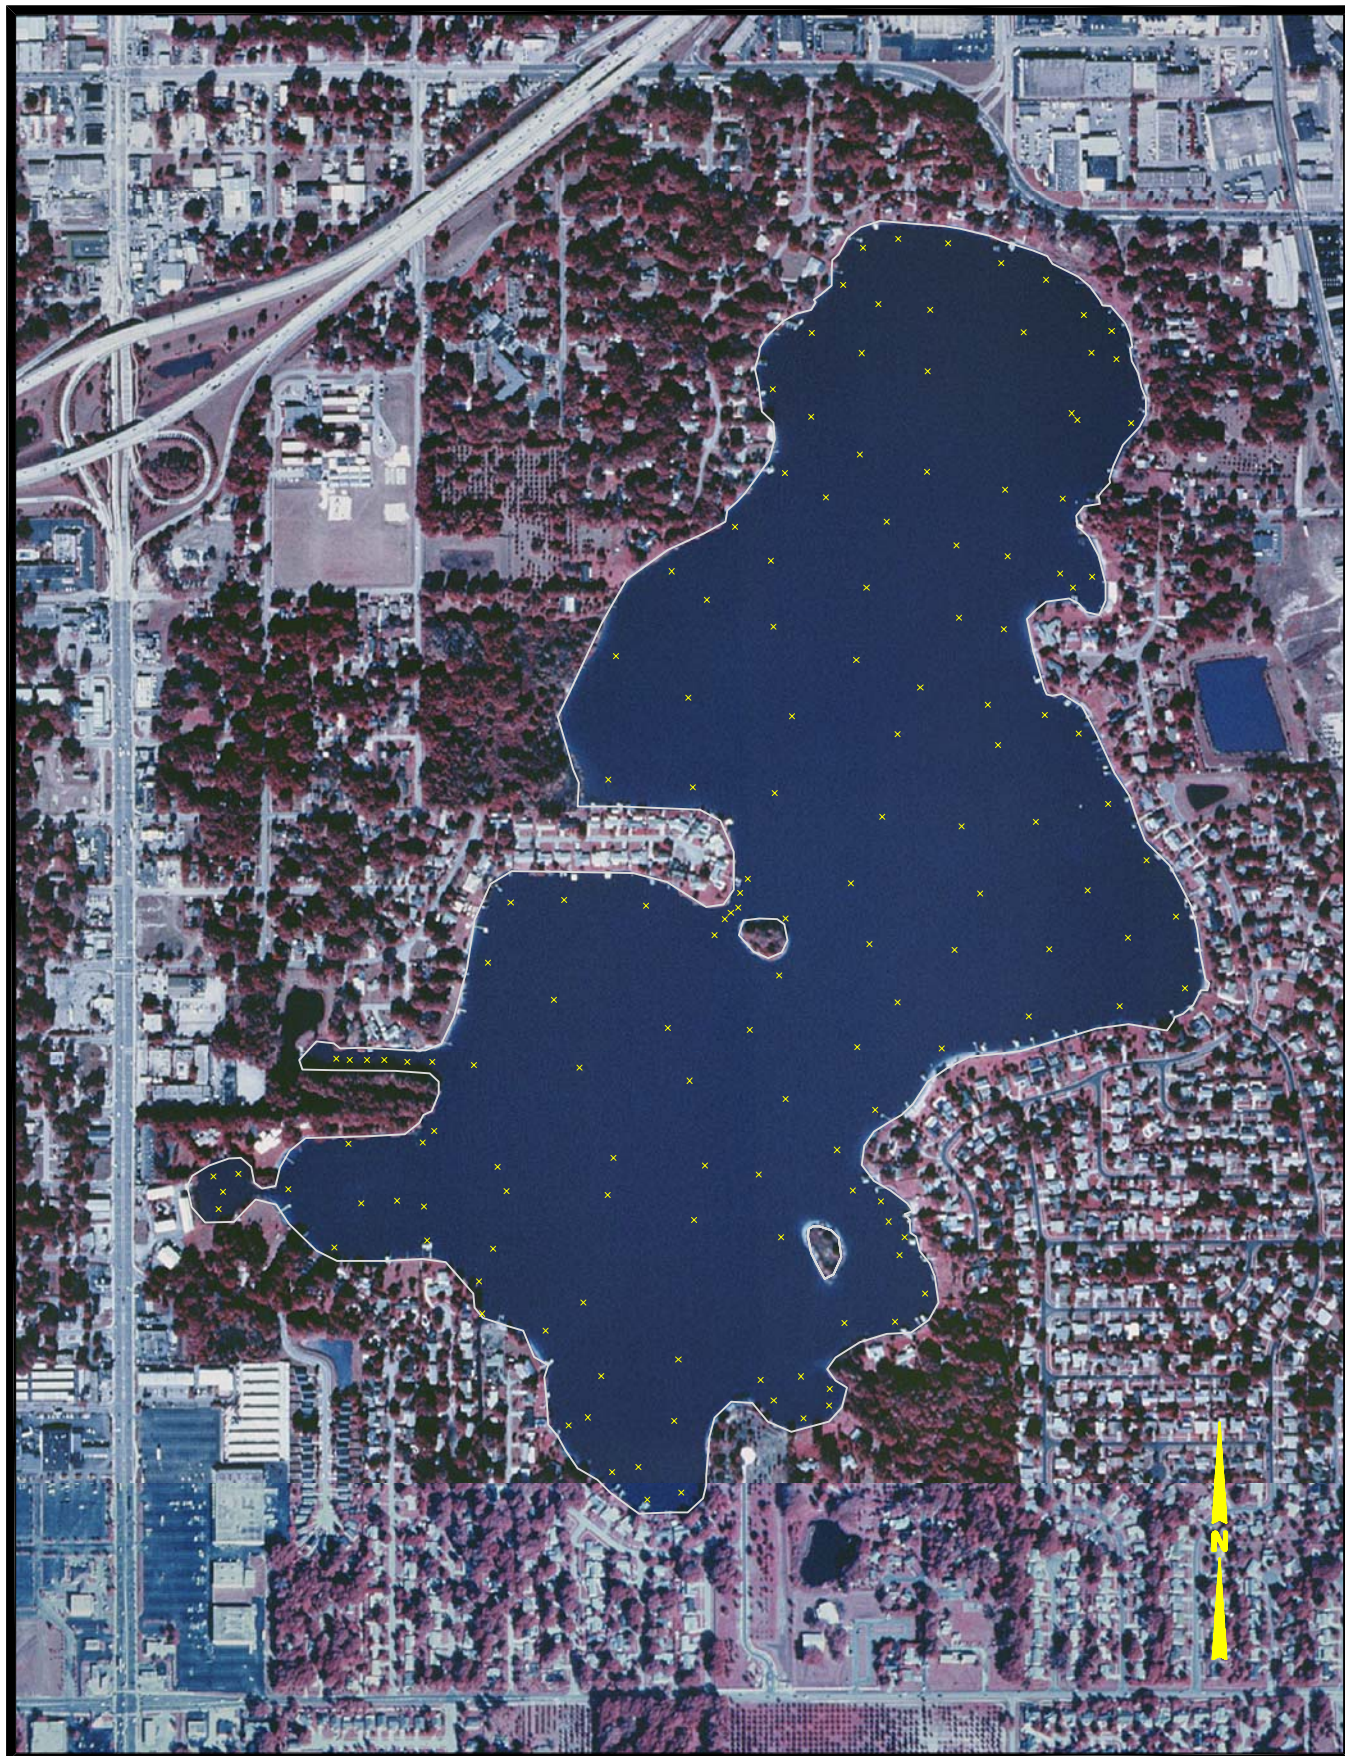
Figure 2-1. Probing Locations for Water and Muck Depth in Lake Holden.

Water depth at each of the data collection sites was determined by lowering a 20-cm diameter Secchi disk attached to a graduated line until resistance from the sediment layer was encountered. The depth on the graduated line corresponding to the water surface was recorded in the field and is defined as the water depth at each site. After measurement of the water depth at each site, a 1.5-inch graduated aluminum pole was then lowered into the water column and forced into the sediments until a firm bottom material, typically sand or clay, was encountered. The depth corresponding to the water surface is defined as the depth to the firm lake bottom. The difference between the depth to the firm lake bottom and the water depth at each site is defined as the depth of unconsolidated sediments.

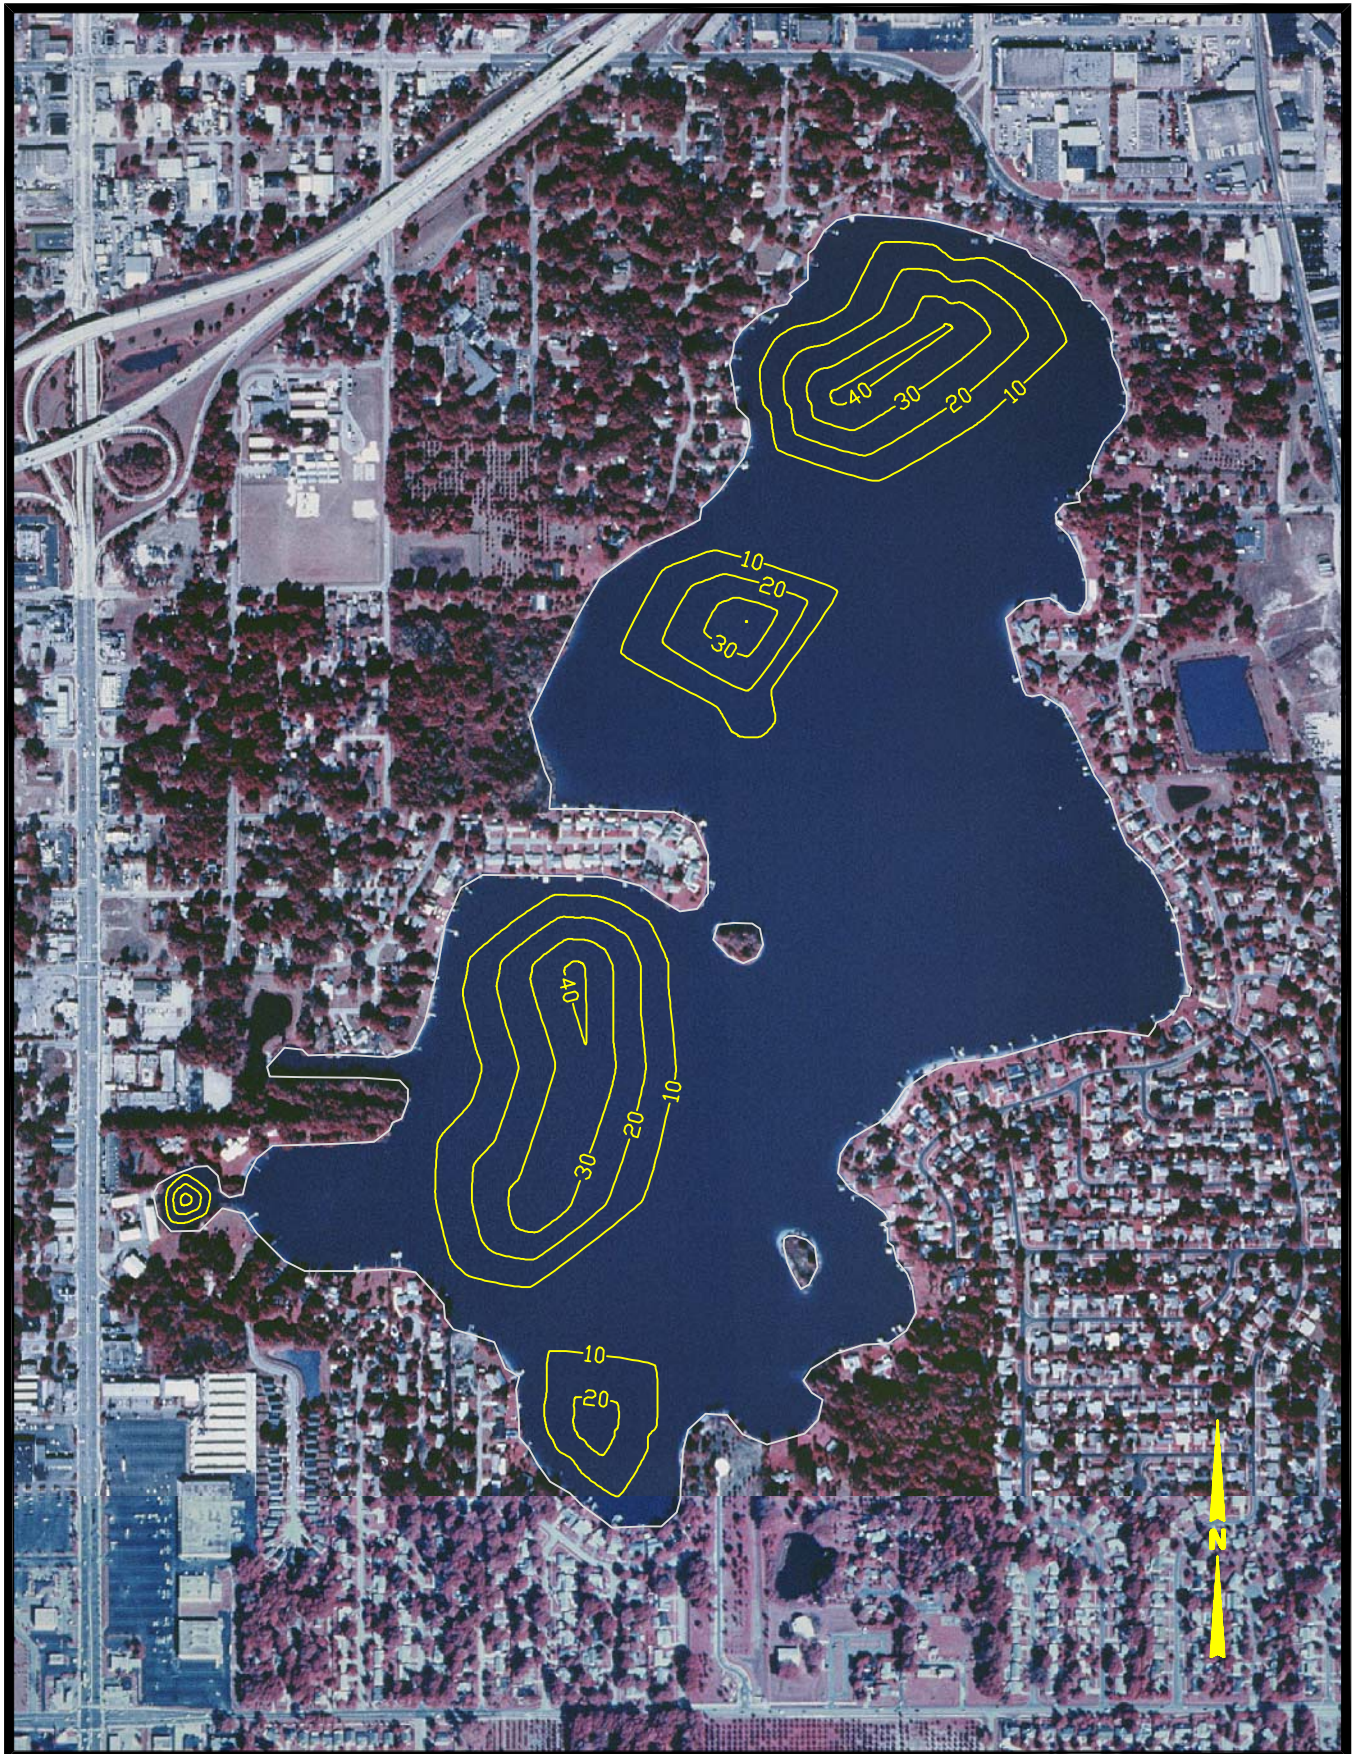
Figure 2-7. Isopleths of Sediment Organic Content (%) in the Top 10 cm in Lake Holden.

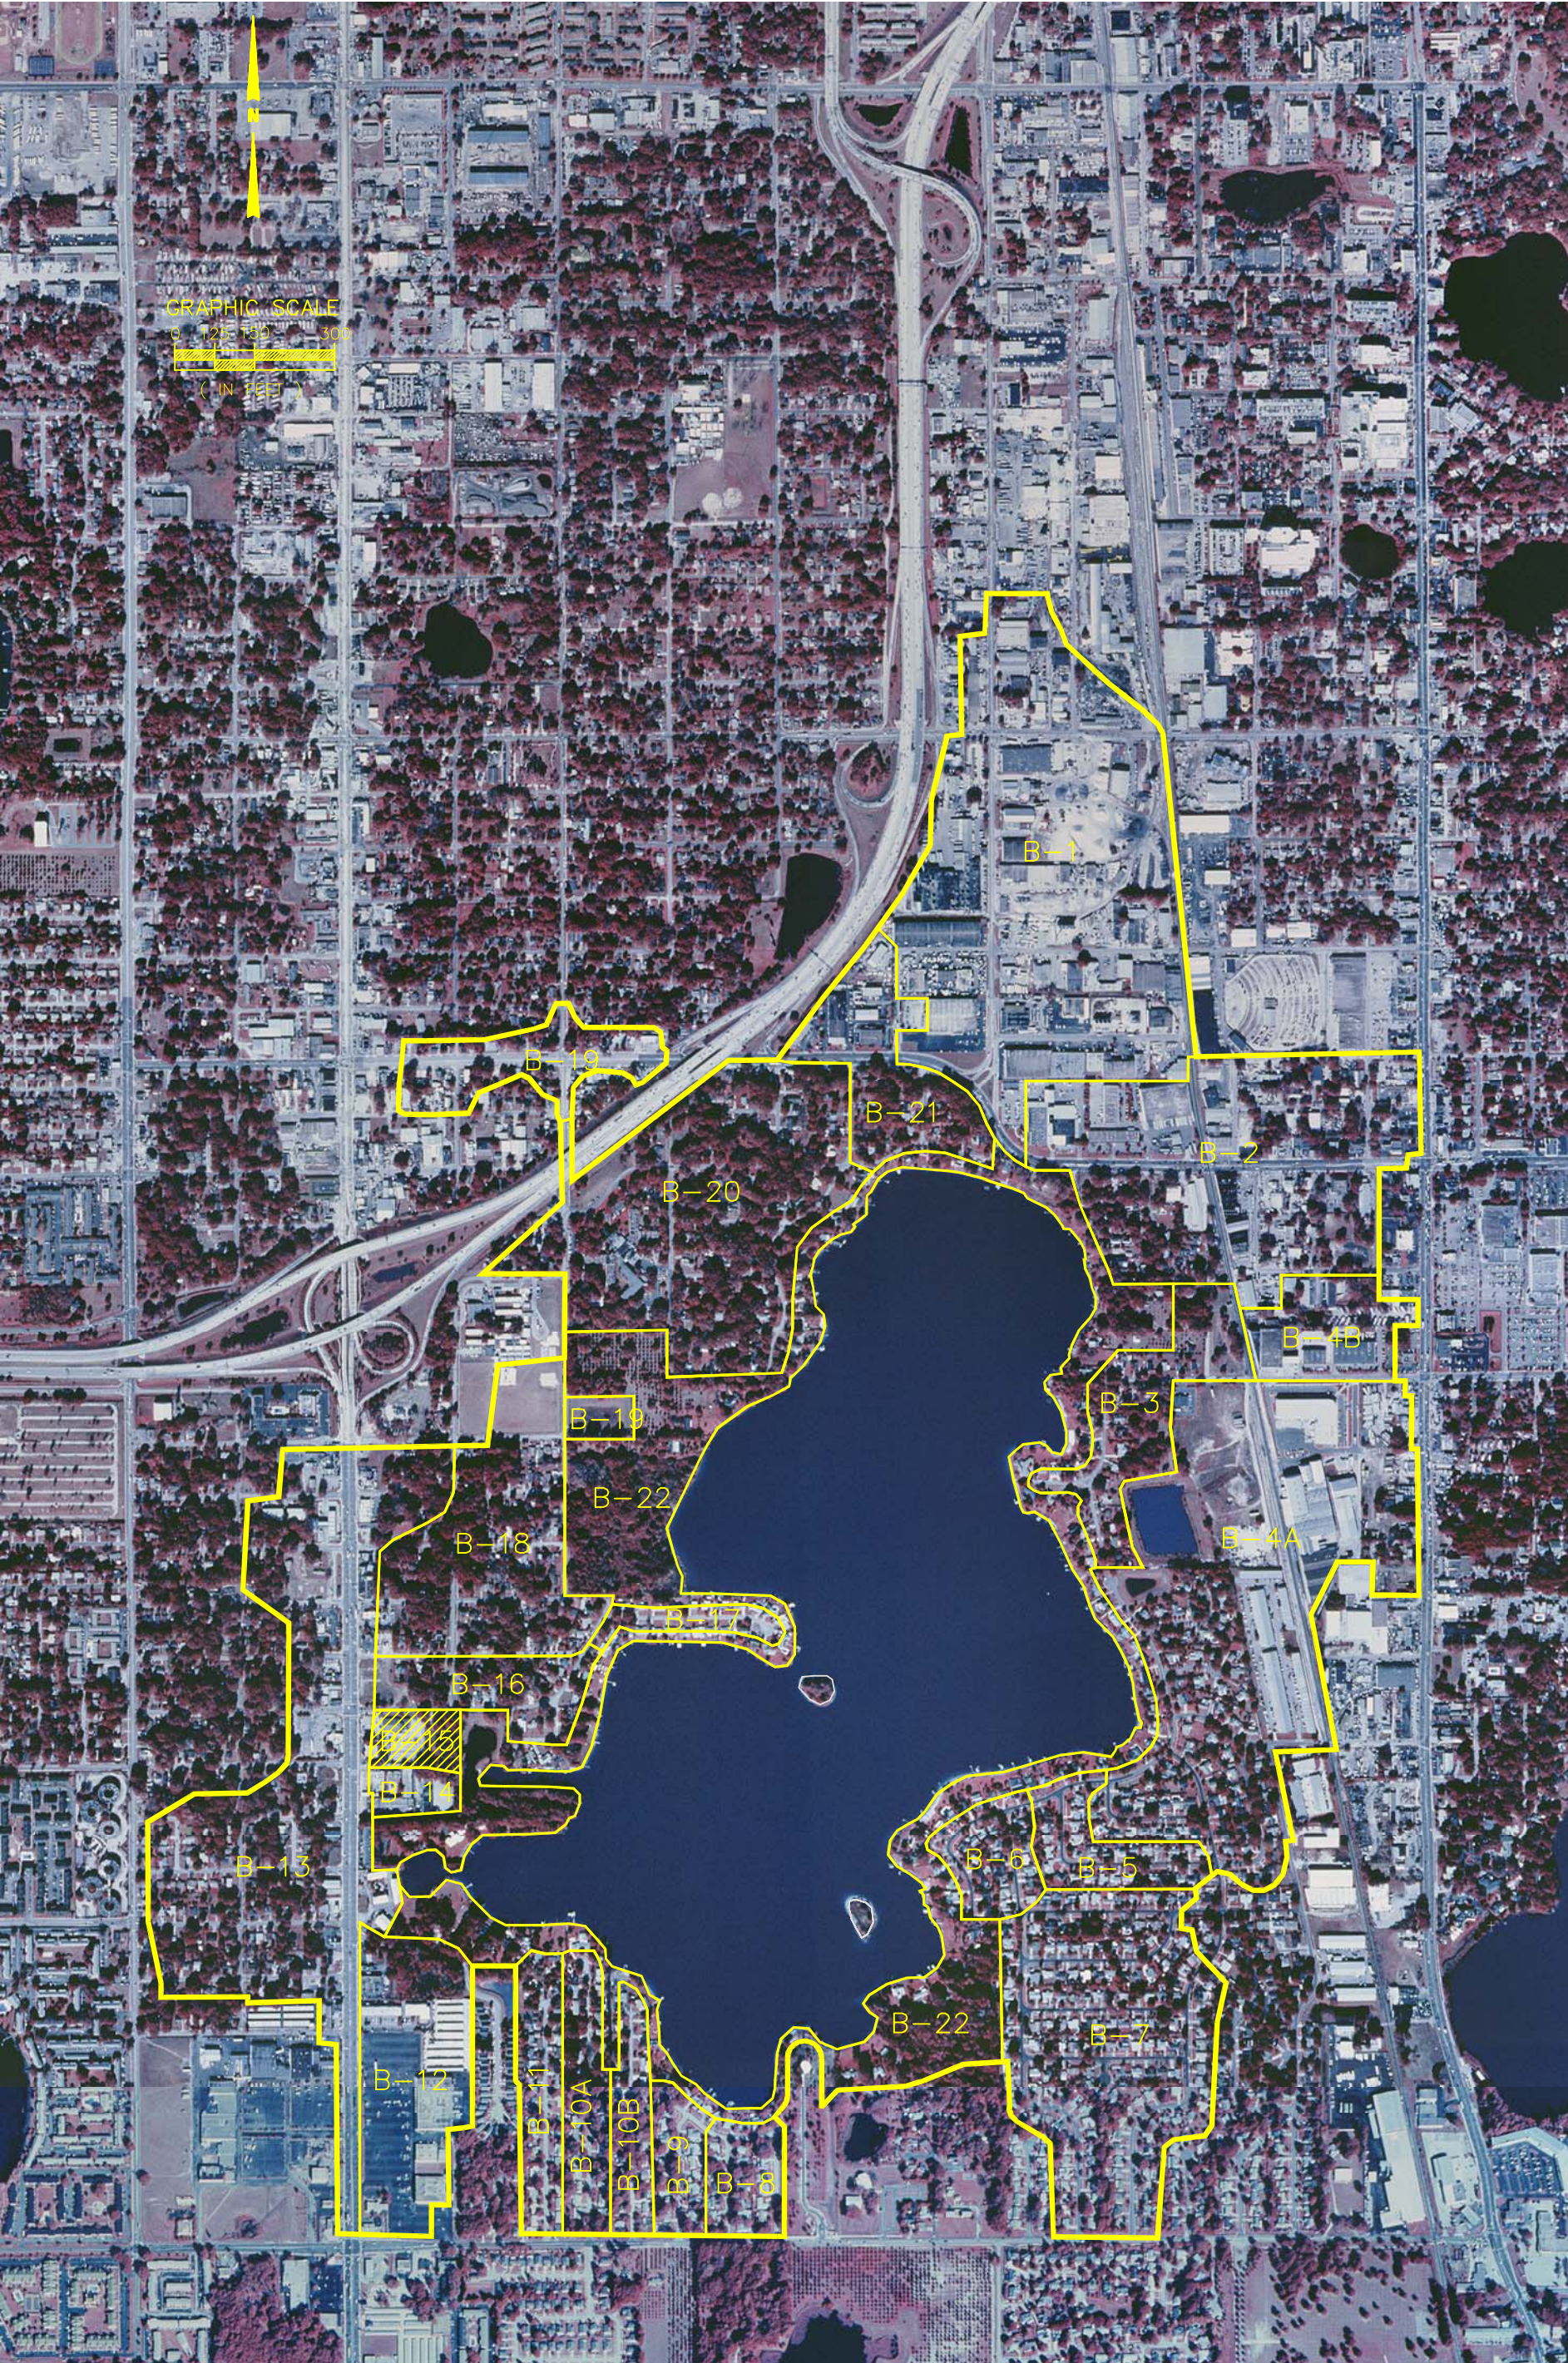
Figure 3-1. Drainage Sub-Basin Areas Discharging to Lake Holden.

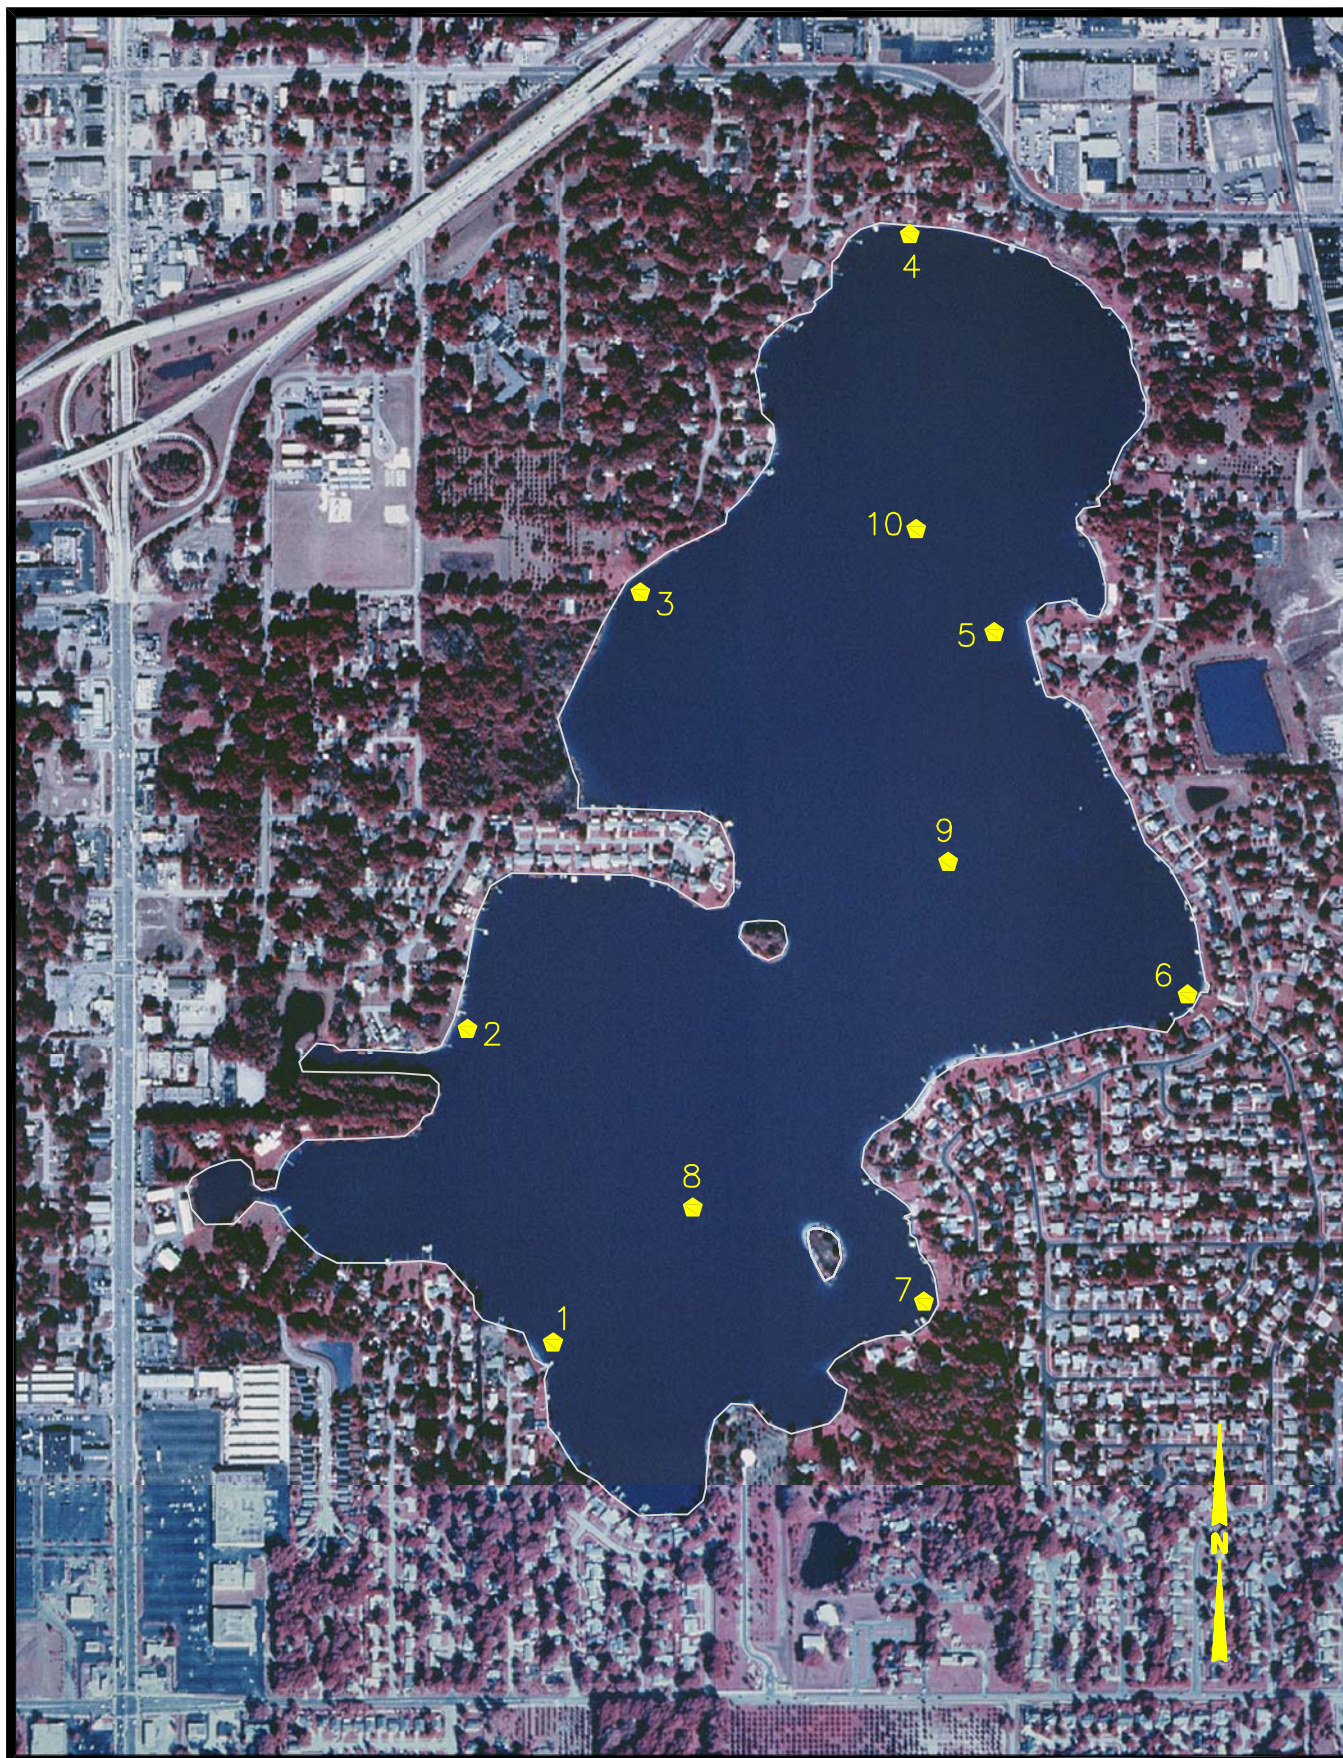
Figure 3-5. Seepage Meter Monitoring Sites.

Each of the 10 seepage meters was monitored on approximately a monthly basis from April-October 2003. A total of seven separate seepage monitoring events was conducted for evaluation of quantity and quality at each of the monitoring sites, with a total of 59 samples collected between the 10 sites.

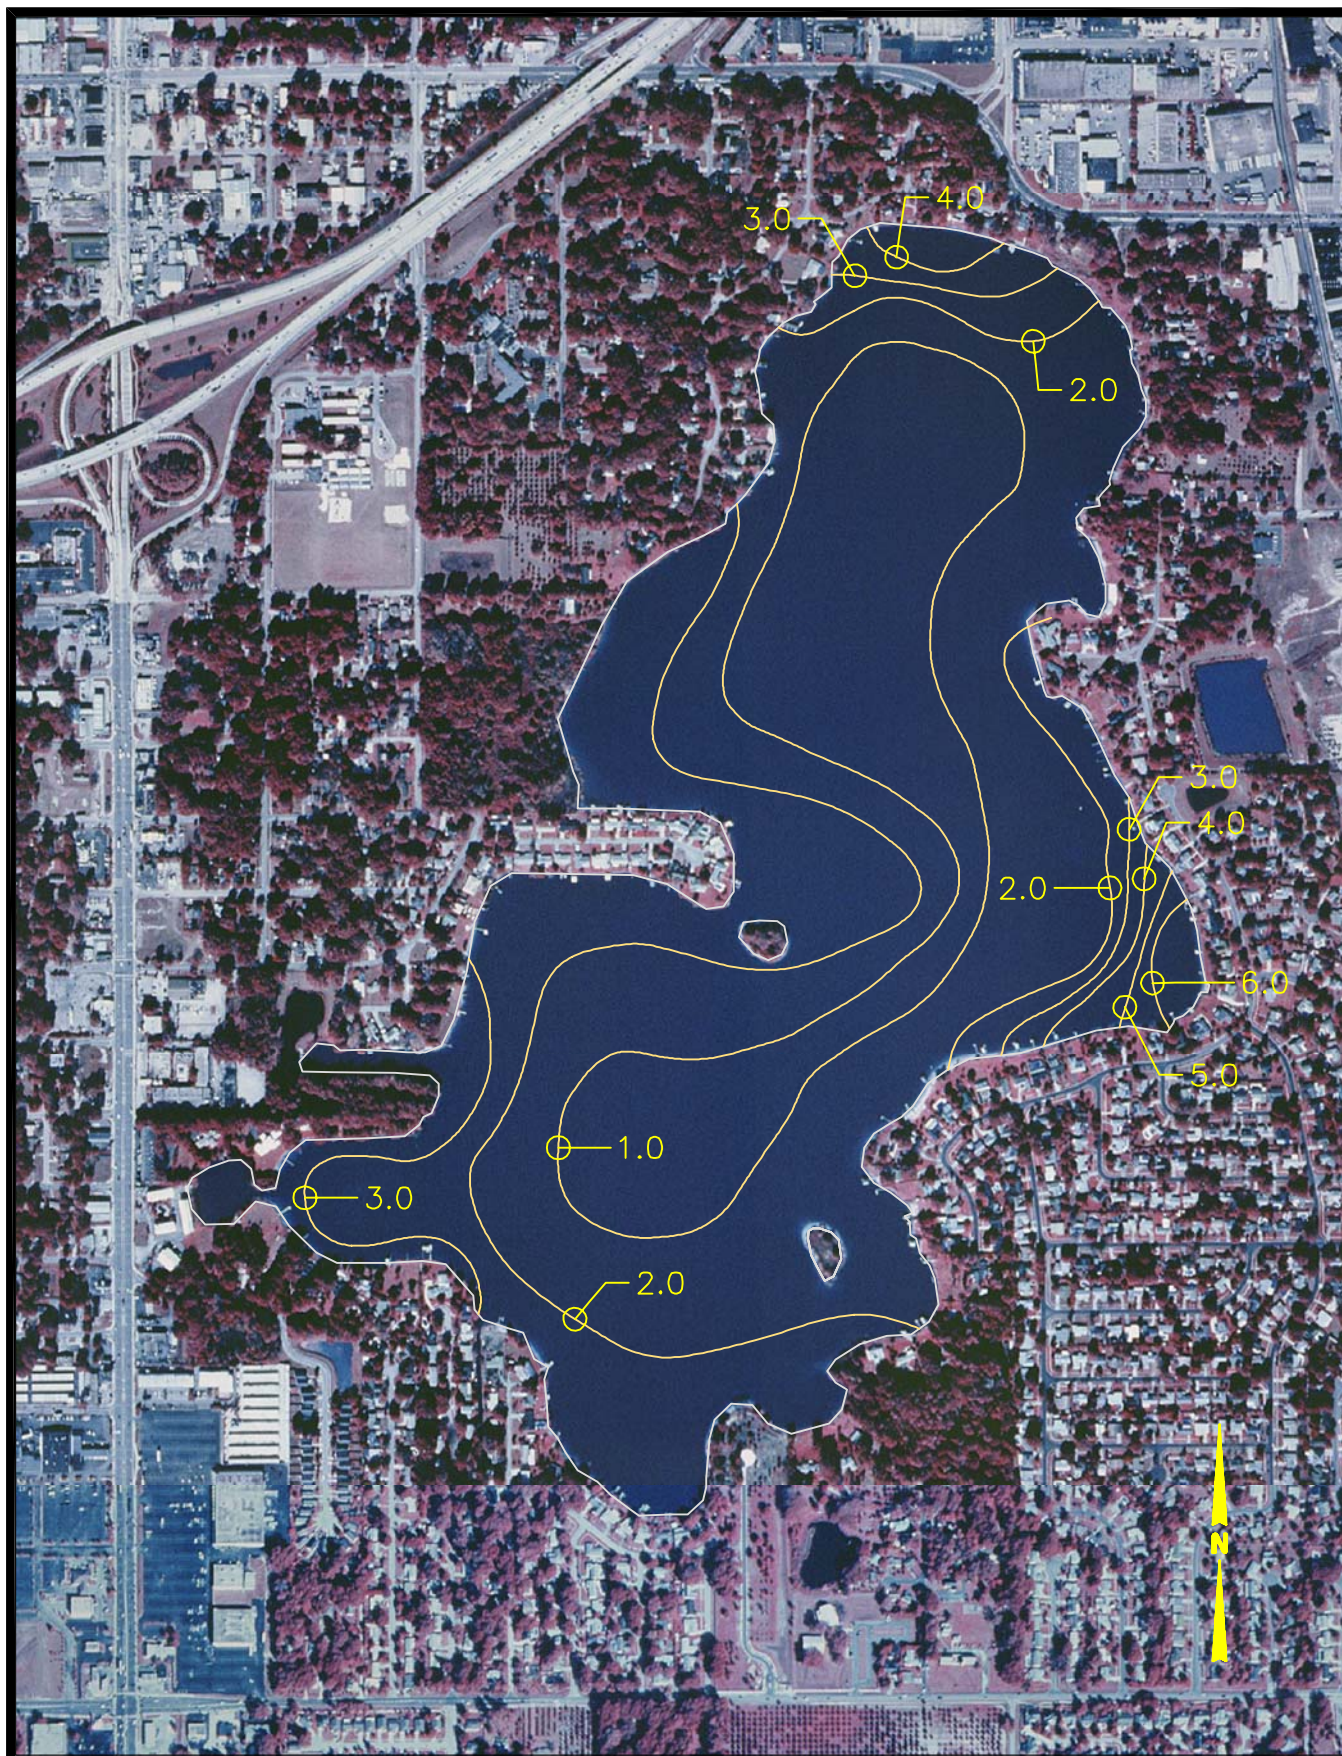
Figure 3-6. Isopleths of Groundwater Seepage ( $\text{l/m}^2 \cdot \text{day}$ ) inflow to Lake Holden.

Estimated seepage inflow isopleths for Lake Holden are illustrated on Figure 3-6. The isopleths present estimates of mean groundwater inflow into the lake in terms of liters per square meter of surface area per day. The highest rates of seepage influx appear to occur in northern, eastern, and western portions of the lake, with lower estimated seepage inflow in central portions of the lake.

The seepage isopleths indicated on Figure 3-6 were graphically integrated to obtain estimates of mean daily seepage influx into Lake Holden. This mean value was converted to an annual average by multiplying by 365 days/year. Based upon this analysis, seepage influx into Lake Holden is estimated to contribute approximately 564.75 ac-ft/yr of water inputs into the lake. This corresponds to an areal loading of 2.156 ac-ft per acre of lake area per year. These values are utilized in subsequent sections for development of an overall hydrologic budget for Lake Holden.

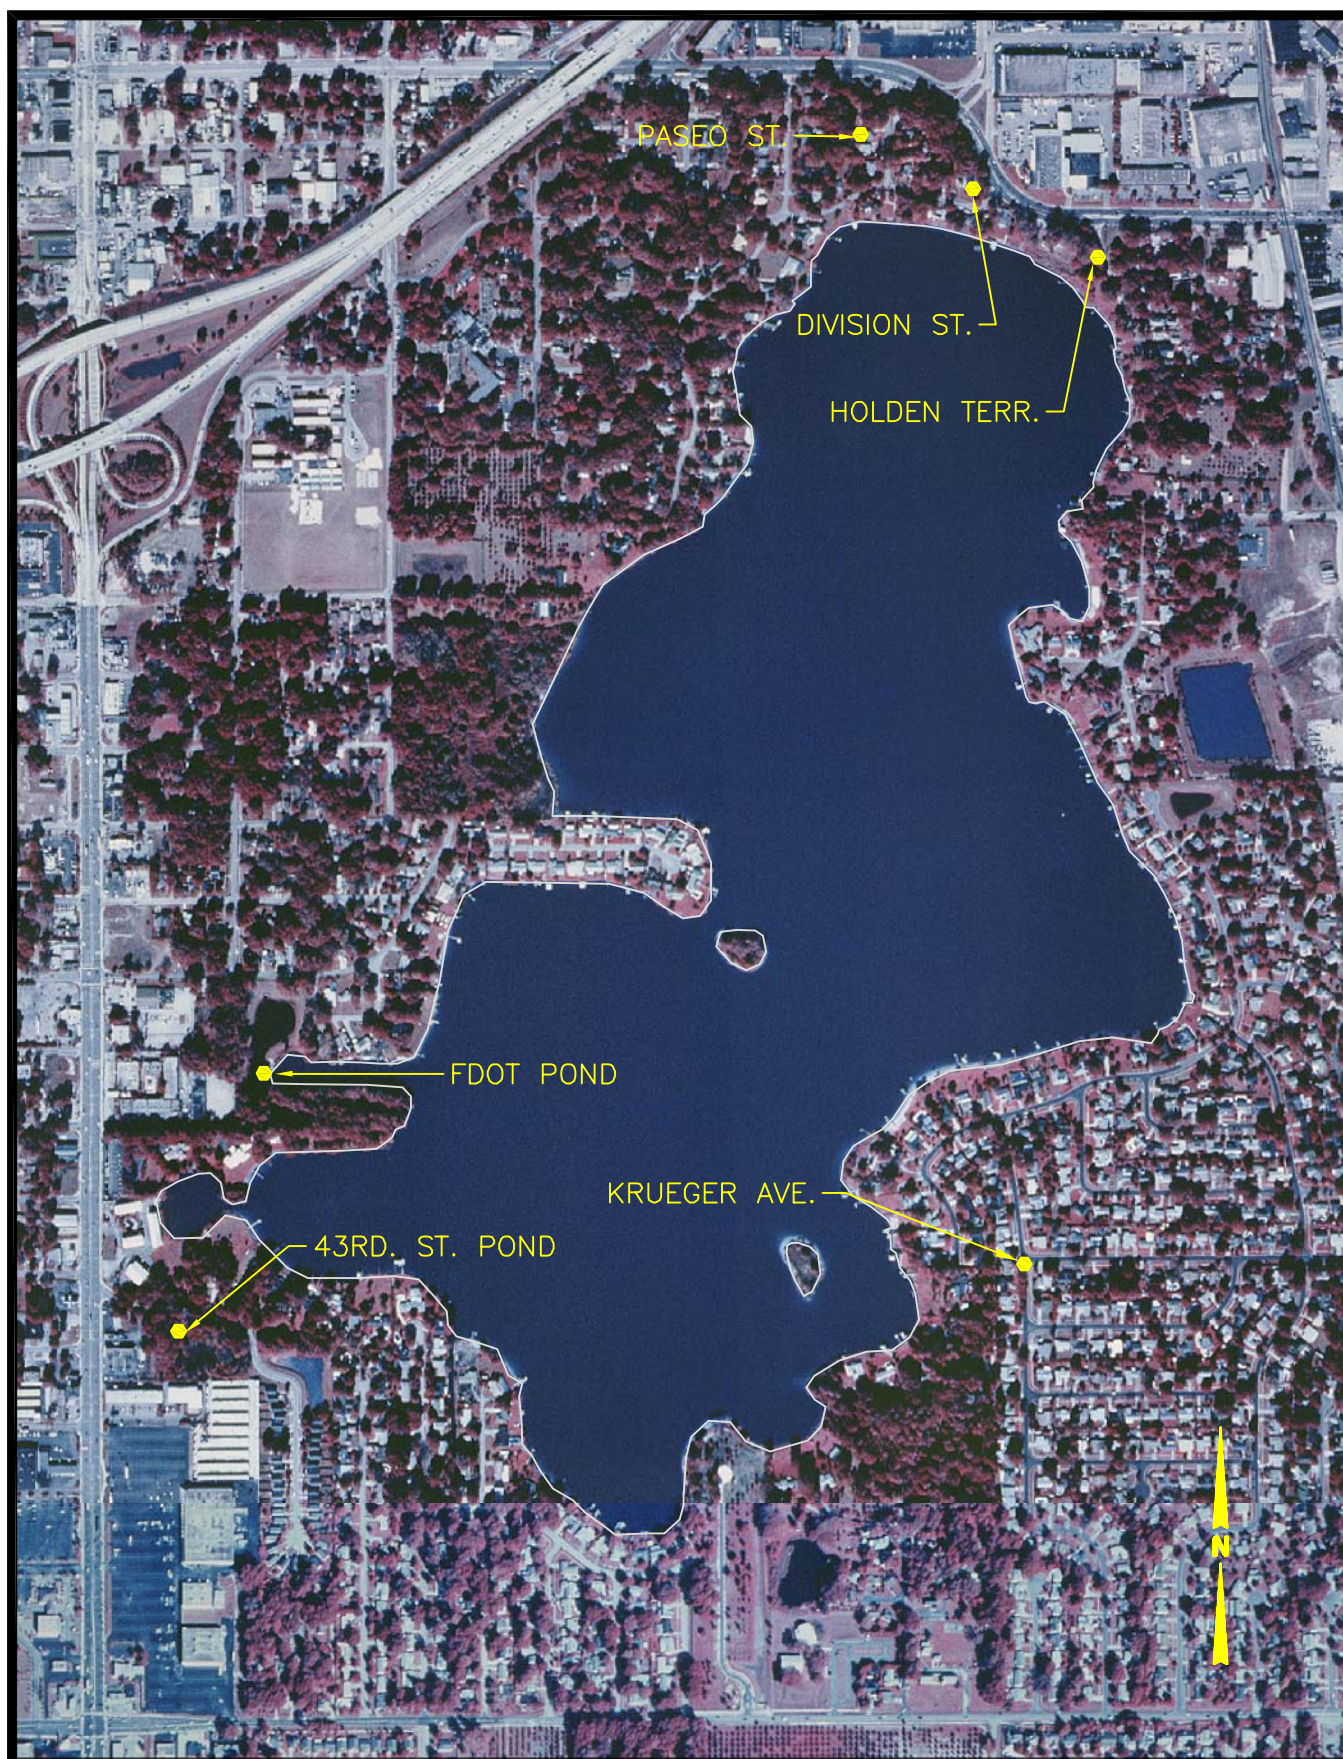
Figure 4-1. Locations of Stormwater Monitoring Sites

Five of the six monitoring sites listed in Table 4-3 have been retrofitted with stormwater management systems since the previous monitoring performed by ERD during 1991-1992. Sub-basins identified as 1, 2, and 21 have been retrofitted with alum injection stormwater treatment systems. Sub-basin areas identified as 12 and 13 have been retrofitted with wet detention ponds. No stormwater retrofit activities have been performed in Sub-basin 7 which consists of a large residential area which discharges along Krueger Street.

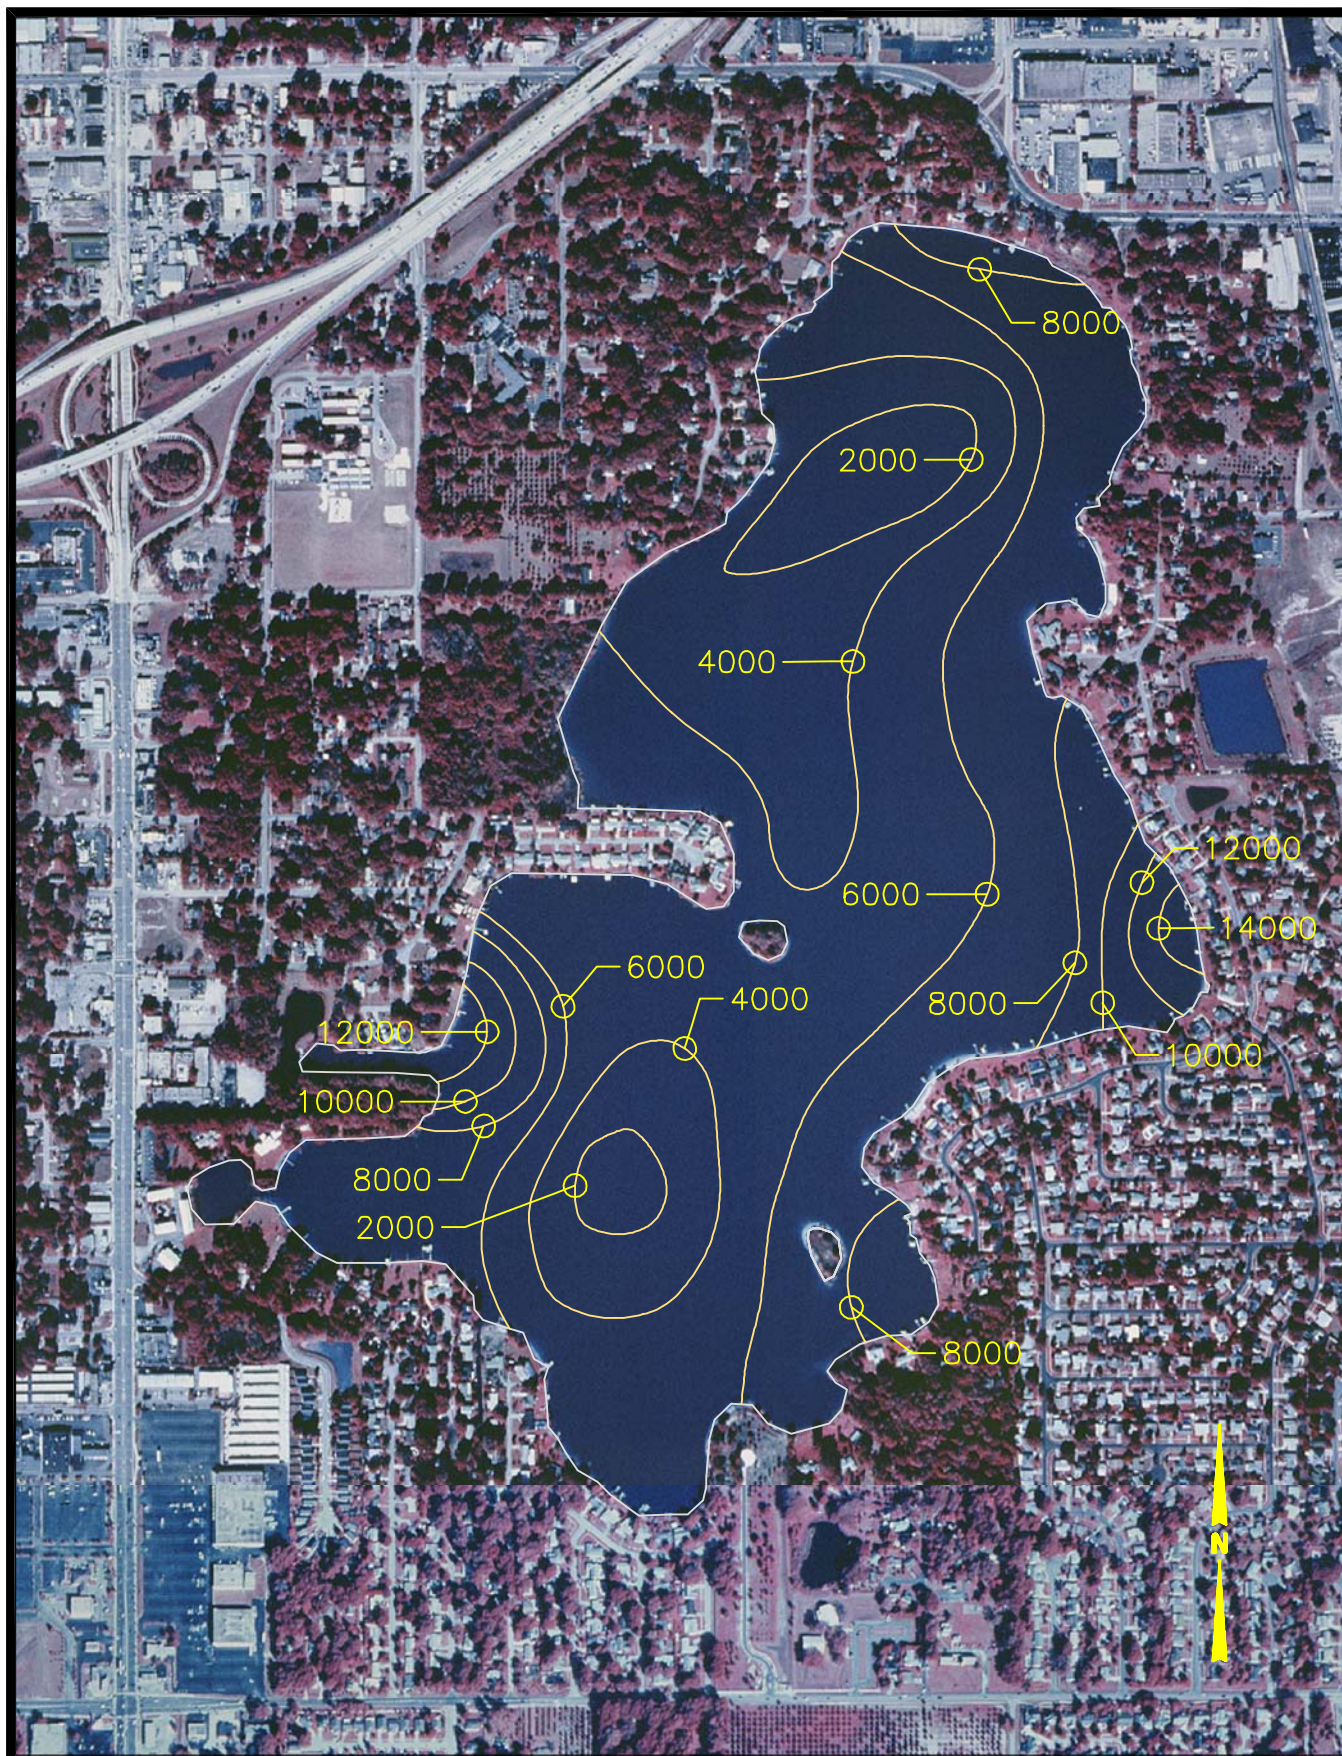
Figure 4-5. Isopleths of Total Nitrogen Influx ( $\mu\text{g}/\text{m}^2 \cdot \text{day}$ ) from Groundwater Seepage Entering Lake Holden.

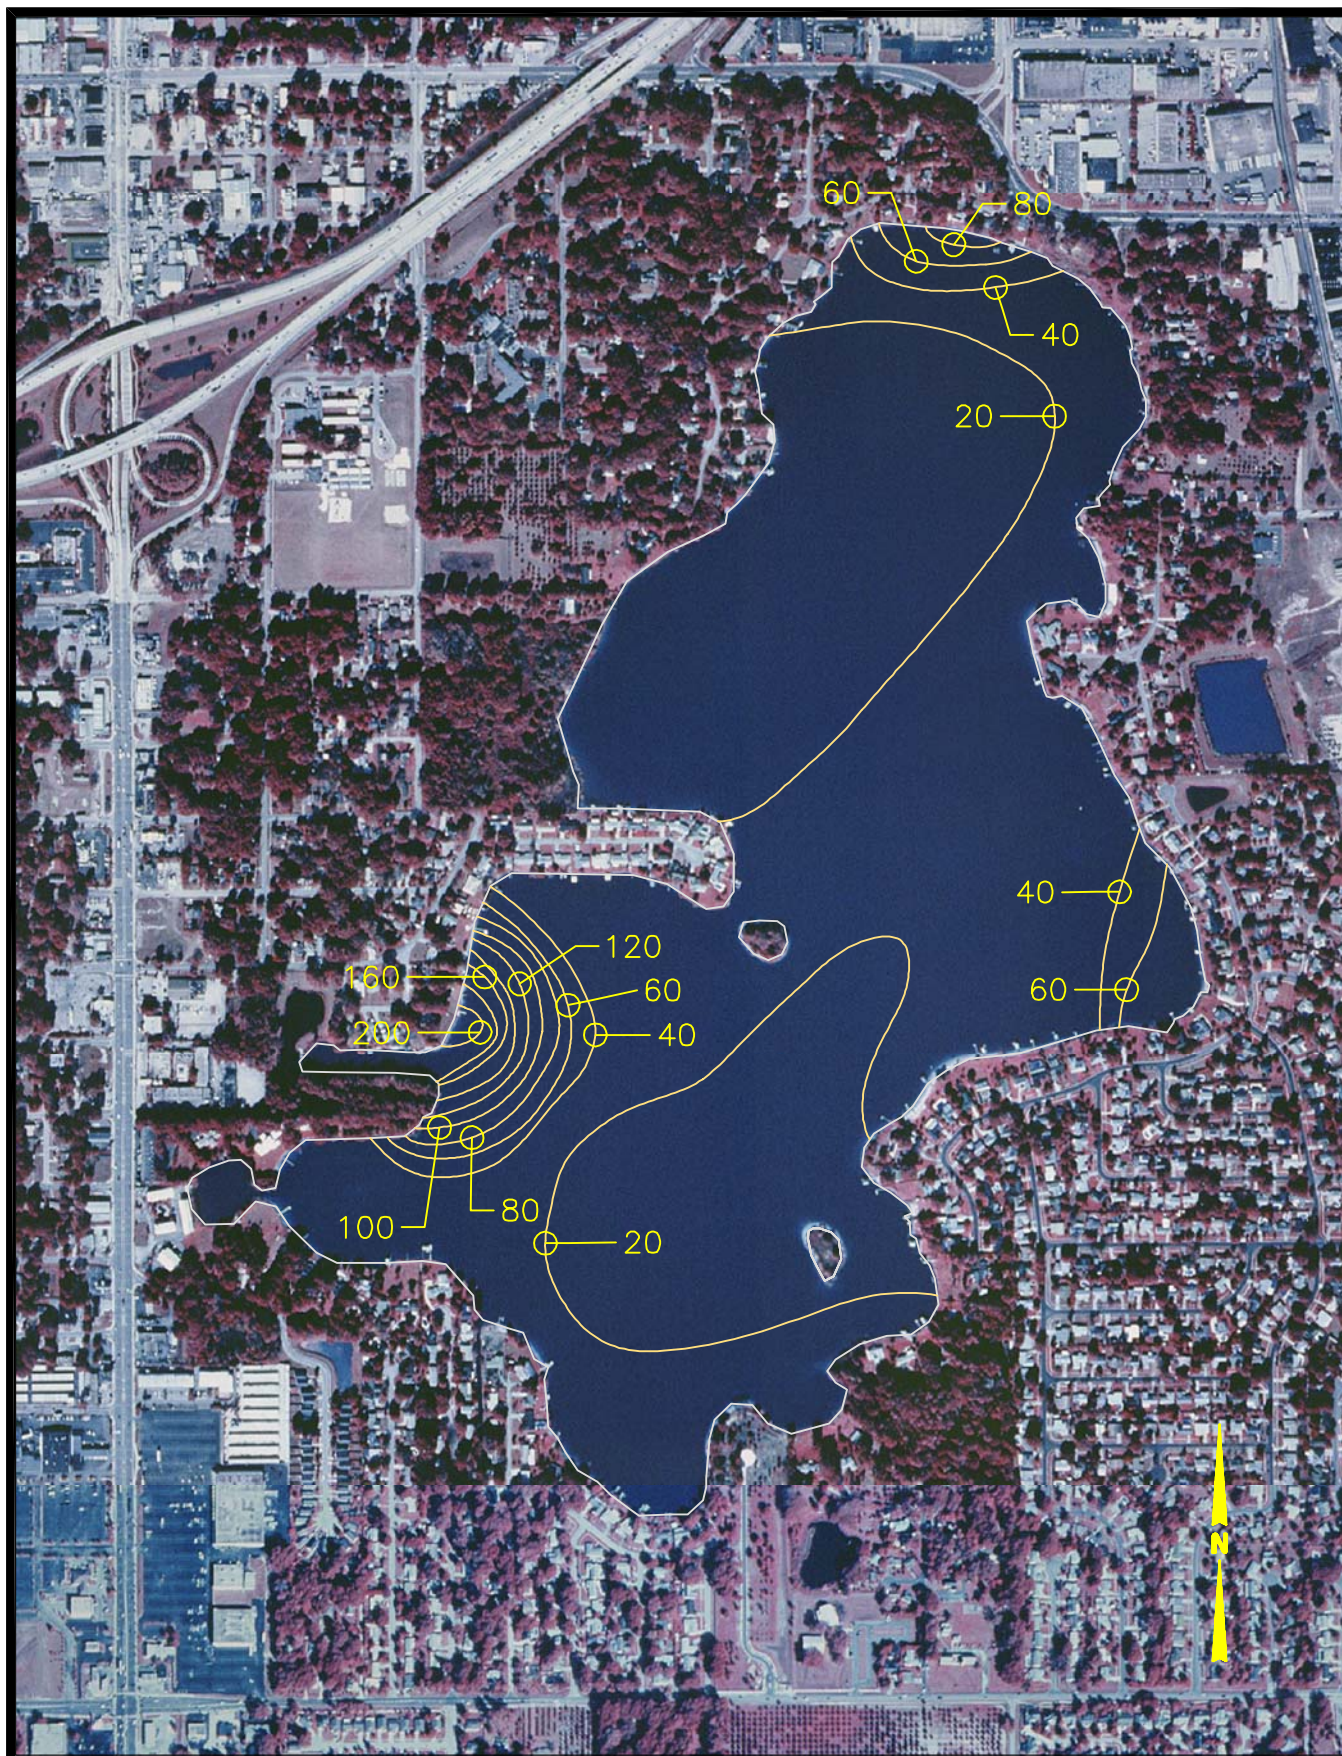
Figure 4-6. Isopleths of Total Phosphorus Influx ( $\mu\text{g}/\text{m}^2 \cdot \text{day}$ ) from Groundwater Seepage Entering Lake Holden.
